Service Bulletin

Bulletin No.: 22-NA-004

Subject: Rear Spoiler Foam Tape Seal Loose, Visible to Customer

Brand:	Model:	Model Year:		VIN:		Engine:	Transmission:
		from	to	from	to		
Chevrolet	Bolt EUV	2022	2023	—	—	All	All

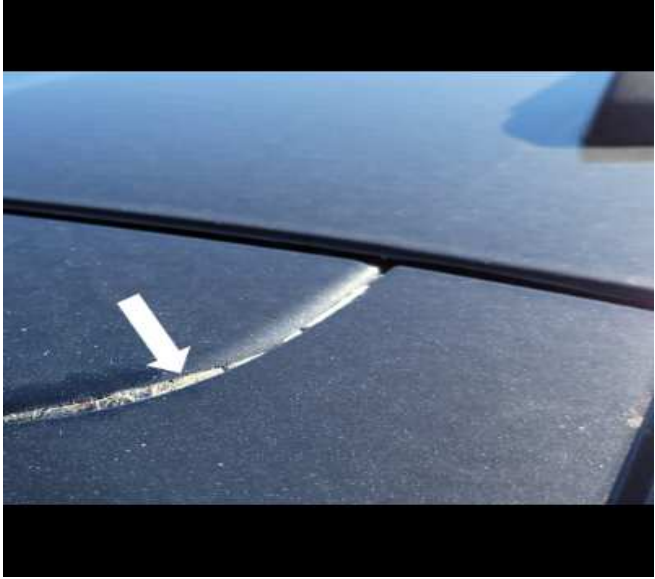
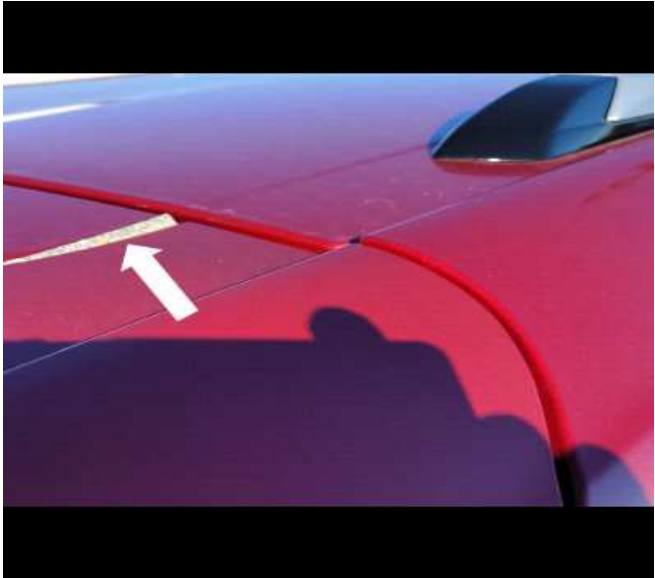
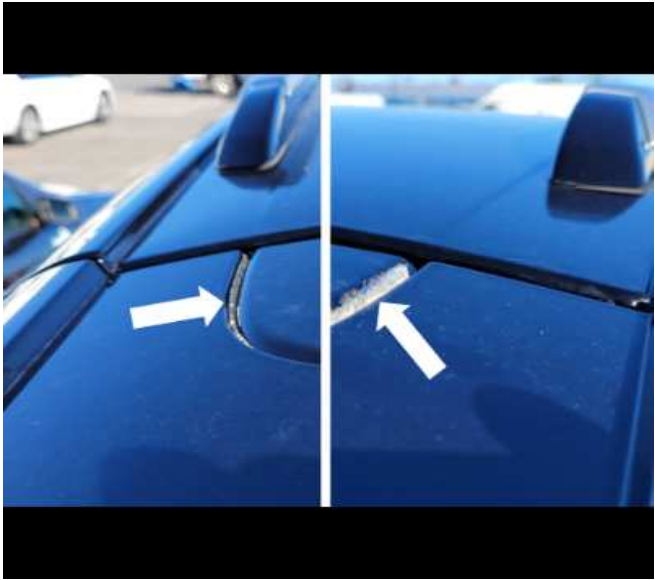
<p style="text-align: right;">5950653</p> <p>Some customers may comment that the rear spoiler foam tape seal is visible and protruding from the roof line.</p>
<p>Cause</p>	<p>The cause of the condition may be that the foam tape seal on the rear spoiler is improperly installed and is detaching from the underside of the spoiler.</p>
<p>Correction</p>	<p>R & R the rear spoiler and replace the seal with a new service part, following the steps in the Service Procedure below.</p>
