Service Bulletin

Bulletin No.: 22-NA-089

Subject: Intermittent Click Noise at Front of Vehicle, ABS, Traction Control System (TCS)/ Stabilitrak Lamps May Illuminate Intermittently and/or Deactivate for Ignition Cycle - DTC P215B, C0035-C0051 Set

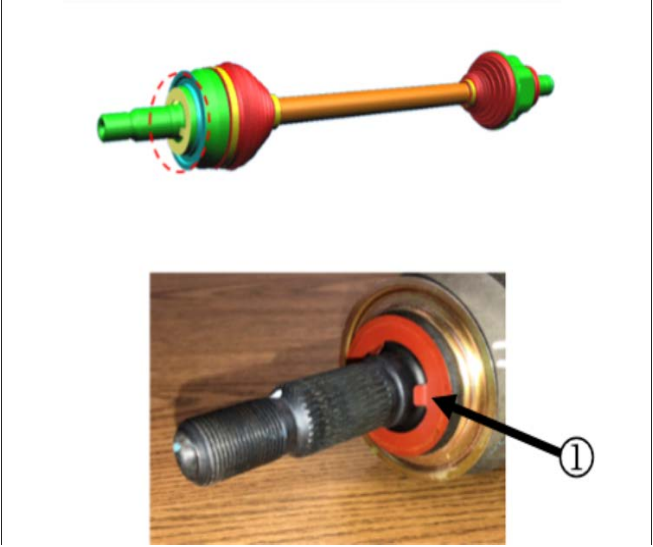
Correction	<p style="text-align: right;">5317523</p> <p>This condition may be caused by fracturing of the front wheel drive shaft anti-click washer (1) and possible collateral damage to the ABS wheel speed sensor (WSS).</p> <p>Note: In cases where the condition is verified on both sides of the vehicle, replace the anti-click washer on BOTH sides.</p> <p>Upon verifying the condition, replace the anti-click washer with new part number shown below on the affected half shaft(s), then inspect the wheel speed sensor on that side(s).</p> <p>Note: If DTC P215B ever sets on the vehicle, replace the wheel speed sensor.</p>

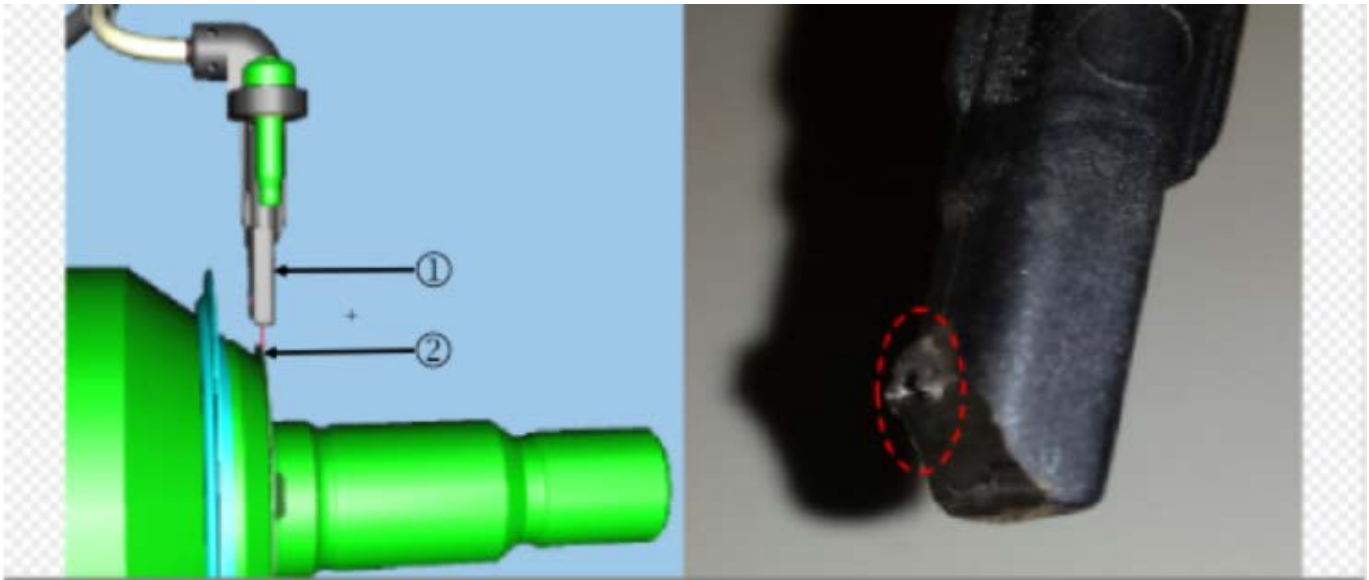
5317529

Note: The example above depicts the wheel speed sensor (WSS) (1) directly in-line with the anti-click washer (2) on the outboard joint of the half shaft.

4. Inspect the WSS on either/both affected side(s) for possible damage.
 - If no damage is found, reinstall the lower control to the steering knuckle, and no further repairs are necessary.
 - If the WSS is found to be damaged (as shown circled in the graphic above), continue ahead to step # 5.
