# Service Bulletin

Bulletin No.: 16-NA-405

**Subject:** Poor Engine Performance in Extremely Cold Weather Conditions, PCV Bypass Hose and Charge Air Cooler Icing for LUV Engines, Malfunction Indicator Lamp (MIL) Illuminated - DTC P0299, P0234, P2227, P00C7 Set

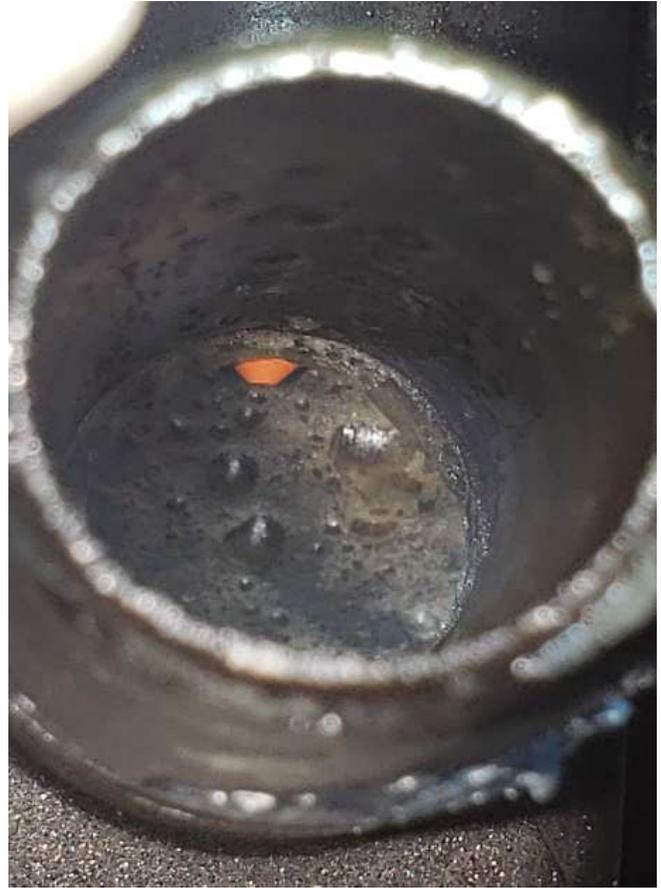
5286434

2. Inspect the vacuum ports of the intake manifold for ice accumulation.

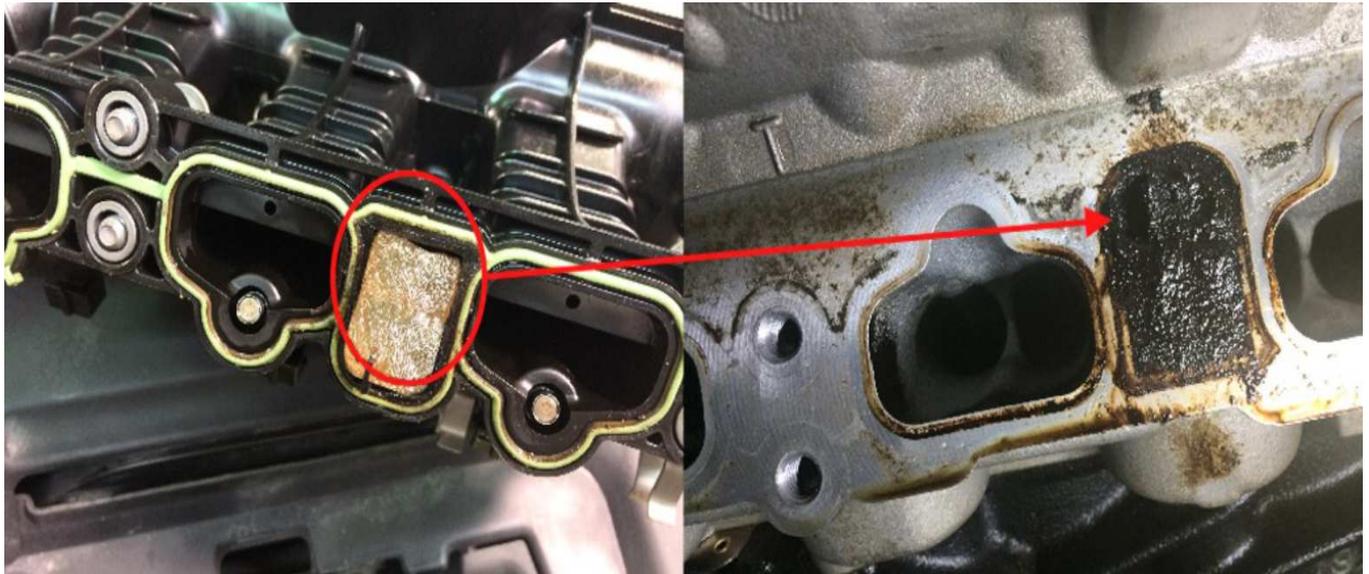
5286457

3. Inspect the PCV intake runner for ice build-up blocking the cylinder head as shown above.

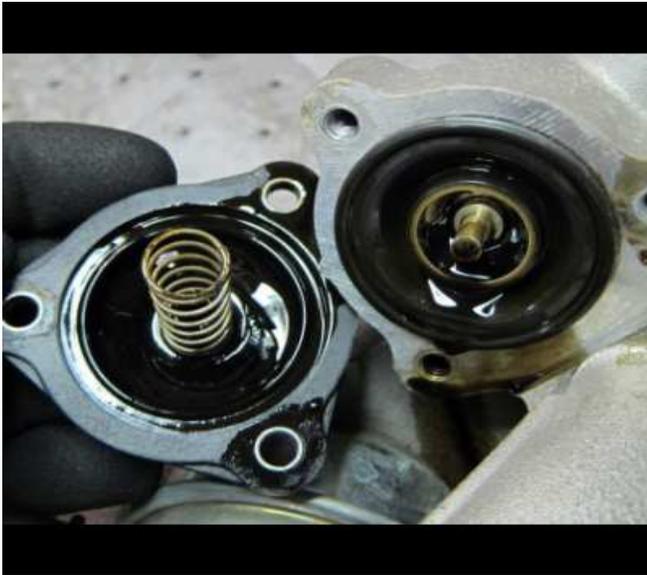
5590616

8. Inspect the charge air bypass valve for oil leaking from the vacuum side port.

- If oil is found leaking from the valve port, disassemble and clean the components. Refer to *Charge Air Bypass Valve Replacement* in SI.
  - Only if necessary, replace the components.
9. Install the valve.
  10. Install the intake manifold.

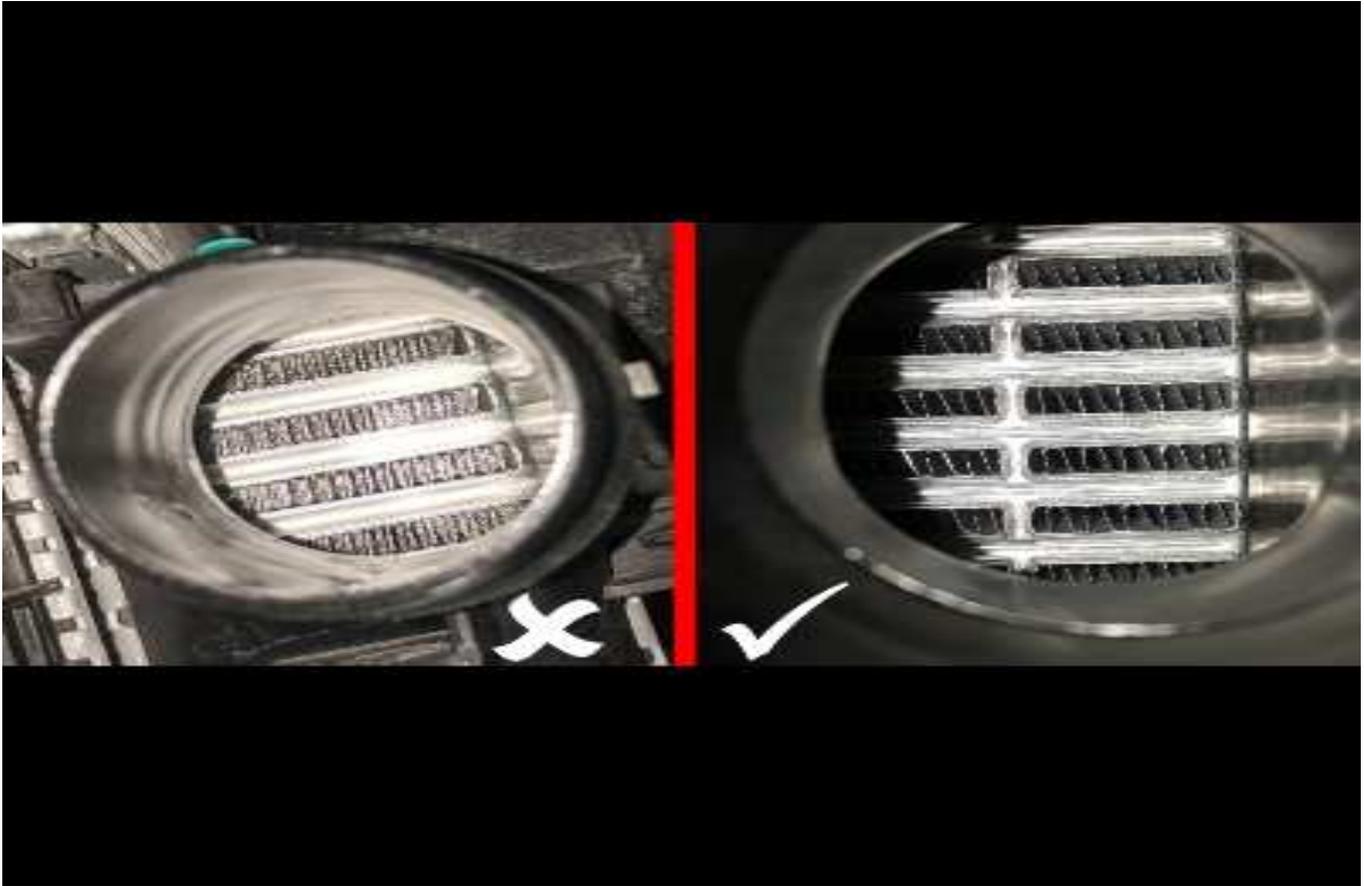
6159510

2. Inspect the charge air cooler through the inlet to determine if the vehicle has the new or old design.
  - If the charge air cooler is the old design (shown by X in the graphic), proceed to the Charge Air Cooler Replacement section below.
  - If the charge air cooler is the new design (shown by the check mark in the graphic – note the wider fin spacing and a division in the middle of the charge air cooler), no charge air cooler replacement is necessary.
3. Remove and clean the IAPT sensor.
4. Using care, remove the bands that secure the air hoses to the elbow duct.

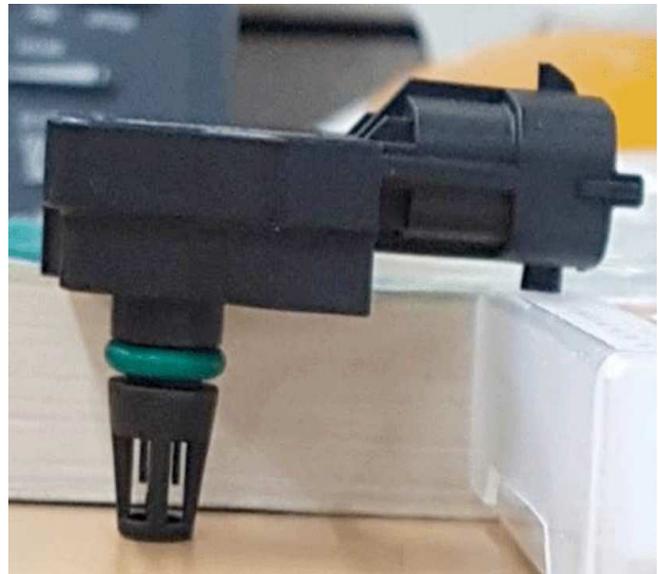
5020216

2. Inspect the IAPT sensor for any contaminants.

3. Allow time for any ice build-up to melt by placing the sensor port down.
4. Clean the sensor with a clean towel.
5. Inspect the IAPT sensor for any contaminants.
6. Install the sensor into the elbow duct.
