Service Bulletin

Bulletin No.: 21-NA-077

Subject: Information on Aero Shutter Related Diagnostic Codes

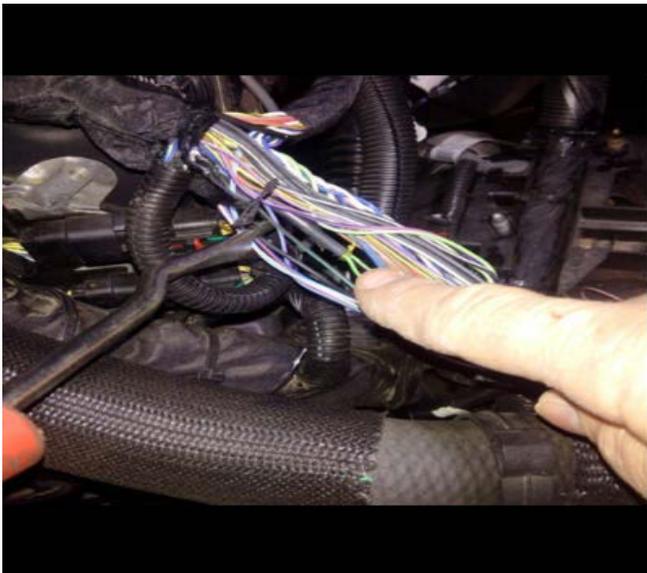
5821156

3. Check the integrity of the **J171 splice**. Moving this splice, even small amounts, can cause intermittent communication issues. If any issues are detected in the splice, repair the splice and report what was repaired.

Note: If the **J171 splice** is found to be an issue, replace the entire splice, do not attempt to repair it. Cut out the splice for part return and submit a photo, **taken prior to cutting the section where the issue has been detected**.

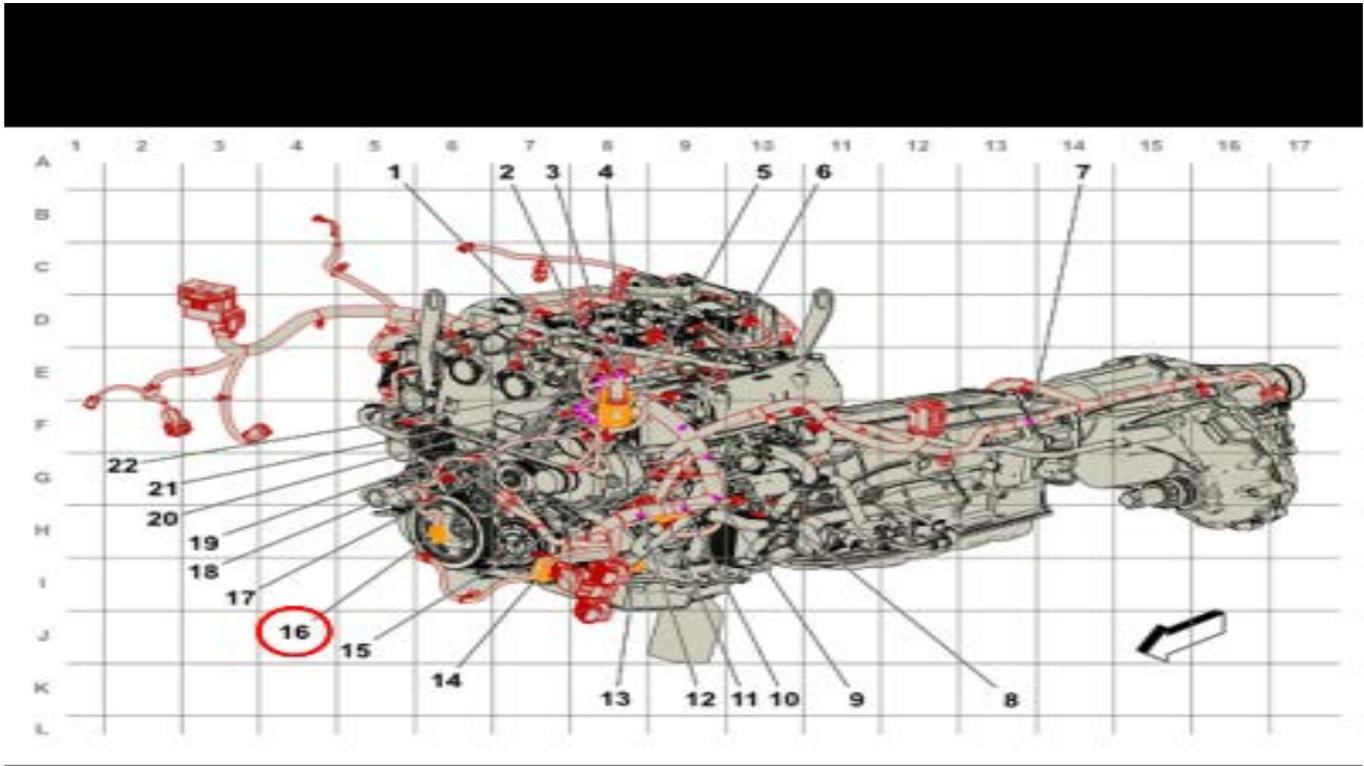
Note: Closely inspect the X132 Engine Harness to Active Grille Air Shutter 1 Actuator Jumper Harness (VTI/WMI) connector (16) for any broken wiring.

7. Check the X132 connector & VTI/WMI (and X133 connector when applicable & WMI) for corrosion and water intrusion. Additionally, check the other connectors to the Aero shutter.
8. If there are signs of water, but not corrosion, please check the seal condition of the connectors. If they are not damaged, please apply dielectric grease to the connector. If there's corrosion present, proceed to replace the shutter. Take photos and hold the part for return.

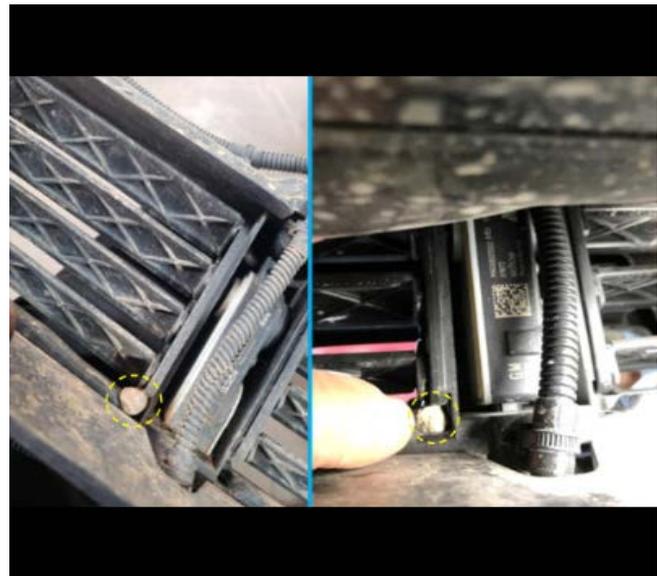
6154862

Note: For vehicles equipped with upper and lower shutters, the upper shutter, top passenger side louvre/vane is intentionally missing from the shutter assembly for airflow reasons. DO NOT replace the shutter for this reason.

1. Check for any debris in the upper and lower shutters. If found, please remove the debris.
2. If there is no debris evident, please look for a louvre/vane that is disengaged from the linkage. If the vehicle has a shutter with this condition, please engage the louvre/vane in the shutter assembly. If shutter is operational, DO NOT replace the shutter.

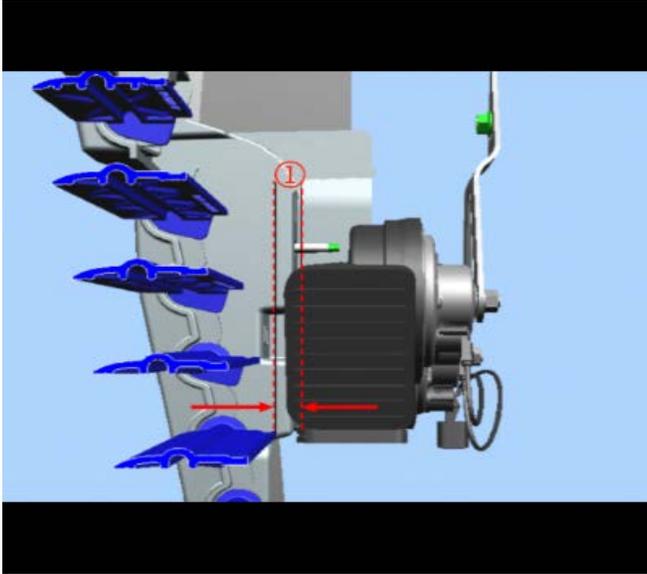
5880462

3. Check to see if the upper shutter in open position is binding on the air induction plenum. It is located on the driver's side upper behind the upper shutter. If this condition exists, secure the air induction plenum to structure behind, using a 2-stage push pin.
4. Check to see if the upper shutter is binding on the **HORN or BRACKET**. It is located on the passenger's side upper, behind the upper shutter

Important: Ensure there is at least 10 mm (0.40 in) clearance (1) between the shutter vane and horn. If there is NOT, bend the horn bracket away from the shutter until the 10 mm (0.40 in) of static clearance is achieved.

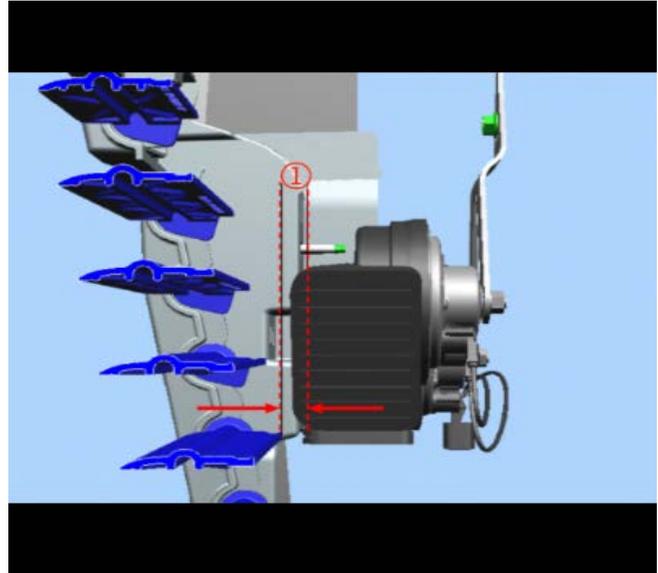
5880462

2. If there is no debris, please look for a louvre/vane that is disengaged from the linkage. If the vehicle has a shutter with this condition, please engage the louvre/vane in the shutter assembly. **DO NOT** replace the shutter.
3. Check to see if the upper shutter is binding on the **HORN or BRACKET**. It is located on the passenger's side upper, behind the upper shutter.

Important: Ensure there is at least 10 mm (0.40 in) clearance (1) between the shutter vane and horn. If there is NOT, bend the horn bracket away from the shutter until the 10 mm (0.40 in) of static clearance is achieved.
