Service Bulletin

Bulletin No.: 22-NA-191

Subject: Super Cruise Enhancement: Trailing and Active Lane Change

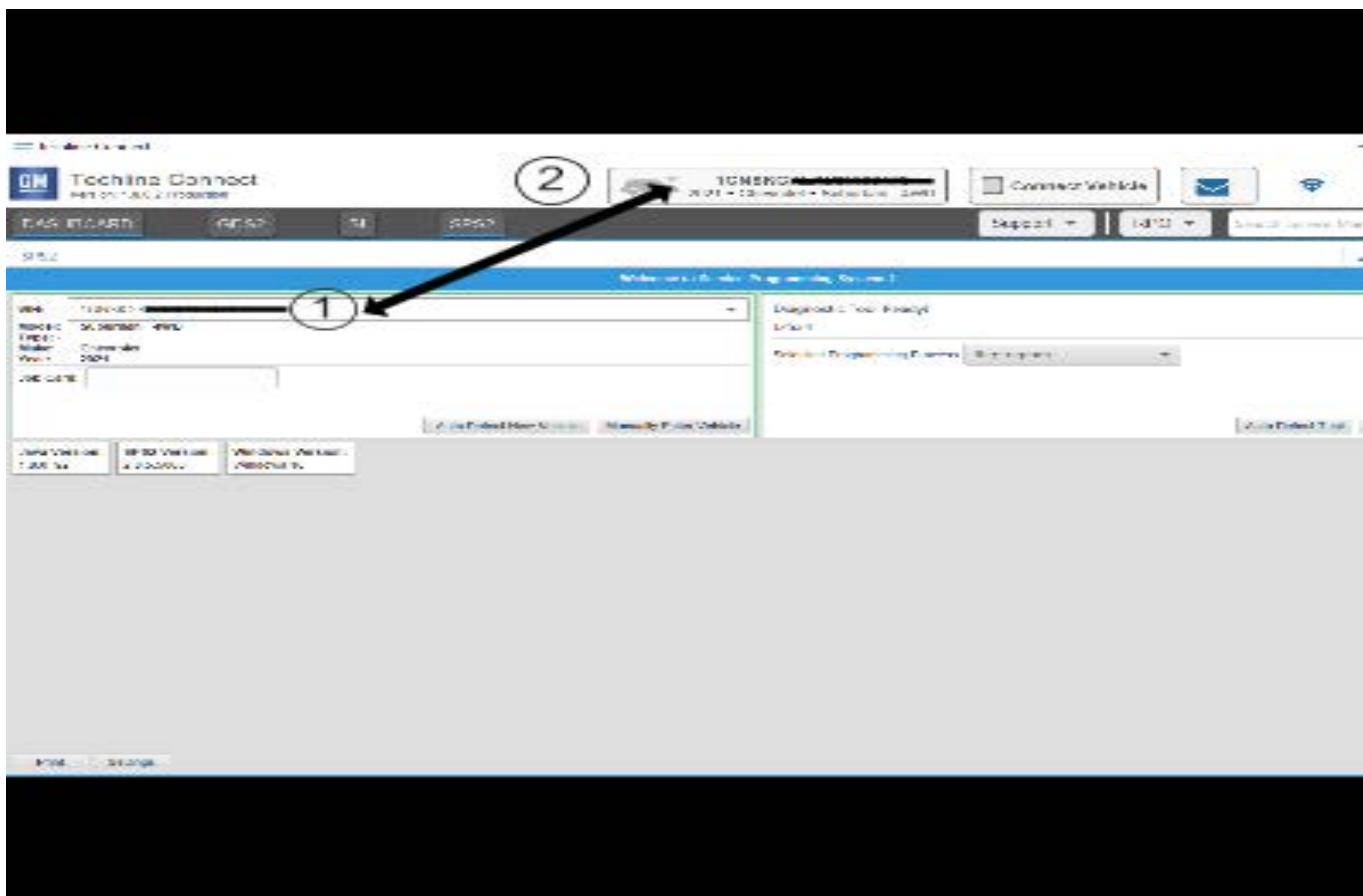
Caution: Be sure the VIN selected in the drop down menu (1) is the same as the vehicle connected (2) before beginning programming.

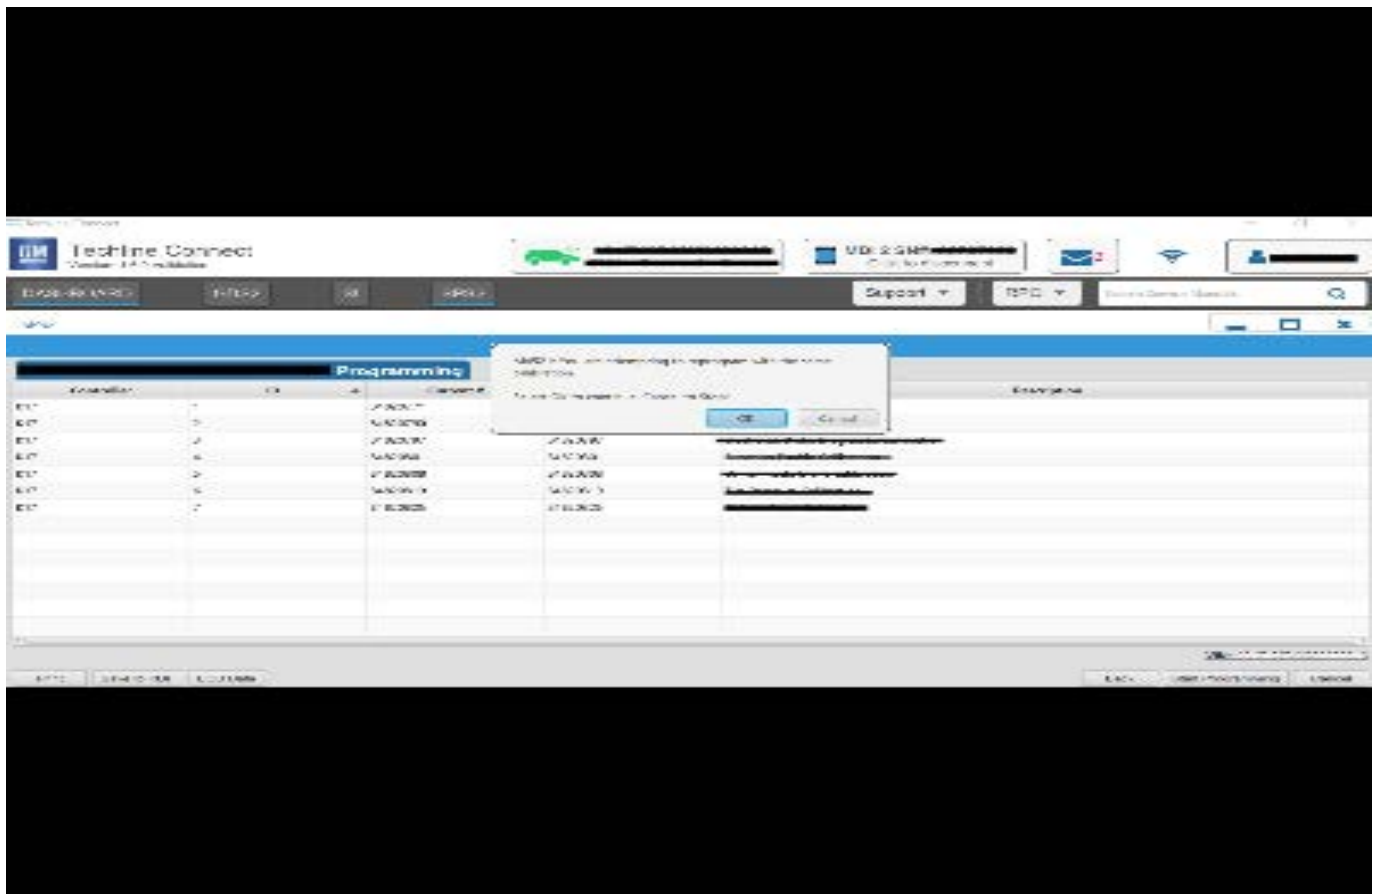
5644477

Important: Techline Connect screen shown above.
