Service Bulletin

Bulletin No.: 22-NA-194
Date: October, 2022

Subject: Wet Headliner and/or Carpet on the Driver Side of the Vehicle, Waterleak at Front Roof Ditch, A-pillar Area

Brand:	Model:	Model Year:		Date Breakpoint:		Engine:	Transmission:
		from	to	from	to		
Chevrolet	Silverado MD 4500HD, 5500HD, 6500HD	2022	2022	March 28, 2022	July 22, 2022	All	All

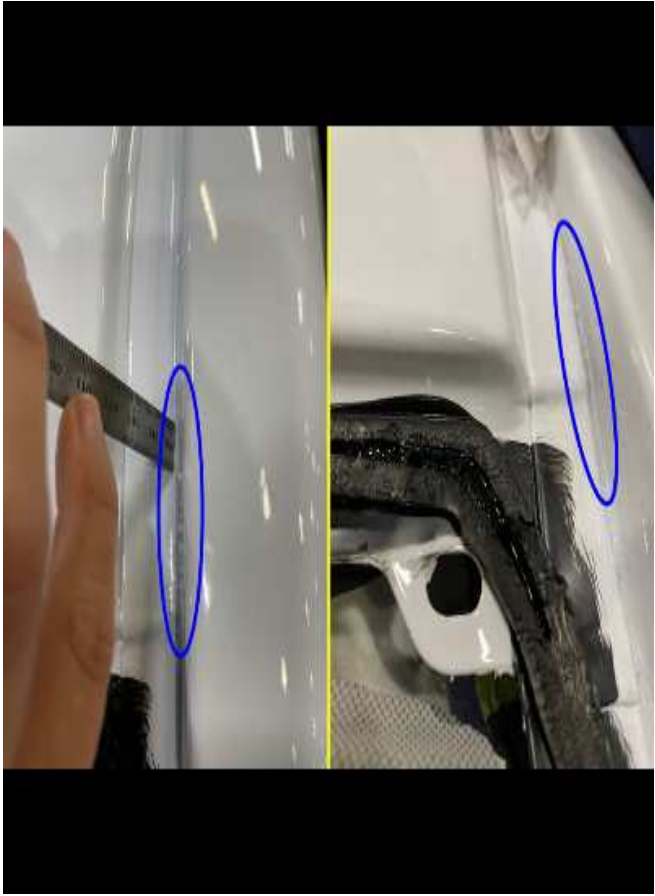
<p style="text-align: right;">6161345</p> <p>The cause of the condition may be that roll on sealer applied along the roof ditch near the A-pillar may have voids within the sealer, allowing for a water leak into the vehicle.</p>
Correction	Inspect driver front roof ditch area near the A-pillar for voids in the sealer and repair following the steps in the Service Procure below.

1. Mix a small amount of Kent® High-Tech Seam Sealer Clear P10200, or Wurth Euroseal Gel Clear 18920104, or equivalent WITH the proper touch-up paint color.
2. Avoiding excess sealer build up within the ditch, work a small amount of the sealer into the hole with a gloved finger.
3. Wipe away any excess sealer with a light amount of solvent on a rag or paper towel. The solvent will help the sealer flow into the hole/crack.
4. Clean and dry any wet trim. Refer to *Floor Carpet Drying* in SI.
