Service Bulletin

Bulletin No.: 22-NA-197

Subject: Excessive Wind Noise Heard Coming from Sunroof Front Edge Area, Front Length of Sunroof Window Inner Seal May Become Loose or Detached

Brand:	Model:	Model Year:		VIN:		Engine:	Transmission:
		from	to	from	to		
Chevrolet	Bolt EUV	2022	2023	—	—	All	All

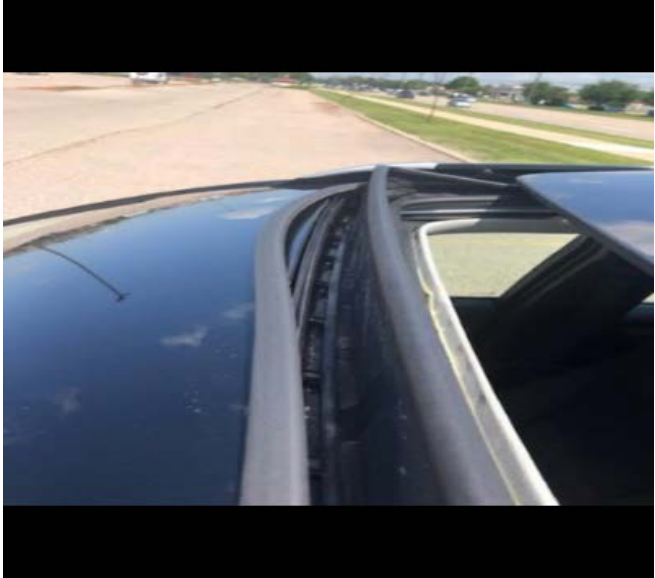
<p style="text-align: right;">6163012</p> <p>Some customers may comment on hearing excessive wind noise from the sunroof front edge area or may notice that the sunroof window inner seal has become detached or loose at the front.</p>
Cause	The cause of this condition may be improper retention of the inner sunroof window seal.
