# SERVICE BULLETIN

BT21-007A

NTB22-018A

## MANUAL FRONT SEAT DOES NOT MOVE FORWARD/REARWARD

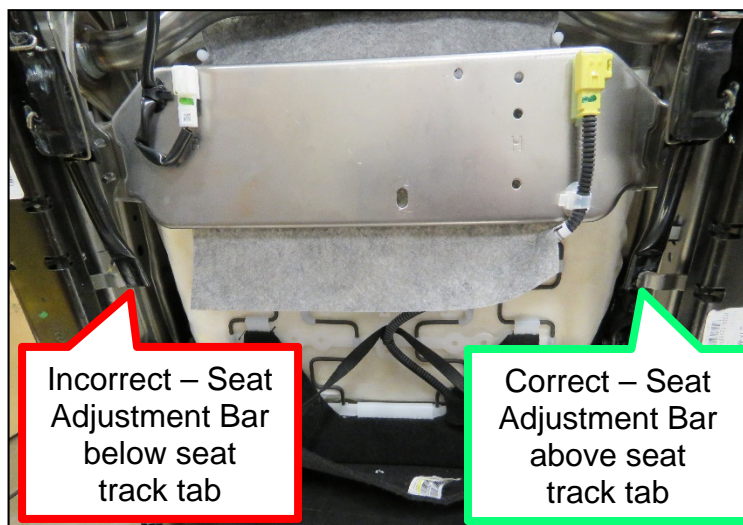
One or both ends of the Seat Adjustment Bar are below the seat track tabs. Figure 1 displays one end of the Seat Adjustment Bar below the seat track tab and the other end above the seat track tab (with the seat removed from the vehicle).

1. Replace the Seat Adjustment Bar on the affected seat(s).
  - Refer to the **SERVICE PROCEDURE** of this bulletin for the repair procedure.
