CAMPAIGN BULLETIN

Cowl Seam Seal Dealer Inventory

Reference: PMA11

PMA11 – 2022 SENTRA COWL SEAM SEAL

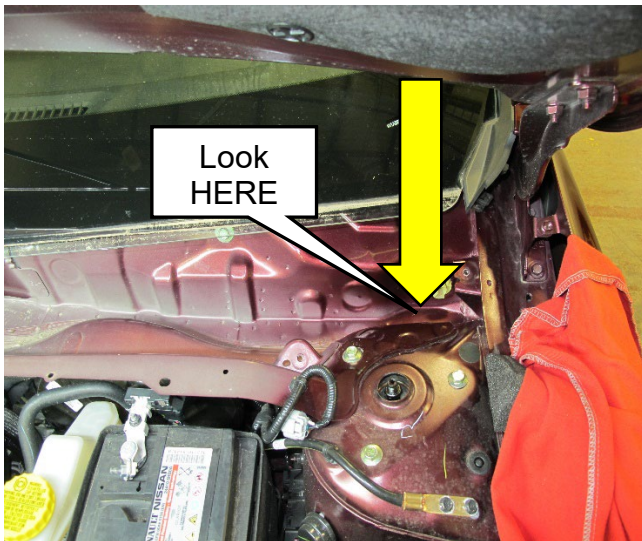
9. Locate the Driver's Side (Left Side) cowl joint seams to be resealed as shown in Figures 13 and 14.

- Figure 13 shows general area of driver's side strut/cowl area
- Figure 14 is seen by looking down the windshield toward the engine bay under the open hood

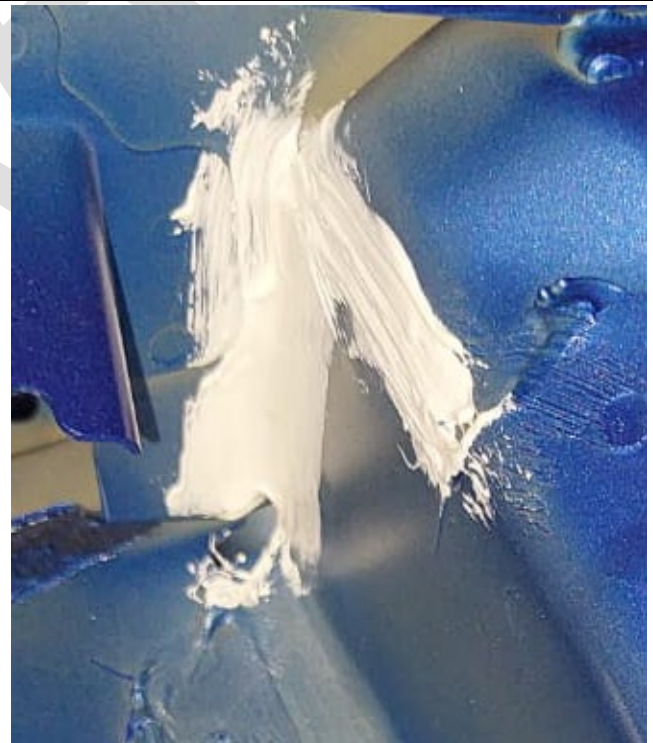
14. Figure 20 shows the cowl area after joint seams have been resealed with the brushed on seam sealer.

15. Once the seam sealer application is completed, allow the sealer to dry for 30 minutes.
