CAMPAIGN BULLETIN Cowl Seam Seal Dealer Inventory

Reference: PMA11
Date: October 14, 2022

PMA11 – 2022 SENTRA COWL SEAM SEAL

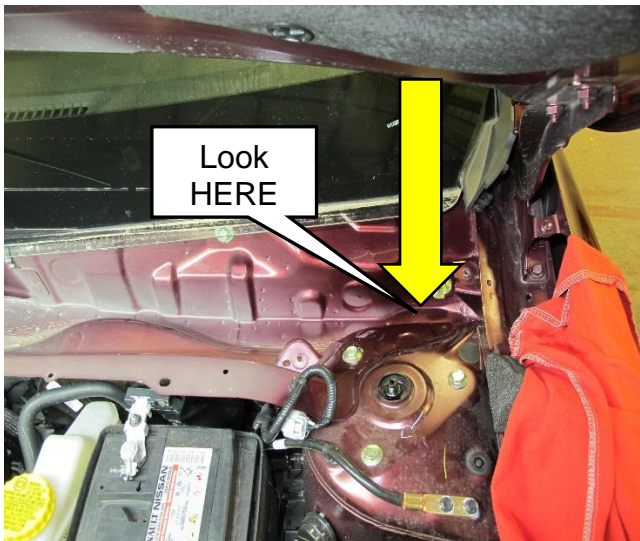
9. Locate the Driver's Side (Left Side) cowl joint seams to be resealed as shown in Figures 13 and 14.

- Figure 13 shows general area of driver's side strut/cowl area
- Figure 14 is seen by looking down the windshield toward the engine bay under the open hood
