STAR ONLINE PUBLICATION

Case Number: S2223000001

Symptom/Vehicle Issue: Rattle Noise From Power Top Driving Over Bumps Or Rough Road

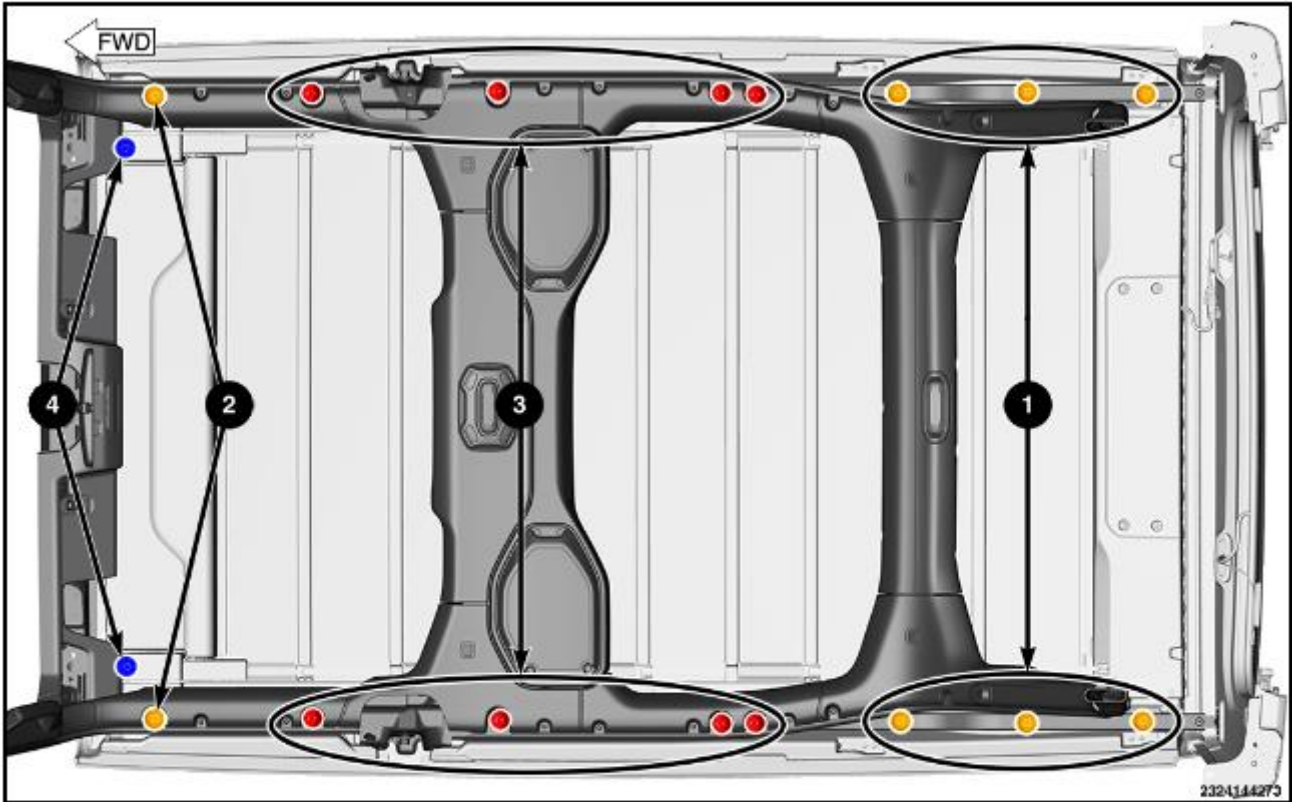
Fig 1

>>>Note there are 3 different length mounting bolts (Fig 1). Verify the correct bolt is in the correct location. Use a torque wrench to verify proper installation.

1 – Rear Screws 70 mm (2.75 in) Screw Length

2 – Front Door Opening Screws 70 mm (2.75 in) Screw Length

3 – Middle Screws 103 mm (4 in) Screw Length

4 – Front Header Screws 20 mm (0.75 in) Screw Length

If a fastener is found under torque value removable grade (blue) thread locking compound may be applied.
