STAR ONLINE PUBLICATION

Case Number: S2223000003

Symptom/Vehicle Issue: 2nd Row Headrest Removal

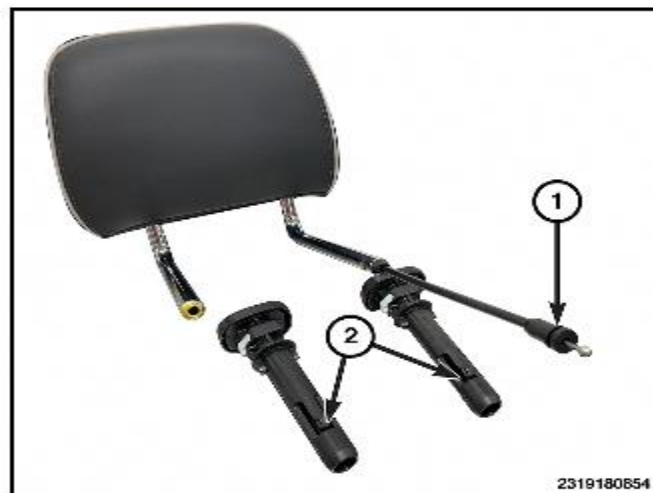
Discussion: Second row seat head rests have a fold feature. The headrest folding mechanism uses a cable that is inside one of the chrome posts that are inserted into the seat back. To correctly remove the headrest, the cable has to be disconnected from the cable junction inside the seat back. Refer to Service Library 23 - Body / Seats, Second Row / HEADREST, Second Row / Removal and Installation. Failure to properly disconnect the cable will result in a damaged part that cannot be diagnosed as a part return.

1 - Cable Junction

2 - Sleeve Retaining Tabs
