STAR ONLINE PUBLICATION

Case Number: S2208000005 – Rev. A

Symptom/Vehicle Issue: D-Pillar 2nd And 3rd Row Power Folding Seat Switch Inop

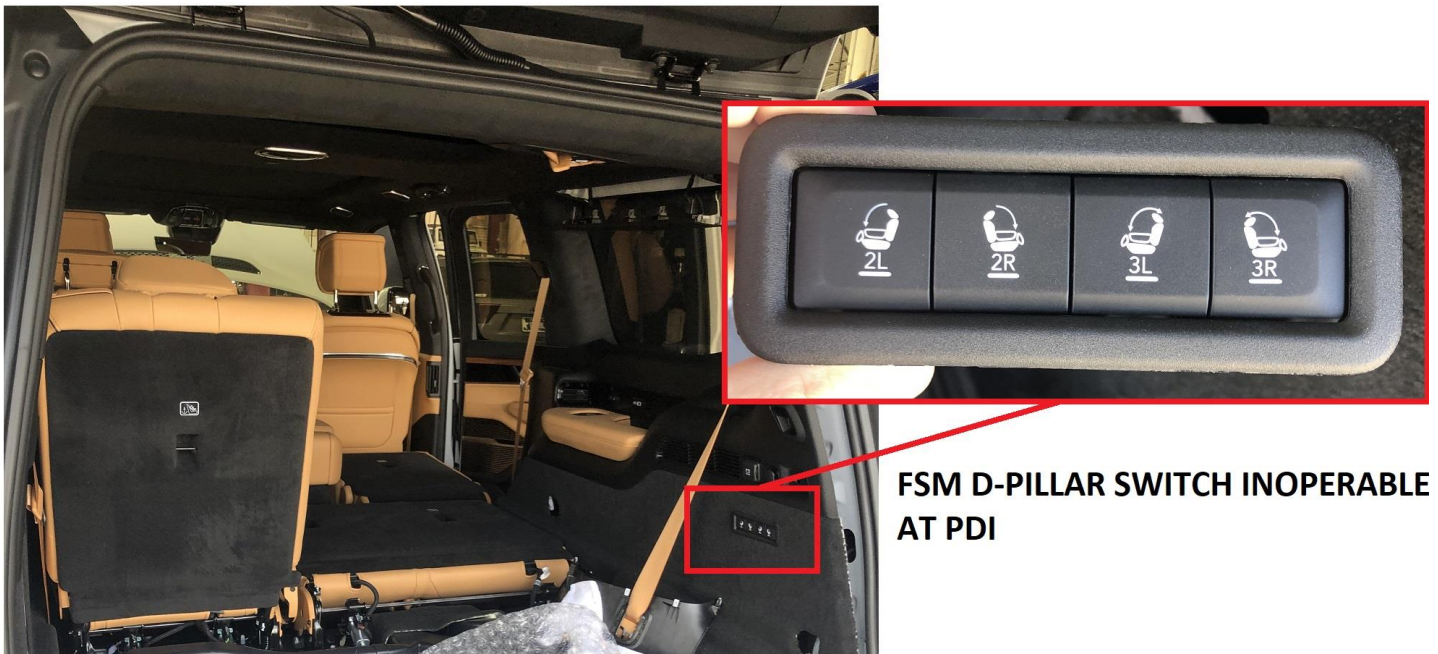
Discussion: The D-Pillar power folding seat switch may be inoperative. There may not be any related faults present. The PLGM may properly report liftgate position (as open/closed) however if the BCM does not see the liftgate in the open position it will lock out the FSM D-Pillar switch resulting in customer complaint.

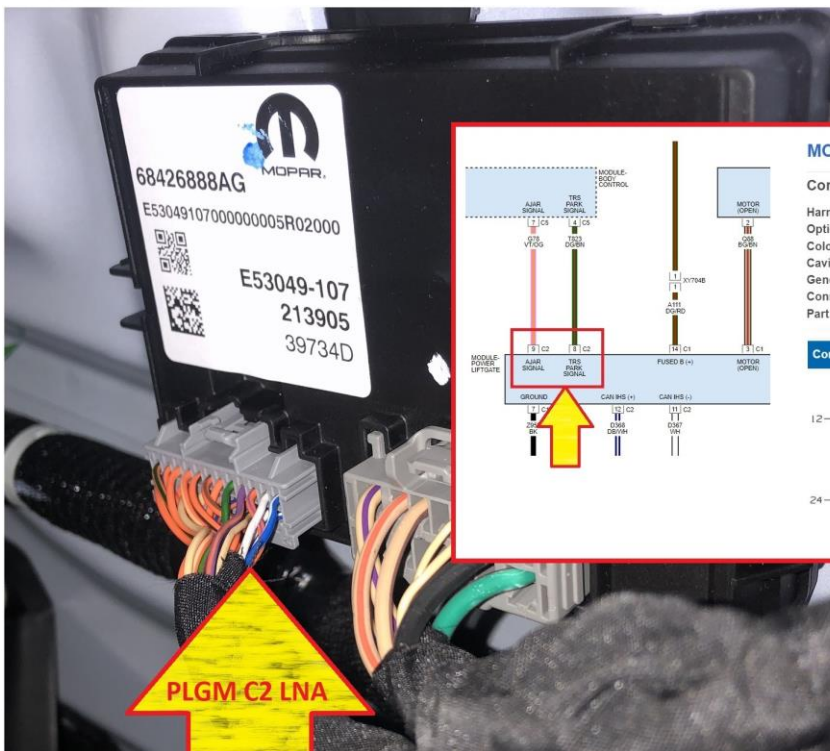
PLGM LIFGATE OPEN

Ungrouped Data				
NAME^	VALUE	UNIT	TYPE	
Battery Voltage Input	14.36	V	Busse Inputs	
Chime Activation	Off		Busse Output	
Gear Position 1 Switch Closed	Yes		Sensors	
Gear Position 2 Switch Closed	Yes		Sensors	
Latch Motor Current Sense	0.000	A	Sensors	
Latch Sector Status	SECTOR_READY_TO_CINCH		Sensors	
Latch Status	Unlatched		Sensors	
Liftgate Status	Open		Sensors	
Number of FlashRom re-writings (F-ROM)	255	Number	Busse Inputs	
Pawl Detent Switch Closed	Yes		Sensors	
PLGM Direction	Stationary Position		Sensors

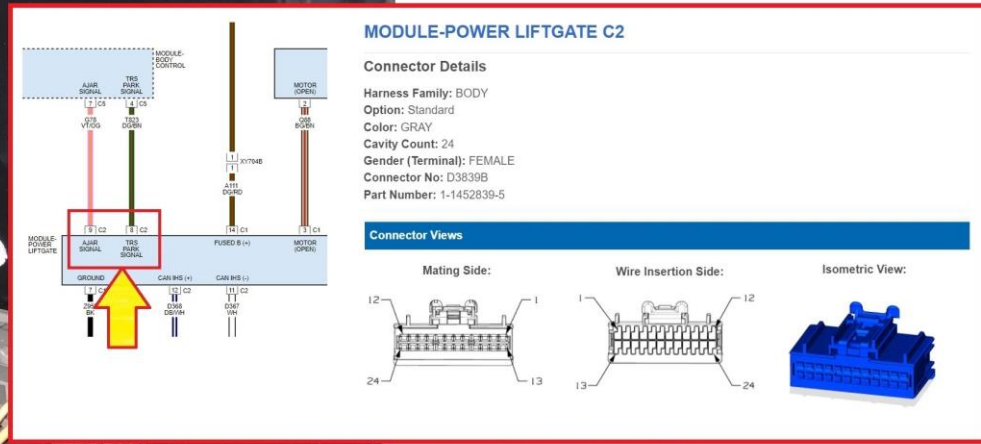
PLGM C2 (D3839B) LNA RESULTING IN D-PILLAR SWITCH LOCKOUT

Repair Procedure: Secure PLGM/BCM connections or repair circuit G78 as needed.
