STAR ONLINE PUBLICATION

Case Number: S2123000064 Rev B

Symptom/Vehicle Issue: Service FCW Message On Cluster And C1418-78 Vertical Misalignment DTC

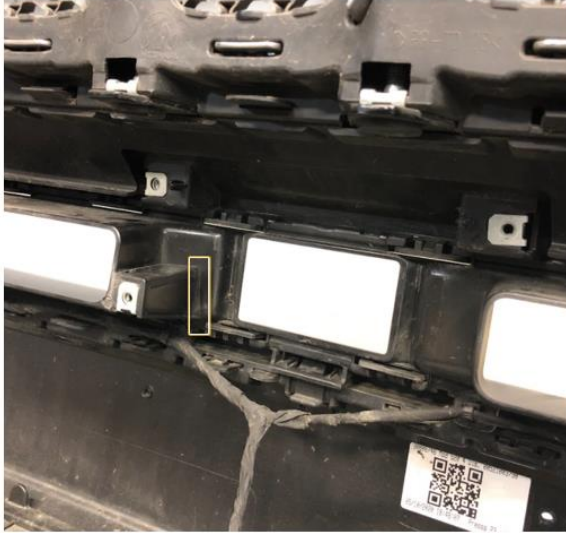
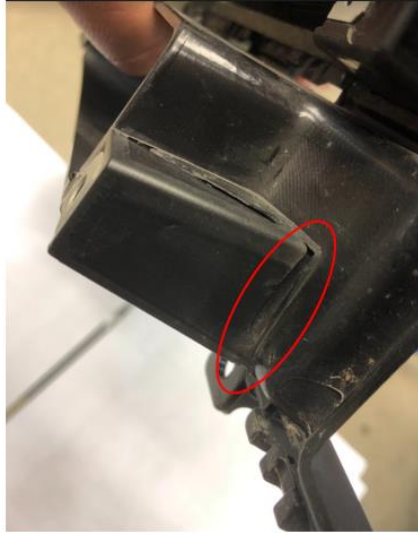
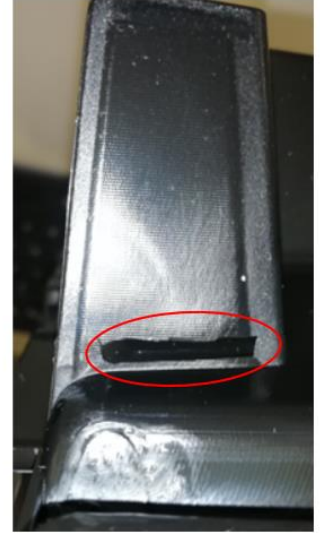
Discussion: The ACC calibration may fail repeatedly due to vertical misalignment. Several reports from the field have found the ACC module appears to be installed and visually looks OK. However, the module is extremely sensitive to being level with the bumper and being fully seated in the bracket. It is suggested to first examine the ACC module mounting. Remove and re-install the module to confirm it is properly and fully seated. While the bracket (STAR Parts refers to this part as a “Center Fascia Grille”) is removed, closely inspect the mounting pedestals for cracking (Fig 1). Replace the Center Fascia Grille if any damage is found to the pedestals.

Fig 1
Broken ACC mounting pedestal.

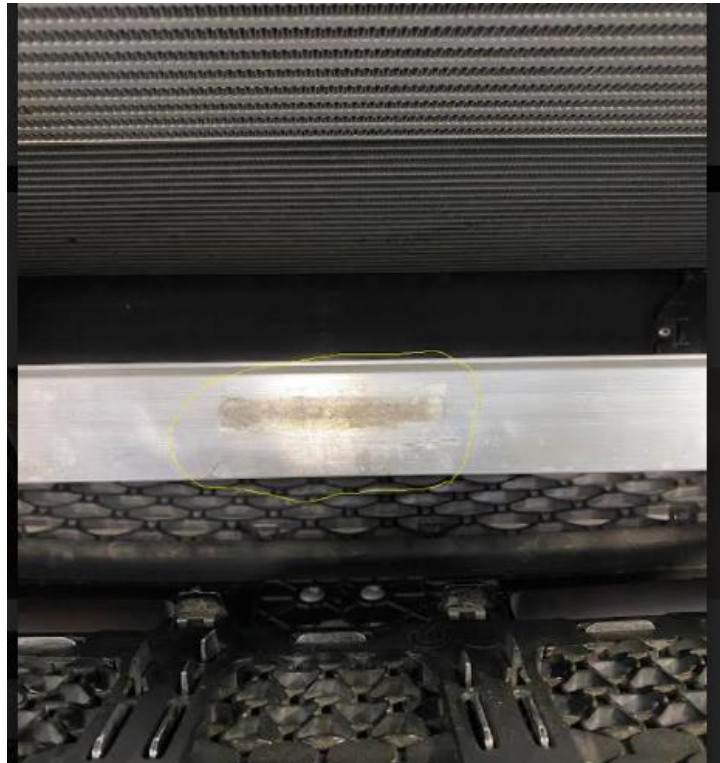
Other reports have also indicated that the ACC module is making physical contact with the aluminum bumper bar. Remove the ACC module and inspect the aluminum bumper for witness marks from contact with the ACC module. Review Fig 2 below.

ACC witness mark on Aluminum bumper

The aluminum bar may be adjusted too high allowing contact with the ACC module. To resolve, begin by removing the front fascia from the vehicle. Then loosen the aluminum bumper mounting bolts and slide the bumper DOWN as far as possible. There are small studs designed to locate the bumper during assembly that will limit downward adjustment. Review image below.

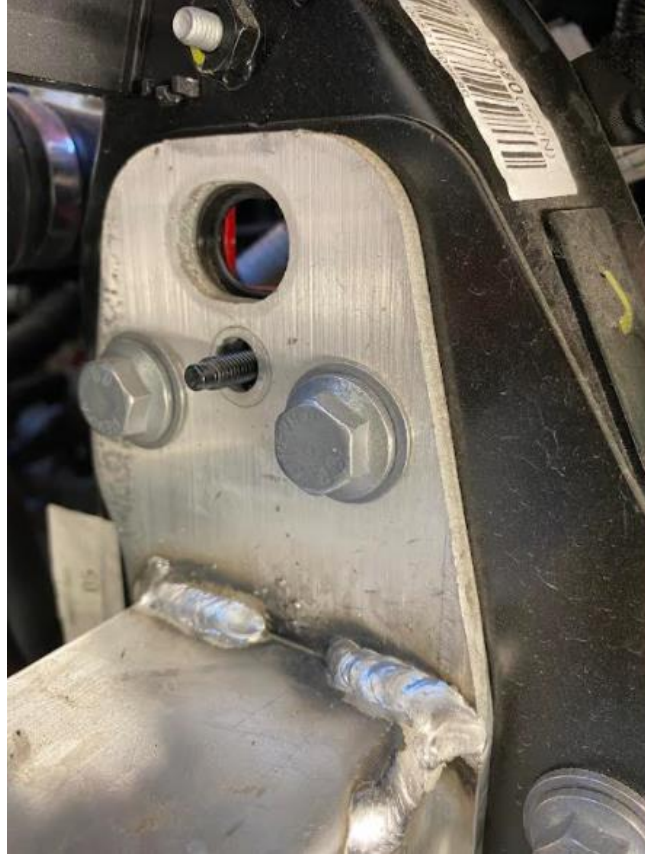
Fig 3
Bumper Mounting Bracket

Once the bumper bar has been moved down as far as it can go, retighten the bottom mounting bolts first, then the top. Reinstall the ACC module and confirm it is no longer making contact with the aluminum bumper bar.
