STAR ONLINE PUBLICATION

Case Number: S2223000005

Symptom/Vehicle Issue: Creak Noise Coming From Integrated Center Stack Or Radio Bezel Area

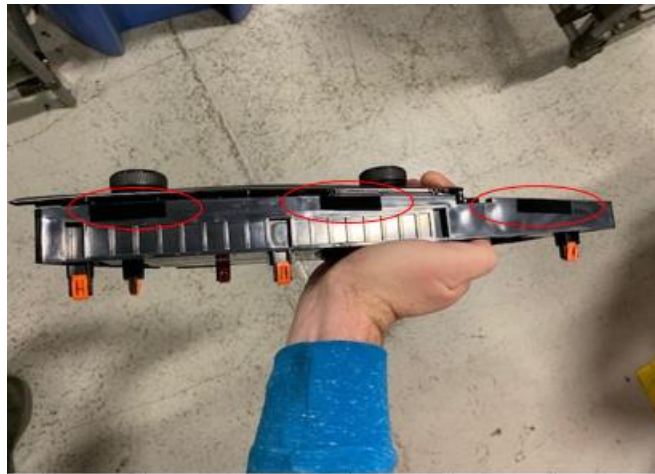
3 pieces of tape applied to top of IC stack

2. Apply felt tape to indicated locations in figures below. Trim tape to $\frac{1}{2}$ " wide x $1\frac{1}{2}$ " long

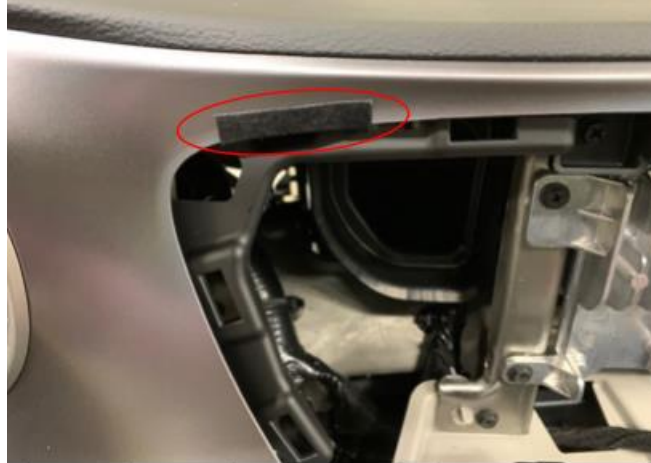
1 piece attached to upper left of Integrated Center Stack Bezel opening.
NOTE>>> Tape should not be visible with the bezel installed.
