STAR ONLINE PUBLICATION

Case Number: S2223000006

Symptom/Vehicle Issue: Mirror Mounted Turn Signal Indicator Service

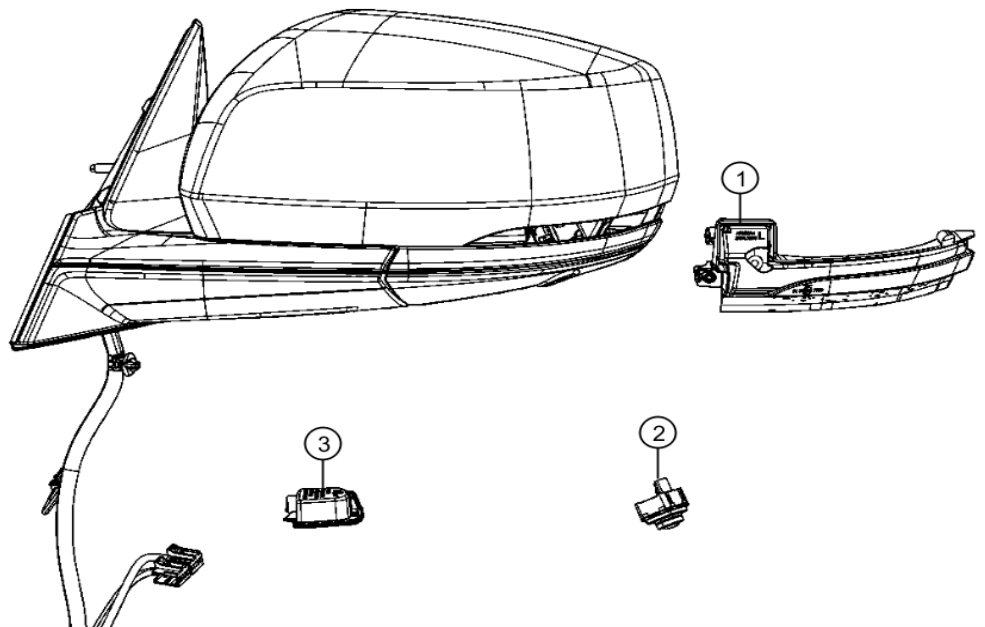
Discussion: Mirror mounted turn signal indicator is available for service. It is not necessary to replace the entire mirror if only the indicator requires replacement. Refer to Service Library 23 - Body / Exterior / MIRROR / Removal and Installation MIRROR COVER. Also see the additional information below.

em	Description (Double Click to add part to Exchange List)	Part Number	Notes	Qty	Super	Tech	Info
1	LAMP, Turn Signal
