STAR ONLINE PUBLICATION

Case Number: S2223000007

Symptom/Vehicle Issue: Power Mirror Makes A Pop Or Popping Noise When Power Folding

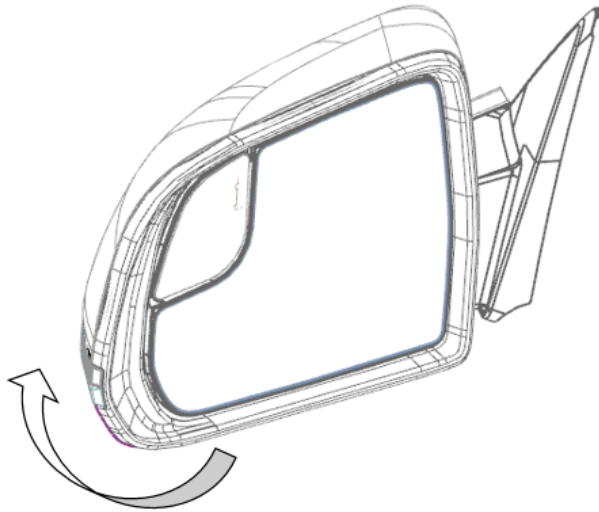
1. With mirror in drive position. Fold away the mirror head forward the vehicle.

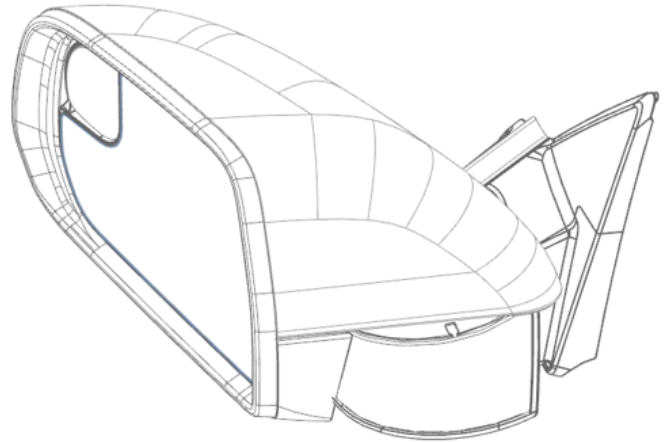
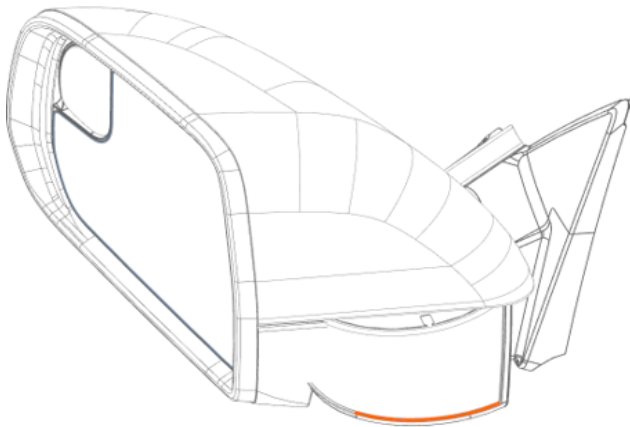
Discussion: A click or pop noise can originate from the rubber cut line seal that is between the pivot head of the mirror and the base. Trimming of the seal may be necessary to reduce the noise. A sharp hobby knife will be required to perform the trimming. Use protective equipment and care when using the knife. The mirror does not need to be removed. The mirror head will need to be rotated forward to expose the rubber cut line seal. See the below figures for reference.

2. Identify the cutline rubber seal.

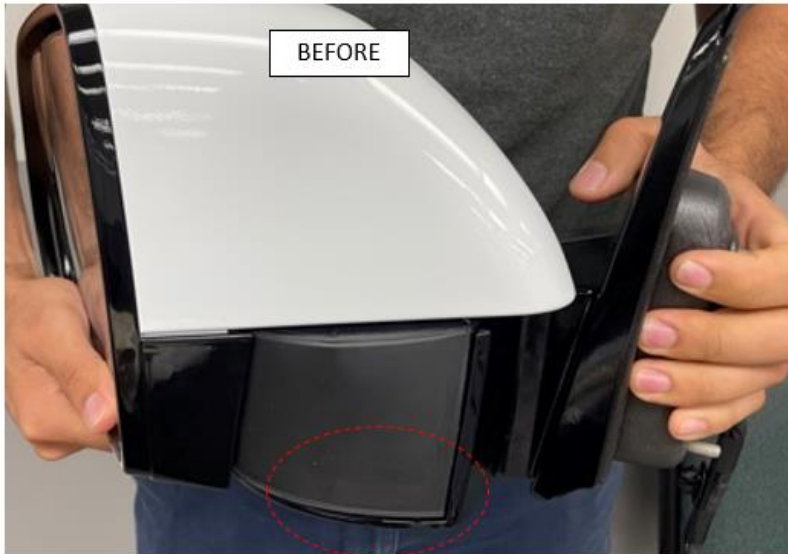
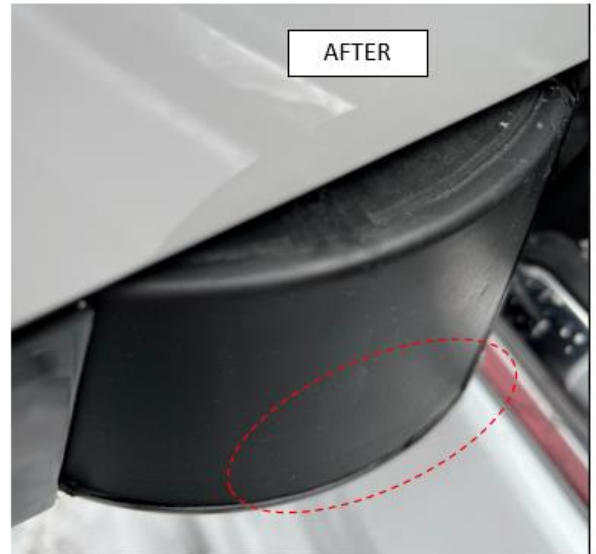
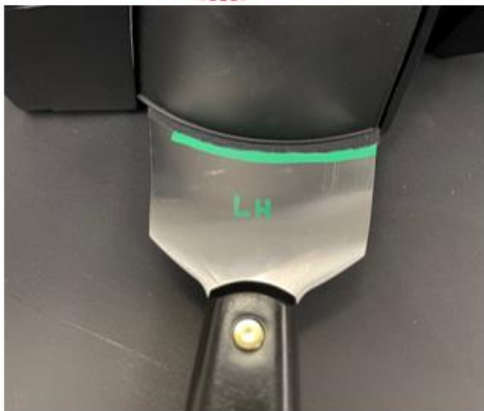
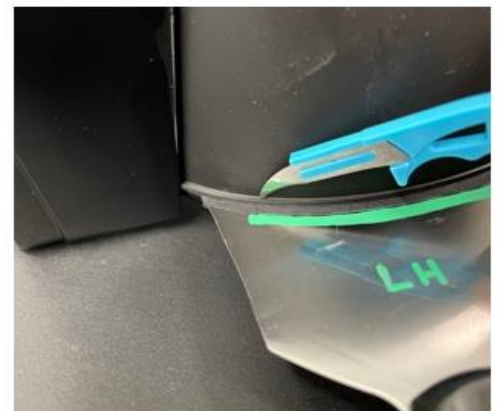
Note: It is not necessary to remove the mirror. Mirror is removed for photo clarity.

3. With a sharp exacto knife, carefully cut and remove the rear 2 inches of the rubber cutline seal lip. Cut must be flush to the vertical seal wall removing all of the molded in lip edge.
