STAR ONLINE PUBLICATION

Case Number: S2108000125 REV A

Symptom/Vehicle Issue: Battery Of Uconnect Box Is Temporarily Low Popup Message

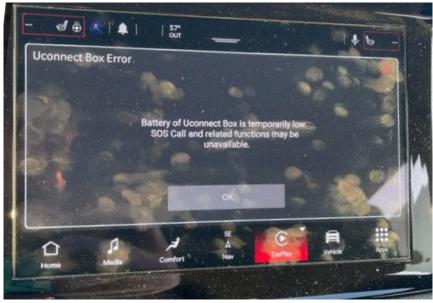
Fig 1

Discussion: Customers might receive a popup message of Uconnect Box Error, showing "Battery of Uconnect box is temporarily low, SOS call and related functions may be unavailable". The popup is a warning message to the customer that the SOS call is not available due to low voltage of backup battery in the TBM module. The failure happens when the battery is drained because the vehicle has not been running for long time. The battery will be fully charged after vehicle runs for approximately 4 hours.

No repair is required for this error message. Please DO NOT replace the TBM module.
