STAR ONLINE PUBLICATION

Case Number: S2208000026

Symptom/Vehicle Issue: Discharged Battery, Ignition Off Draw (IOD) From Aftermarket Electronic Accessories

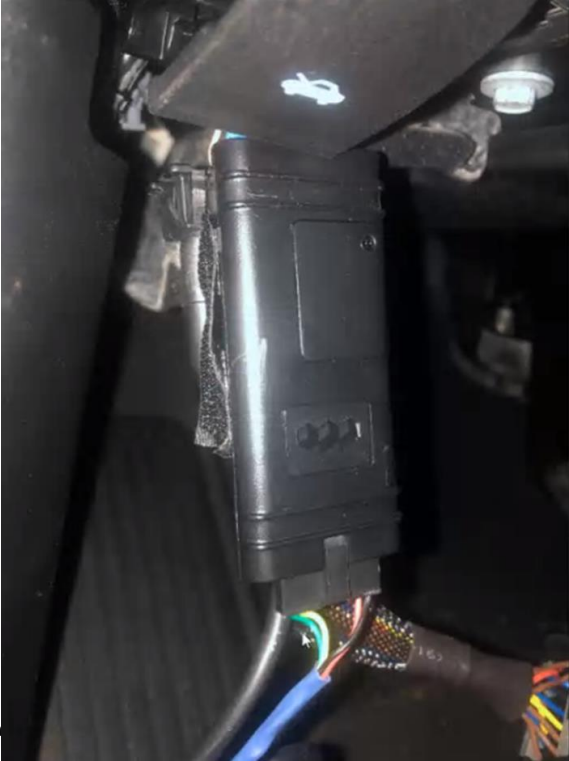
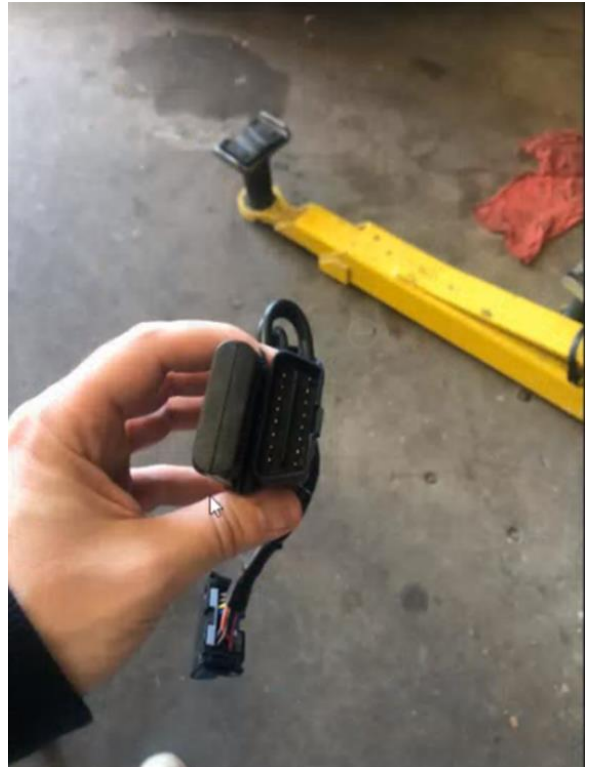
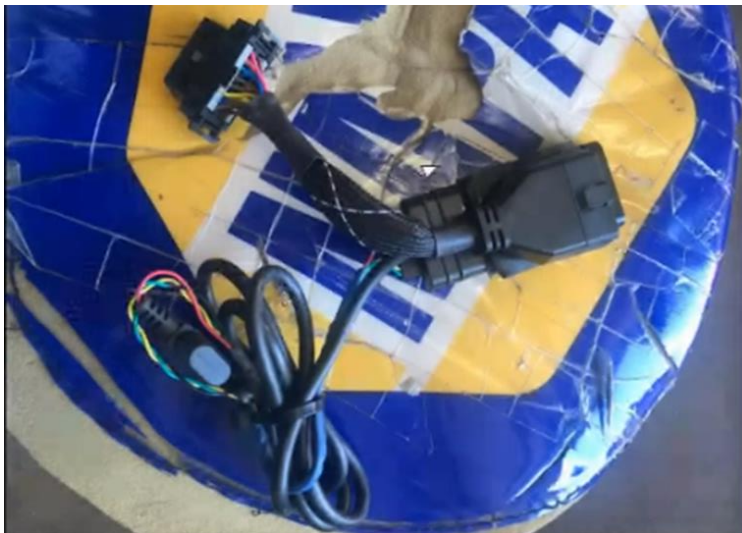
Discussion: The customer may find the vehicle's battery is discharged. This may be caused by aftermarket accessories connected to the vehicle. Commonly GPS trackers have been known to cause Ignition Off Draws resulting in discharged batteries.

Example of aftermarket GPS device found in the OBD II port.

Repair: If an aftermarket device is found, isolate it from the vehicle electrical system and verify the IOD is no longer present. Once the aftermarket equipment is confirmed as the source of the IOD, discuss your finding with the customer to explain the device should be permanently removed from the vehicle.

Recommend the built in GPS tracking as mentioned previously or for other electronic devices refer the customer to the approved list of Mopar Accessories.
