STAR ONLINE PUBLICATION

Case Number: S2008000033 REV. A

Symptom/Vehicle Issue: MIL Lamp On, DTC P0325 - Knock Sensor 1 Circuit

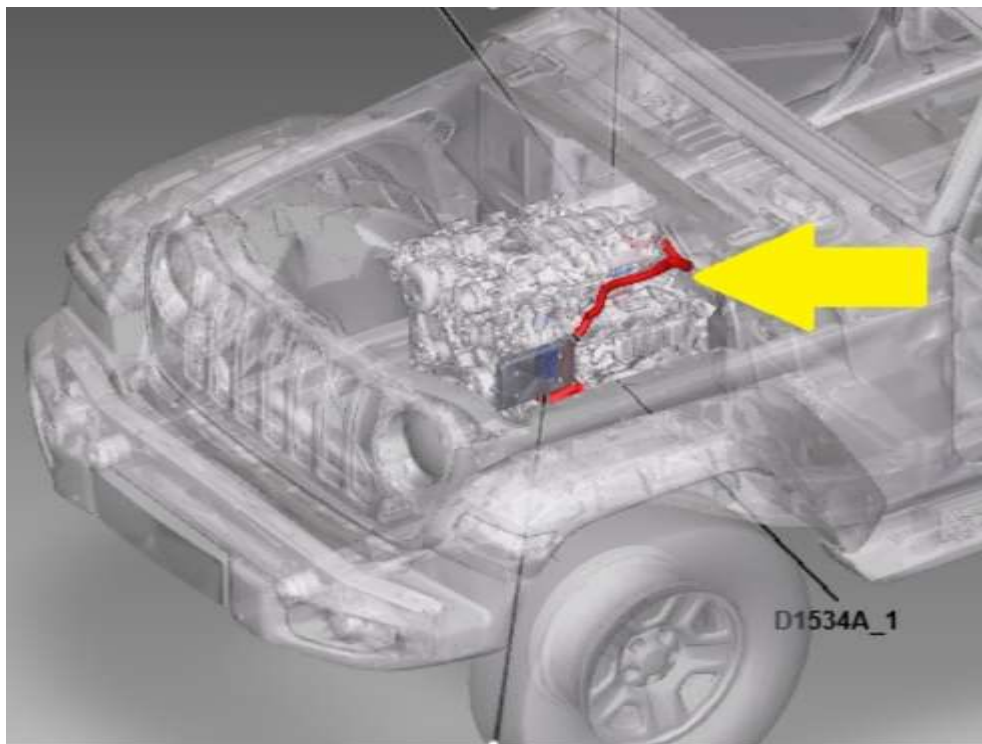
Fig 1

Discussion: Inspect the engine harness routing at the rear of the engine as shown and or the C2 PCM connector terminal 53 K42 circuit Fig 1, 2, 3. Review for any signs of chaffing damage, repair and isolate the harness concern as needed, no parts required.

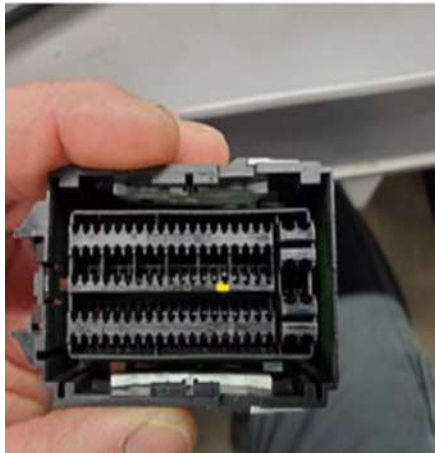
Found the terminal for K42 Knock Sensor 1 Signal pushed out of the PCM C2 Connector

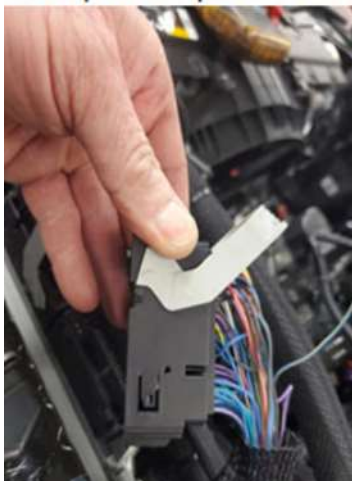
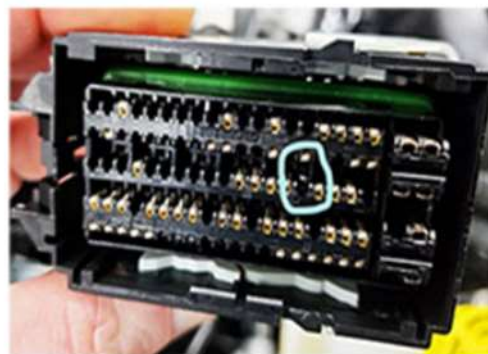
Fig 3

Plastic locking tab in the PCM C2 Connector that retains/locks pin in place is deformed and allows the pin to push out

Terminal Pushout at Cavity #53
