## STAR ONLINE PUBLICATION

**Case Number:** S2223000004

**Symptom/Vehicle Issue:** Cruise Control SET + Button Sticking. DTC P1593 SPEED CONTROL SWITCH 1/2-STUCK and or P0585 SPEED CONTROL SWITCH 1/2 CORRELATION

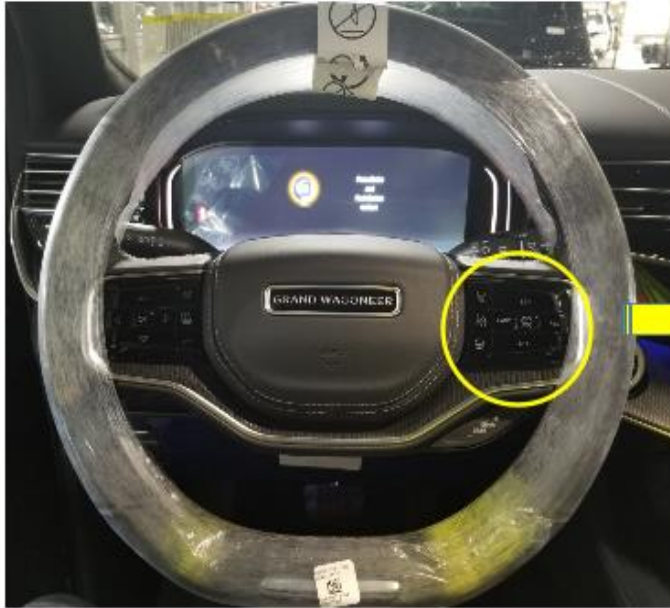
"SET+" Switch

**Customer Complaint/Technician Observation:** Customer may complain the “SET + button does not return to its rest position or it sticks down. If this condition is present inspect the steering switch bezel fitment. The bezel may be not fully seated and sticking up causing the condition. See the below figures for more information.

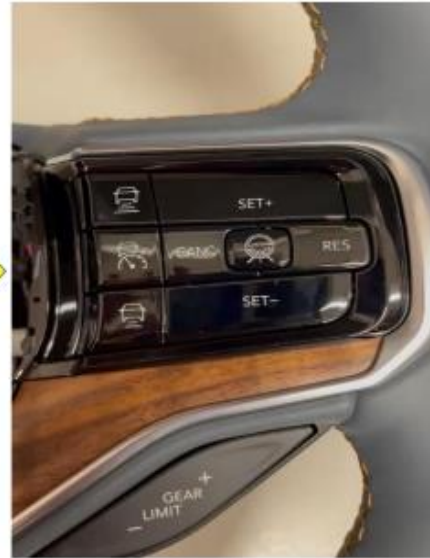
### ACCEPTABLE SWITCH

"SET +" Switch is flush with surrounding trim piece by design.

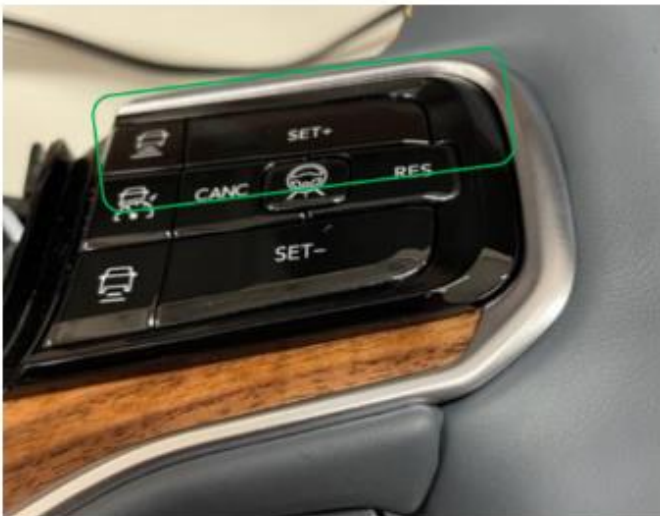
### UNACCEPTABLE SWITCH

"SET +" Switch is stuck and under flush with surrounding trim piece.

To allow the "SET+" switch to spring back to design position, press down on the trim piece at the top right corner of the switch. You will hear a "click" noise when the trim piece becomes fully engaged.
