NUMBER: 08-003-22

GROUP: 08 - Electrical

DATE: January 8, 2022

UAQ and UCQ Radio Enhancements

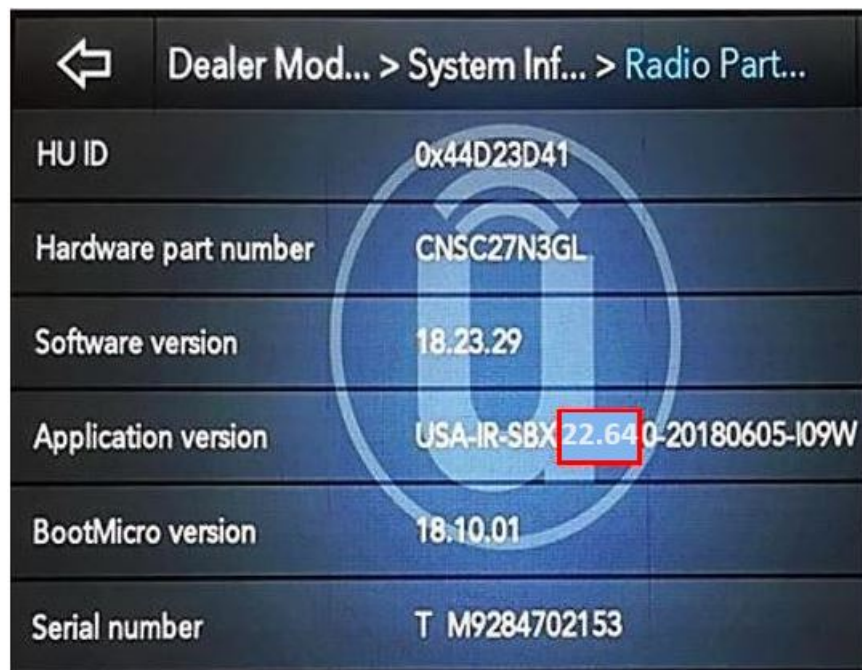
Fig. 1
Radio Software Level Screen

1. Verify the radio software version. Radio must be in Dealer Mode to verify by following these steps:
 - a. Press and hold both lower corners of the display screen, until the Dealer Mode screen appears (approximately seven seconds). Release screen.
 - b. Select "Radio Part Information". The software version will be listed next to "Application Version" (Fig. 1) .

2. What is the radio software level (Application Version) at?
 - 39.5 or higher >>> The radio software is already up to date. Normal diagnostics should be performed.
 - At or above 22.64 and under 39.5 >>> Proceed to [Step 1](#) of the Repair Procedure.

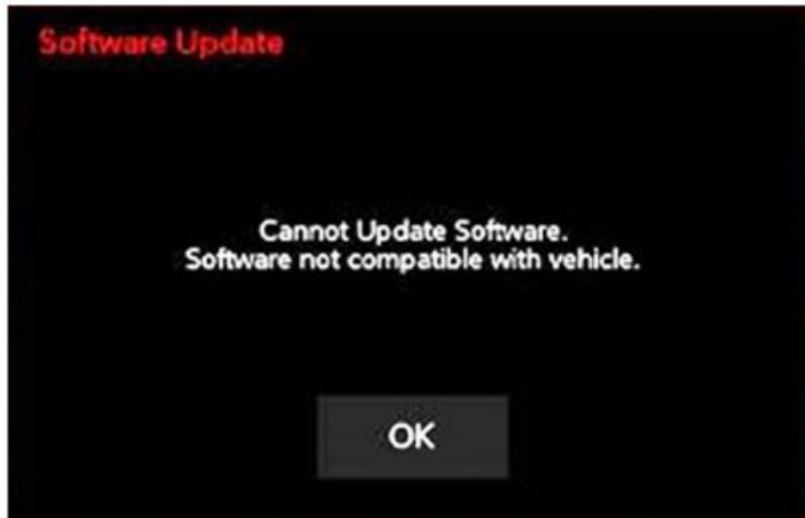
Fig. 5
Software Not Compatible Screen

11. If the screen in (Fig. 5) is displayed, the USB flash drive was not set up correctly. Use a top name brand USB flash drive, like Kingston, create a new USB flash drive and start the update again.

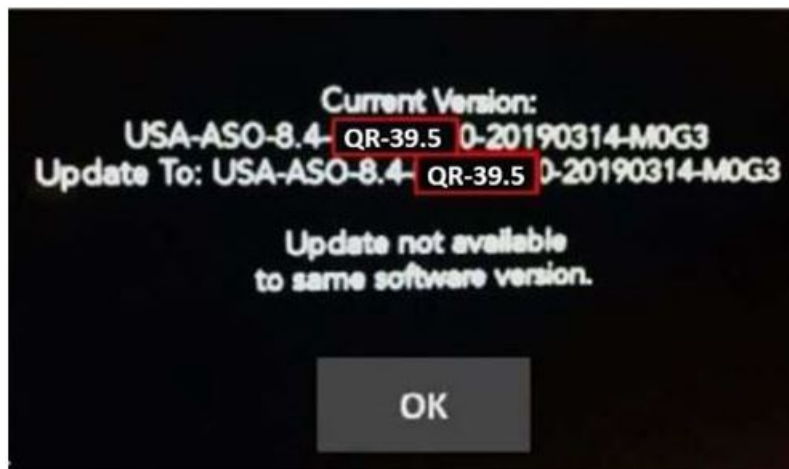
Fig. 6
Screen Displayed When Radio Software Level Is Up To Date

12. If the radio software is already up to date, the screen in (Fig. 6) will be displayed. Press "OK" and remove the USB flash drive.

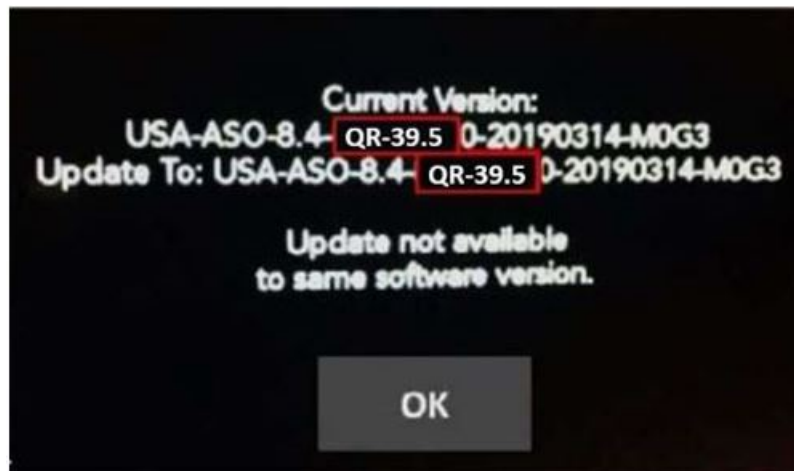
Fig. 10
Radio Software Has Been Updated

16. After the update has completed, the radio will shut down. With the USB flash drive still inserted in the USB port, cycle the ignition back to the run position. If the radio software was updated correctly the "Current Version:" and the "Update To:" software levels in (Fig. 10) will display the identical software level. Press "OK" and remove the USB flash drive.
