NUMBER: 08-004-22

Sirius XM Inoperable

2022 (DT) RAM 1500 Pickup

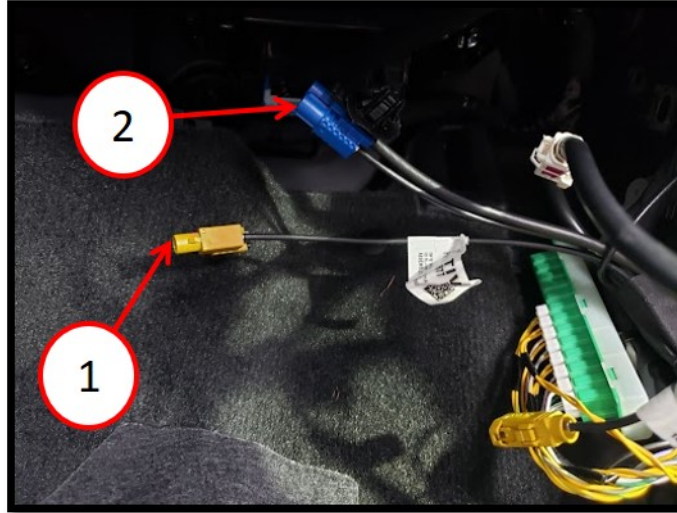
Fig. 1
Wires Needing Re-Work

- 1 - Yellow Connector Wire Y341A
2 - Blue Connector Wire Y342A
-

1. Remove the cowl trim panel trim. Refer to the detailed service procedures available in DealerCONNECT/ Service Library under: Service Info 23 - Body / Interior / Panel, Cowl Trim / Removal and Installation.
2. Access the Y342A (**Blue Connector**) wire and the Y341A (**Yellow Connector**) wire (Fig. 1) . These are the two wires that will require re-work.

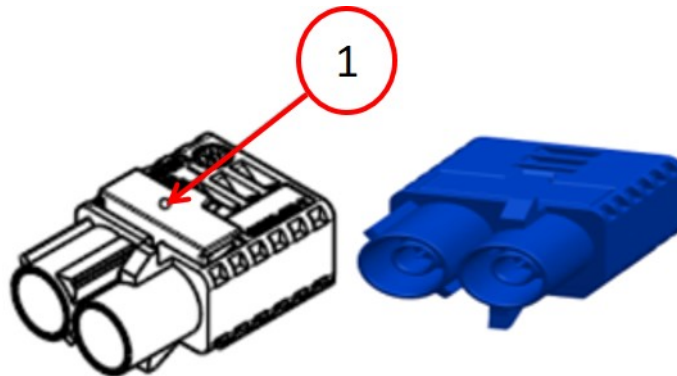
Fig. 2
Y342A Connector Lock

- 1 - Purple Y342A Connector Lock
-

3. Working with the Y342A (**Blue Connector**) wire and using a prying tool, remove the purple connector lock (Fig. 2) .

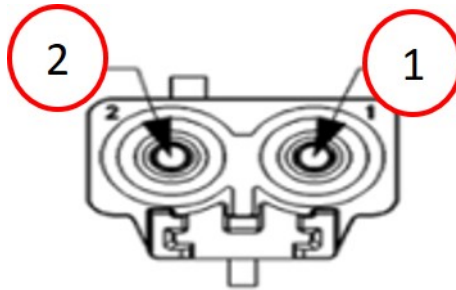
Fig. 3
Cavity One Y342A Wire

- 1 - Cavity One Wire To Remove From Y342A Connector
 - 2 - Cavity Two Wire That Does Not Get Removed From Y342A Connector
-

4. Lift the connector tab carefully to not break it and remove the thinner wire from Y342A cavity 'one' (Fig. 3) .

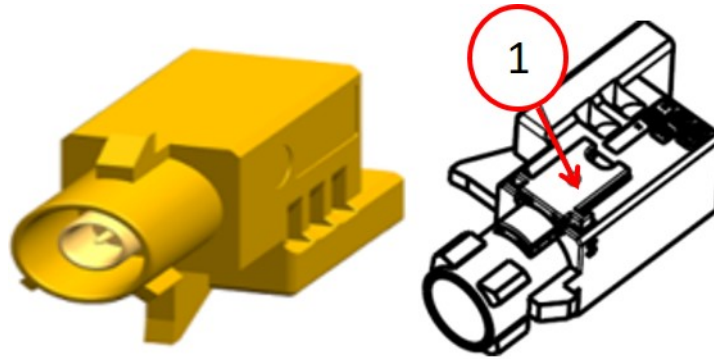
Fig. 4
Y341A Connector Lock

- 1 - Y341A Connector Lock
-

5. Working with the Y341A (Yellow Connector) wire and using a prying tool, remove the purple connector lock (Fig. 4) .

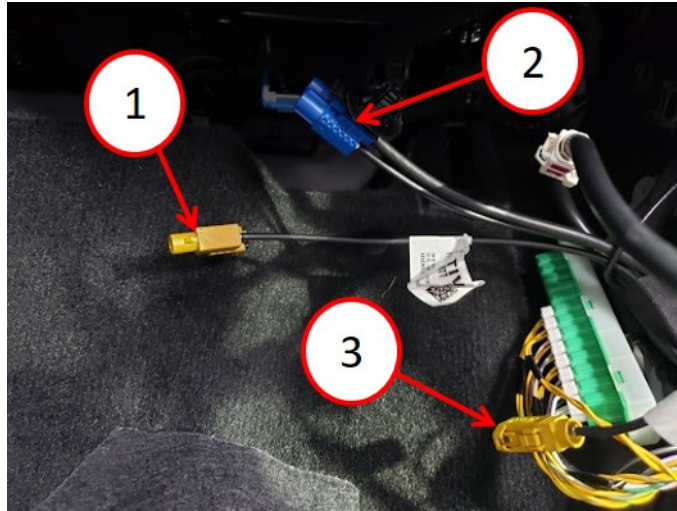
Fig. 5
Yellow And Blue Connectors

- 1 - Y341A Male Connector
- 2 - Y341A Female Connector
- 3 - Y342A (Blue Connector) Wire

9. Plug both the yellow male and female connectors together (Fig. 5) .

10. The leftover cable from the Y342A (**Blue Connector**) wire (Fig. 5) in Step 4, should be taped back and secured to prevent noise.
