NUMBER: 23-002-22

Dust Infiltration Inside Cabin

This bulletin involves possibly replacing the exhausters and sealing cabin body joints.

RAM 1500 Pickup

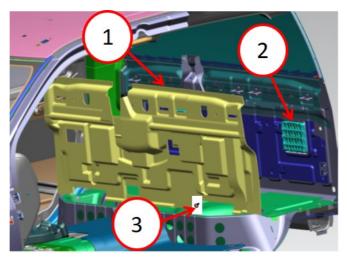
Fig. 1
Silencer And Exhauster

- 1 Silencer
- 2 Exhauster
- 3 Silencer Fastener

- 1. Remove the rear seat. Refer to the detailed service procedures available in DealerCONNECT/ Service Library under: Service Info>23 - Body / Seats, Rear / Seat, Rear / Removal.
- 2. Remove the C-pillar trim. Refer to the detailed service procedures available in DealerCONNECT/Service Library under: Service Info>23 Body / Interior / Panel, C-Pillar Trim, Lower / Removal.
- 3. Remove the fasteners securing the silencer to the cabin and remove the silencer (Fig. 1).
