**NUMBER:** 08-015-22

**DATE:** January 19, 2022

Sirius XM Inoperable

2022 (DS) RAM 1500 Pickup

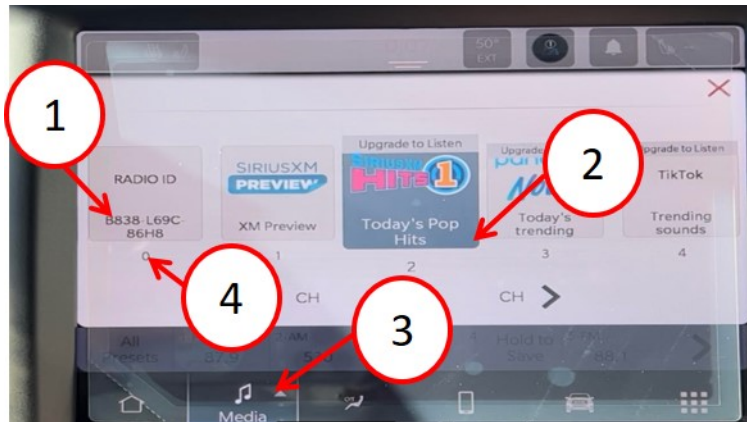
**Fig. 1**  
**SXM Screen And Channels**

- 
- 1 - Channel “0” Radio ID 12 Characters
  - 2 - Channel “2”
  - 3 - Media Button
  - 4 - Channel “0”

5. Press seek up on the SXM screen. **All channels other than channel “0” and channel “1”, will show a banner “upgrade to listen” ([Fig. 1](#)) .**
6. Write down the Radio ID 12 characters shown in channel “0” ([Fig. 1](#)) .
7. Press on any SXM channel ([Fig. 1](#)) and an “Upgrade Your Plan” prompt with a phone number will be displayed ([Fig. 2](#)) .
