NUMBER: 07-001-22

Water Pump Inlet Tube Fastener Torque

This bulletin involves checking the torque on the water pump inlet tube fasteners to possibly eliminate coolant leak at this location.

2018 - 2021 (JL) Jeep Wrangler

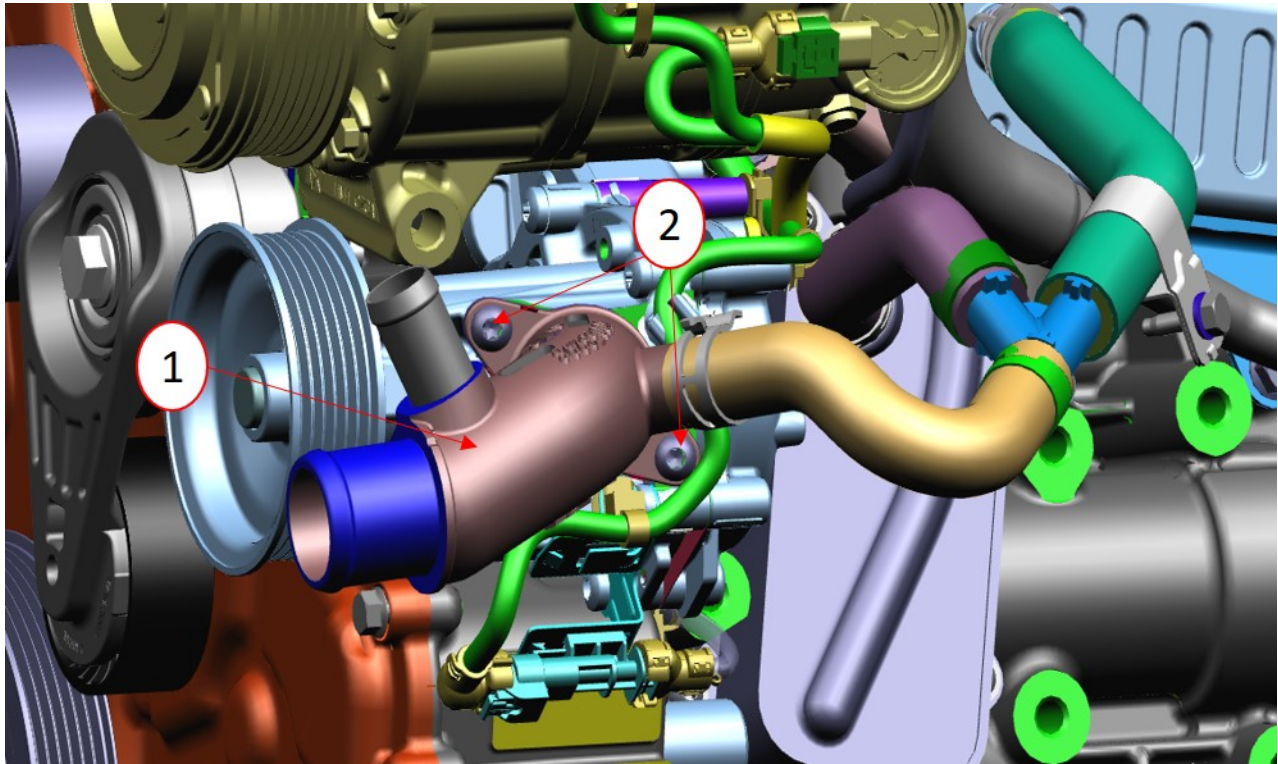
Fig. 1
Water Pump Inlet Tube Fasteners

1. Pressure check the coolant system. Refer to the detailed service procedures available in DealerCONNECT> Service Library under: Service Info>07 - Cooling / Diagnosis and Testing >Leak Testing>Pressure Tester Method.
2. Was coolant found to be leaking from the water pump inlet tube at the engine (Fig. 1) ?
 - YES>>> Proceed to [Step 1](#) of the Repair Procedure.
 - NO>>> Coolant was not leaking from this area. This bulletin does not apply. Normal diagnosis should be performed.

1. Remove one inlet tube fastener (Fig. 1) .

2. **Apply Mopar 04318031AC (or equivalent) to fastener thread.
3. Install the water pump inlet tube fastener and tighten to 11 N·m (97 in. lbs).
4. Remove the other water pump inlet tube fastener.
5. Apply Mopar 04318031AC (or equivalent) to fastener thread.
6. Install the water pump inlet tube fastener and tighten to 11 N·m (97 in. lbs).
7. Wait 10 minutes after last fastener is installed prior to pressure testing the coolant system or running the engine to allow for prescribed Loctite cure time.**
8. Pressure check the coolant system. Refer to the detailed service procedures available in DealerCONNECT>Service Library under: Service Info>07 - Cooling / Diagnosis and Testing >Leak Testing>Pressure Tester Method.
9. Is coolant still leaking from the water pump inlet tube at the engine (Fig. 1) ?
 - YES>>> Further diagnosis should be performed.
 - NO>>> This bulletin has been completed.
