STAR ONLINE PUBLICATION

Case Number: S2223000014 Rev A

Symptom/Vehicle Issue: Water Leaking From Overhead Console Or Headliner
Microphone On Sunroof Equipped Vehicle

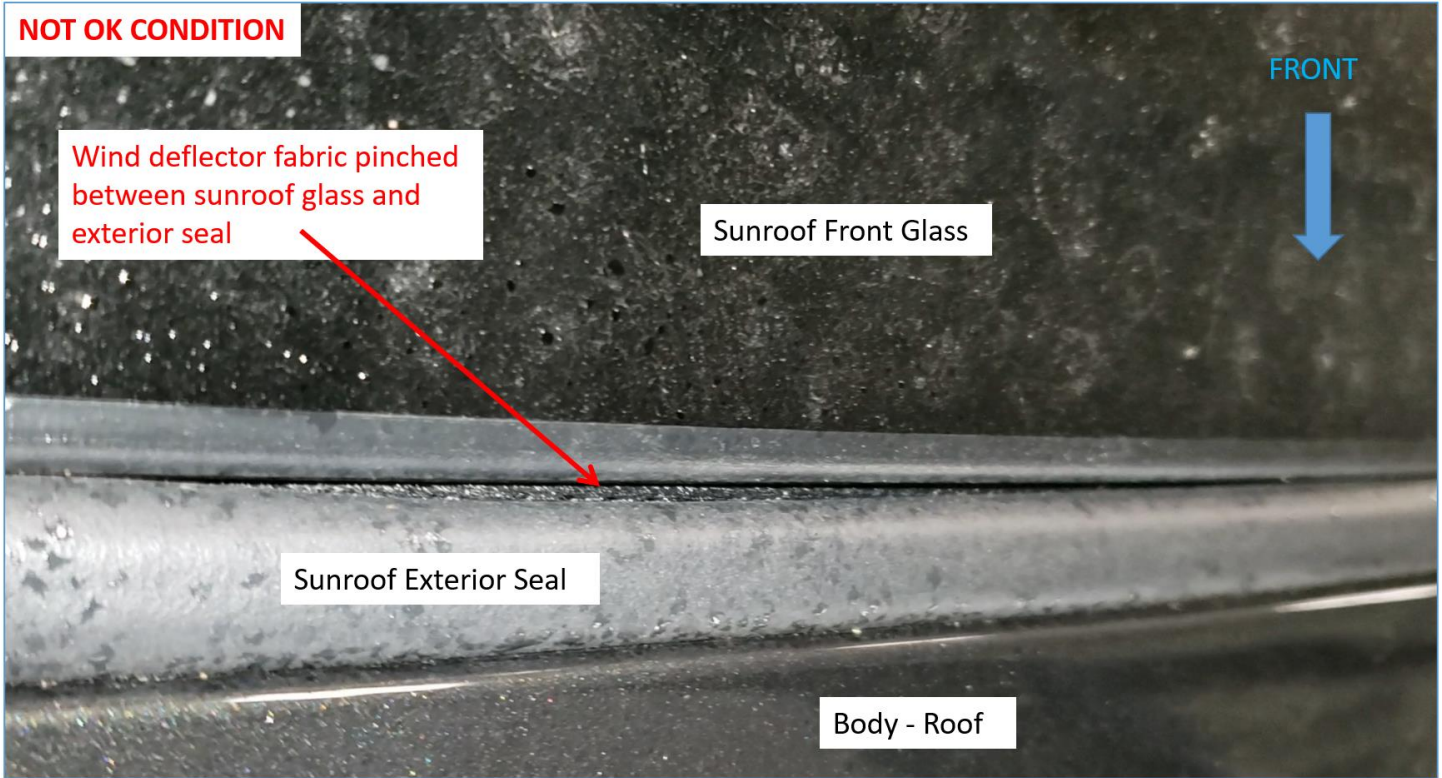
Fig 1

NOT OK CONDITION

Wind deflector fabric pinched. Incorrect installation.

Discussion: With sunroof glass in closed position visually inspect from top of roof the interface of front sunroof glass to sunroof exterior seal along the front for pinched wind deflector fabric (Fig 1). If wind deflector fabric is pinched between sunroof glass and exterior seal replace both the wind deflector and sunroof exterior seal. Next inspect the exterior seal for any areas where it has lifted up away from the body (Fig 2). If exterior seal is found to be lifted remove and replace the exterior seal. Next open sunroof glass and remove sunroof exterior seal (perimeter seal) by lifting up. Visually inspect for sunroof auxiliary seal trapped under body roof opening flange around entire perimeter of roof opening (Fig 3). If the auxiliary seal is folded and visible – sunroof frame will require removal to replace the auxiliary seal. See cut-away images (Fig 4 & 5)
