STAR ONLINE PUBLICATION

Case Number: S2208000067

Symptom/Vehicle Issue: No Start, Service Hybrid Electric Cluster Message, Turtle Warning Lamp On

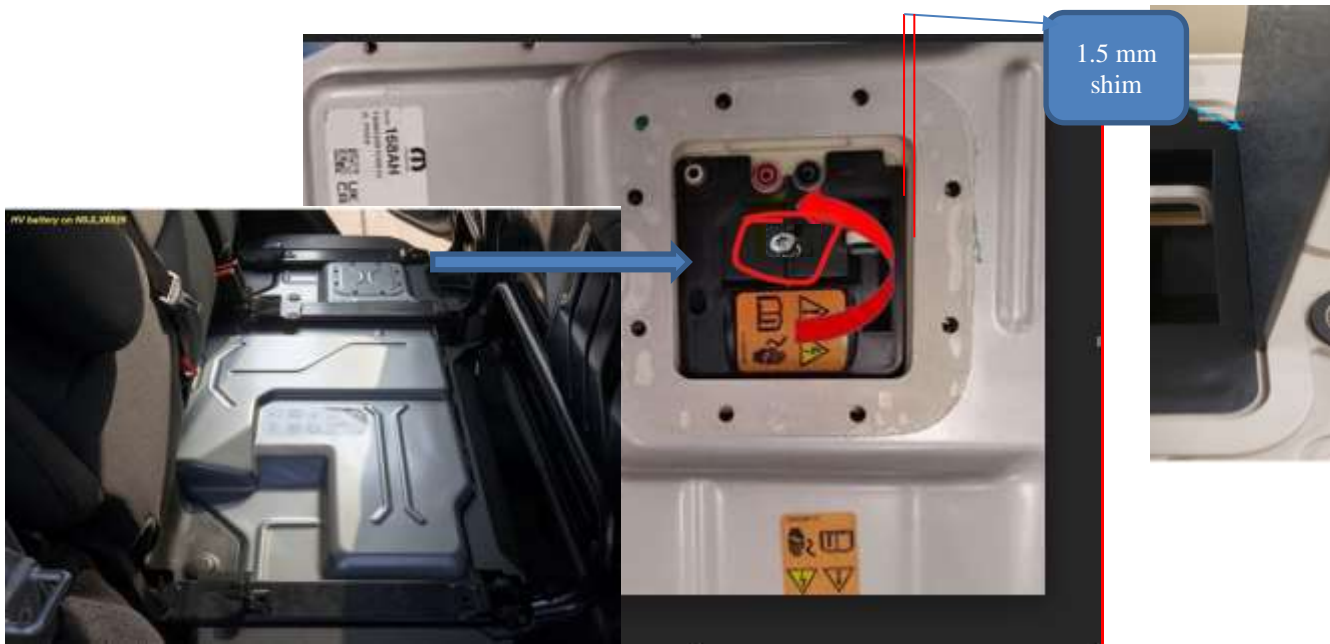
Owner Complaint/Technician Observation: Owner complains of a no start concern, service hybrid electric system warning message, MIL Lamp on or turtle lamp on while driving. Technician observed the vehicle is setting DTC P1AE2-00-BATTERY ENERGY CONTROL MODULE HIGH VOLTAGE SYSTEM INTERLOCK CIRCUIT.

Repair Procedure: Follow the diagnostic service procedure for the DTC P1AE2, for vehicles equipped with the high voltage system, you must thoroughly read and follow all High Voltage Safety procedures. In addition, before performing any diagnostic or service procedure near a high voltage component, you must perform the High Voltage Power Down. Inspect the fuse orientation within the fuse tray, loosen and rotate fuse to ensure a gap of 1.5 mm using a shim as required; Tighten the M5 T25 Torx, 6Nm +/- 3Nm.
