STAR ONLINE PUBLICATION

Case Number: S2208000069

Symptom/Vehicle Issue: PCM Ground G929A Is Not Fully Tightened. Vehicle Does Not Start

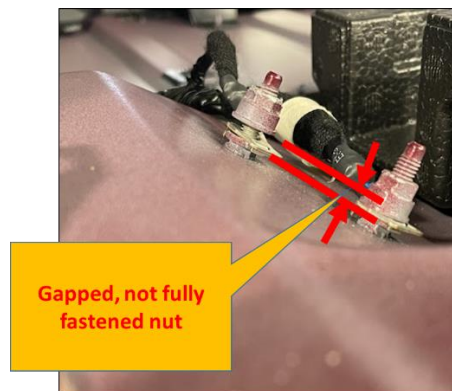
Discussion: The customer may complain that the vehicle does not start. This may be caused by the PCM ground G929A not being fully tightened. Causing an intermittent connection.

Diagnosis: Inspect the G929A ground in the engine bay on the drivers frame rail.

Repair Procedure: Tighten ground to 10.5 Nm.
