STAR ONLINE PUBLICATION

Case Number: S1708000118 REV. B

Symptom/Vehicle Issue: Battery Drain Concern, Dual USB Port Normal Operational Draw, Extended Illumination Or Extended Operation After Key Off

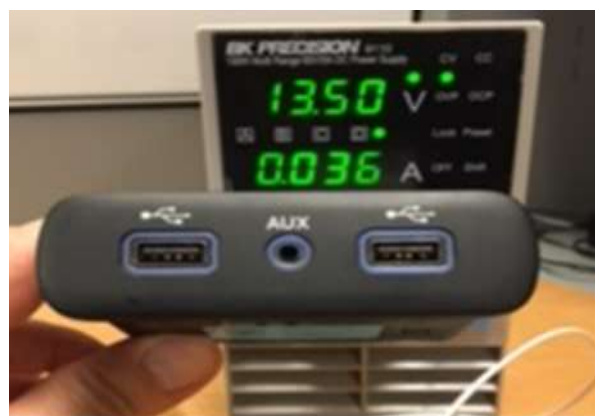
Vehicles equipped with the sales code RS4 - DUAL REMOTE USB PORT – CHARGE or RSF MEDIA HUB (SD, USB, AUX) come equipped with the active charging feature starting in 2017. The Media hub (s) can continue to charge and or allow extend key off operation for the user's device for up 60min post the ignition off. The IOD draw can be in a range of approximately 36mA.

Example of USB port draw

Discussion: Inspect for anything connected to any of the vehicles USB ports, disconnect before any further IOD testing.

NOTE: Do not replace the USB media or charging ports for battery drainage complaints.
