STAR ONLINE PUBLICATION

Case Number: S2208000135

Symptom/Vehicle Issue: Malfunction Indicator Lamp (MIL) On, Diagnostic Trouble Code (DTC) P0480 Cooling Fan 1 Control Circuit Open

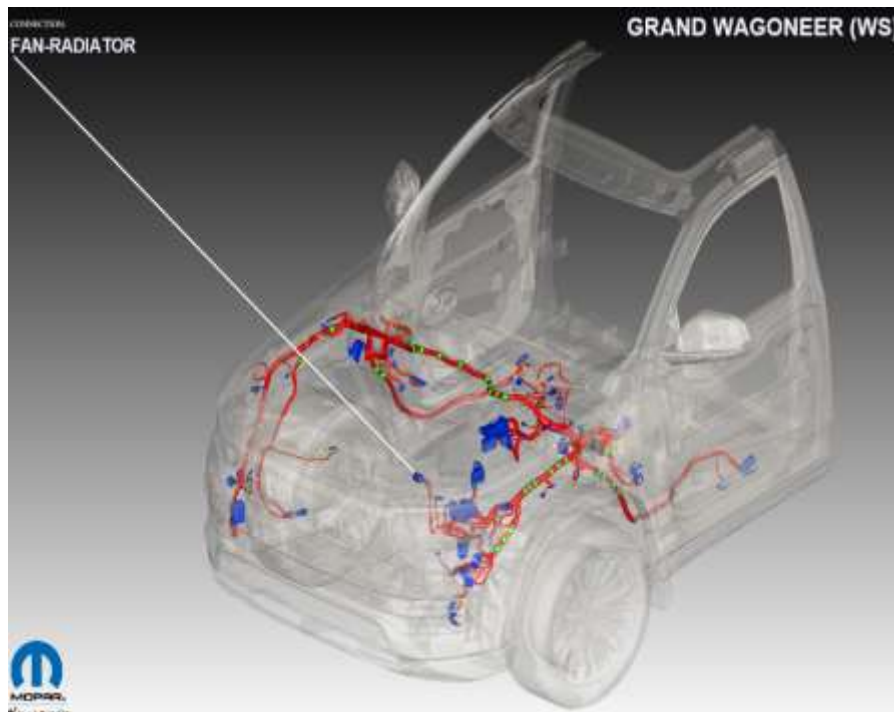
Fig 1

Customer Complaint/Technician Observation: Owner complains the MIL indicator lamp is illuminated. Technician observed the Powertrain Control Module (PCM) DTC P0480 - Cooling Fan 1 Control Circuit Open as stored or active.

Repair Procedure: Inspect the radiator cooling fan connector for any signs of a Terminal Pushed Out (TPO) conditions and secure all terminals. Test the involved circuits for power, ground and Pulse Width Modulation (PWM) control circuit from the PCM as needed, no parts required Fig 1, 2.

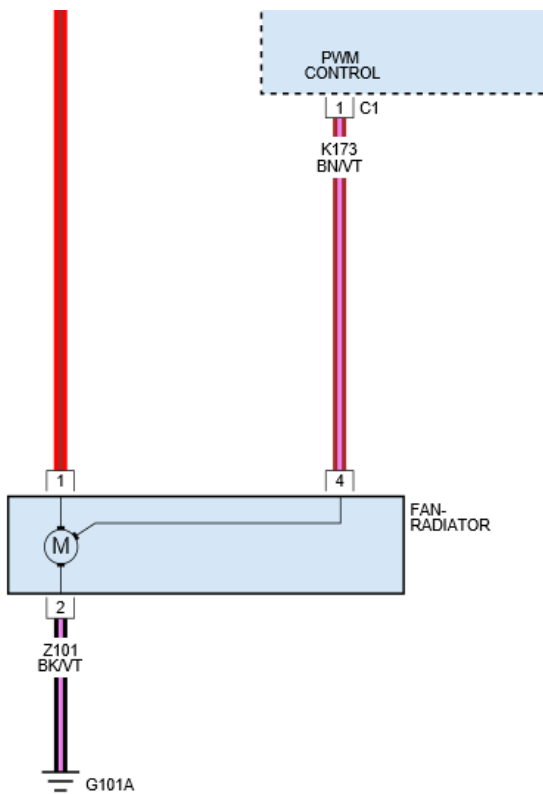
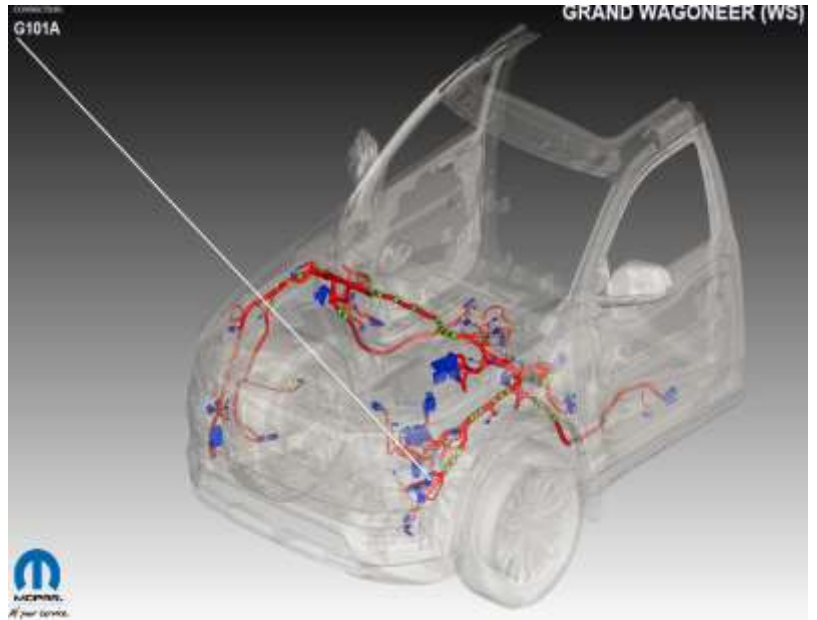
Fig 2

Dark Gray 4 Way

Pin	Circuit	Wire Color	Gauge/Size	Function
1	A13	RD/BN	12.0	FUSED B(+)
2	Z101	BK/VT	12.0	GROUND
4	K173	BN/VT	0.35	PWM CONTROL
