Case Number: S2208000119

Symptom/Vehicle Issue: Trailer Tow Lamps Inoperative After Mopar Trailer Tow Wiring Installation

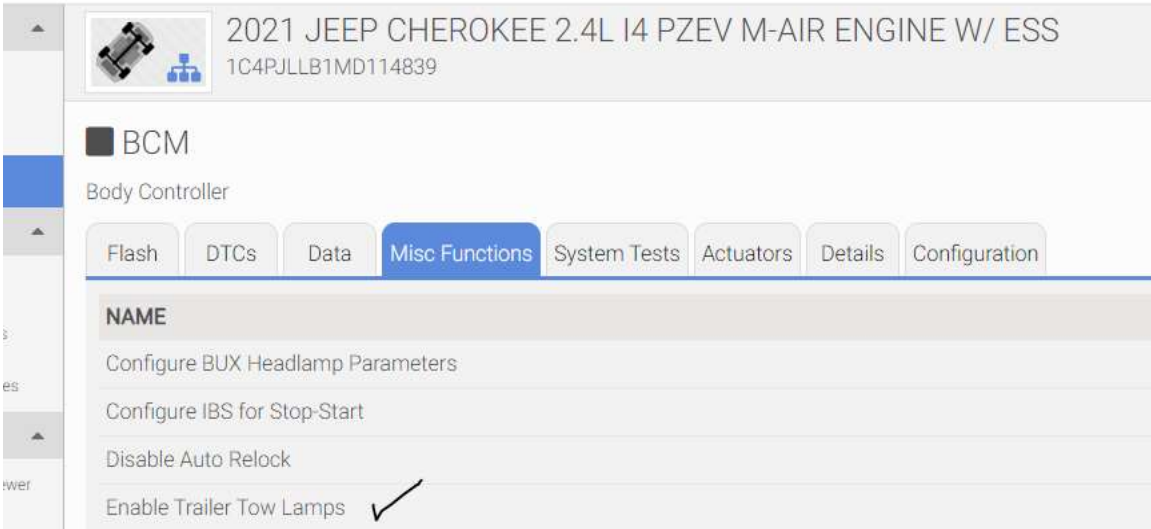
Fig 1

Technician Observation: Vehicle had trailer lamps installed or may have had a recent BCM service update and or replacement and the trailer lamps do not illuminate. Vehicle’s sales code configuration displays the proper sales code (XEY Trailer Tow Wiring Harness) and the vehicle reconfiguration has been performed.

Repair Procedure: Using the scan tool, access the BCM > MISC TAB > SELECT ENABLE TRAILER TOW LAMPS. Verify the operation of the trailer tow lamps once completed Fig 1, 2.
