STAR ONLINE PUBLICATION

Case Number: S2208000141

Symptom/Vehicle Issue: Cluster Display Option For Full Map Turn By Turn In Cluster Is Greyed Out

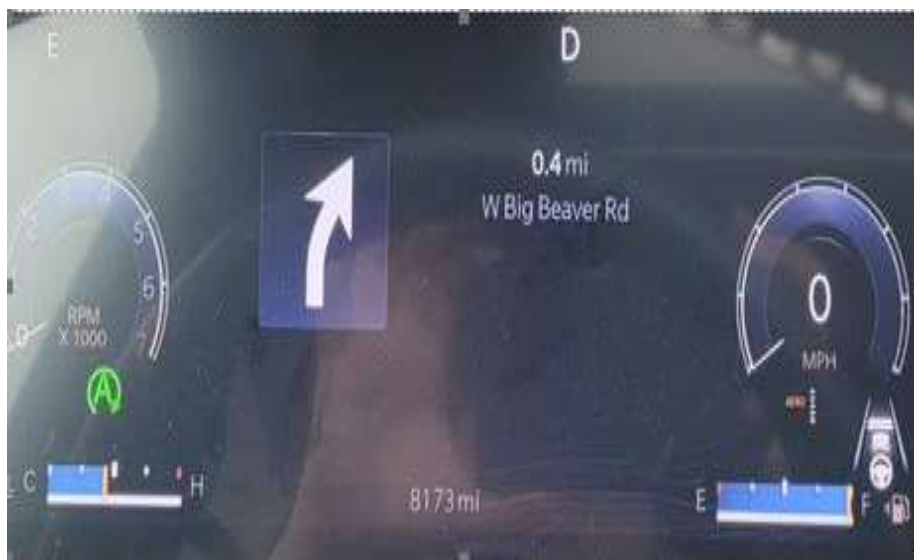
Note: Cluster turn by turn directional arrows are an available feature when a destination is entered into the radio NAV system and the vehicle is being driven.
