Clicking Noise From the Front Wheel Area During Slow Speed Turns

Service Category Brake

Section Brake (front)

Some 2013 – 2022 model year Lexus vehicles equipped with a 2WD drivetrain and the F Sport package may exhibit a clicking noise from the front wheel area during slow (parking lot) speed turns. The clicking noise that can be heard during sharp turns is a normal condition for certain vehicles originally equipped with a lightweight two-piece aluminum rotor assembly. For customers who find this objectionable, an alternative steel rotor is available. Before performing the repair in this bulletin, it is recommended to review the visual differences of the steel rotor with the customer. Follow the Repair Procedure in this bulletin to address this condition.

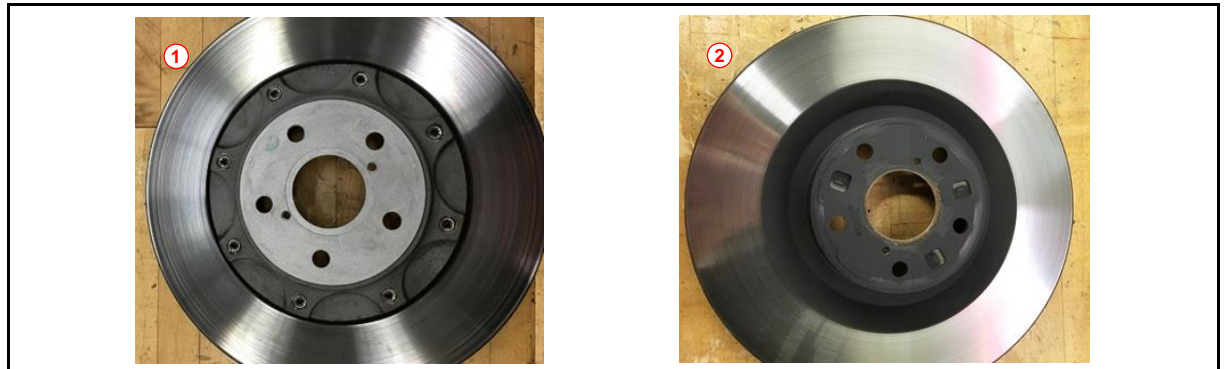
Figure 1. Rotor Differences

1	Before (Aluminum)
2	After (Steel)

If the vehicle is a GS 200t, GS 300, GS 350, GS 450h, RC 200t, RC 300, or RC 350 model, review the visual differences of the steel rotor with the customer BEFORE replacing the rotors.

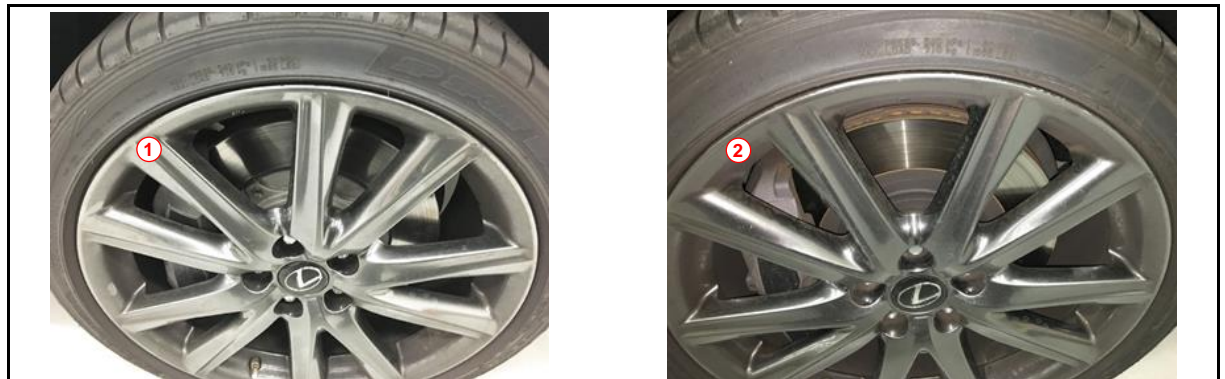
Figure 2. Example of One Wheel Type for the Vehicle*

1	Before (Aluminum)
2	After (Steel)

*Other wheel types may have slightly different results.

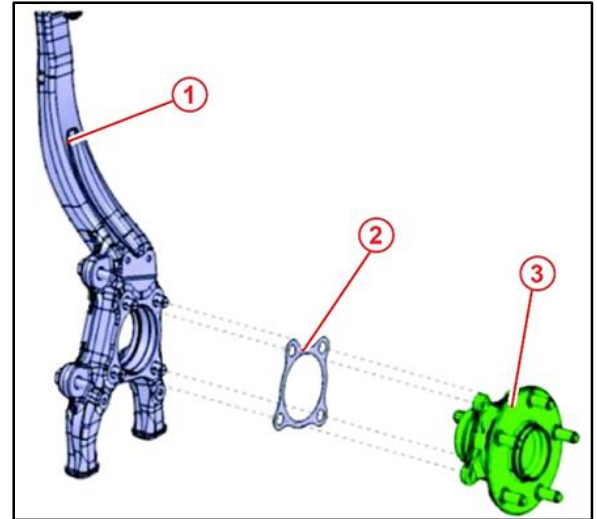
Figure 3.

1	Knuckle
2	Shim
3	Hub Bearing

- B. Install the painted brake shim between the hub bearing and knuckle as shown.

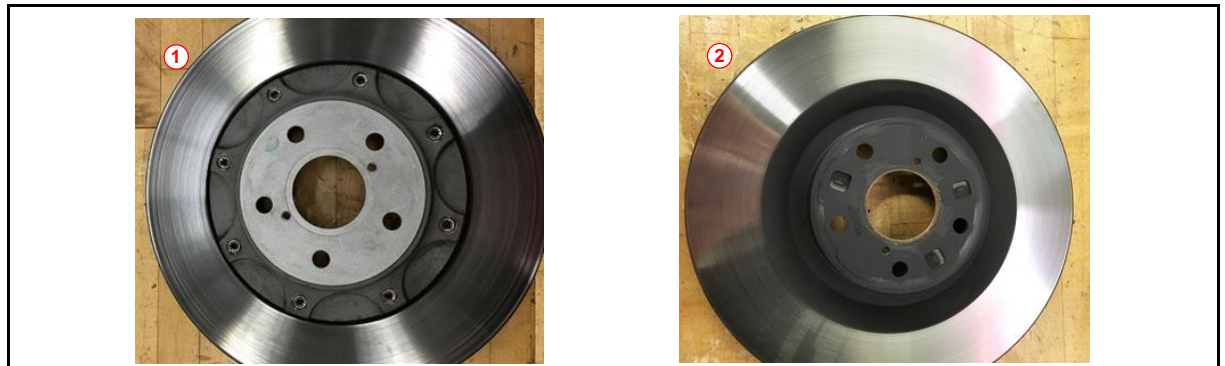
Figure 4. Rotor Differences

1	Before (Aluminum)
2	After (Steel)

7. Review the visual differences of the steel rotor with the customer BEFORE replacing the rotors.

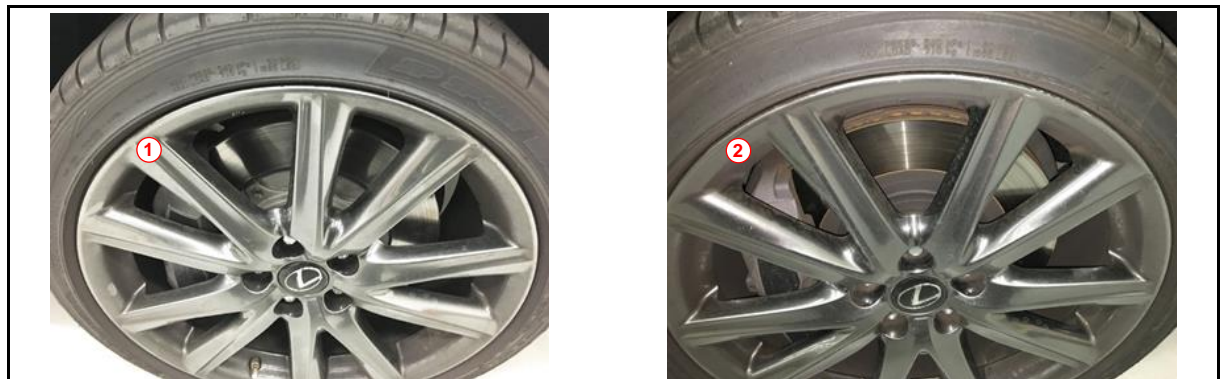
Figure 5. Example of One Wheel Type for the Vehicle*

1	Before (Aluminum)
2	After (Steel)

*Other wheel types may have slightly different results.

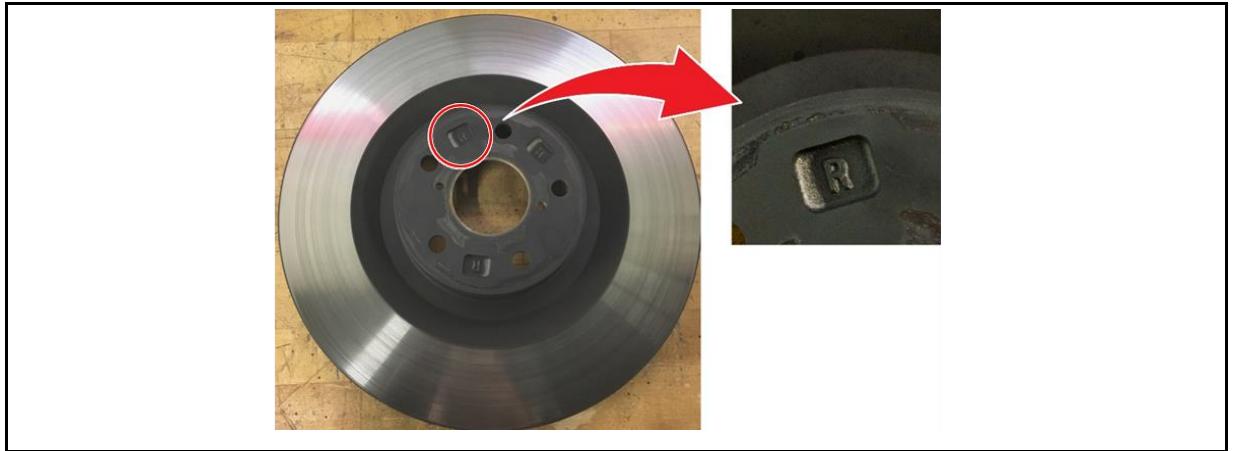
Figure 6.

NEW steel one-piece rotors do NOT have paint marks as shown in the Repair Manual. They are marked with an "L" or an "R" to indicate which location to install, as shown.

9. Install the updated (steel one-piece) front rotors and brake pad kit.
