TECHNICAL INSTRUCTIONS

LIMITED SERVICE CAMPAIGN 22TD04

ACCESSORY DASH CAMERA FIRMWARE UPDATE

CERTAIN 2021 MODEL YEAR SIENNA VEHICLES
CERTAIN 2021 MODEL YEAR VENZA VEHICLES

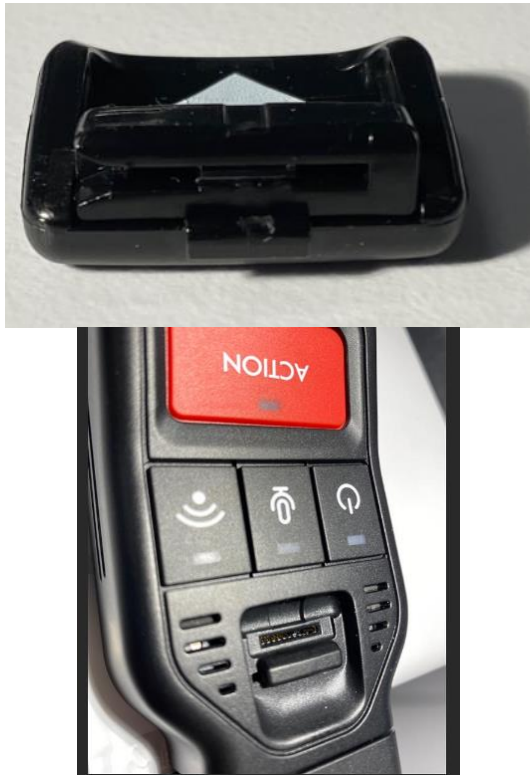
Example of **OK** Dash Camera Housing and SD Card Holder

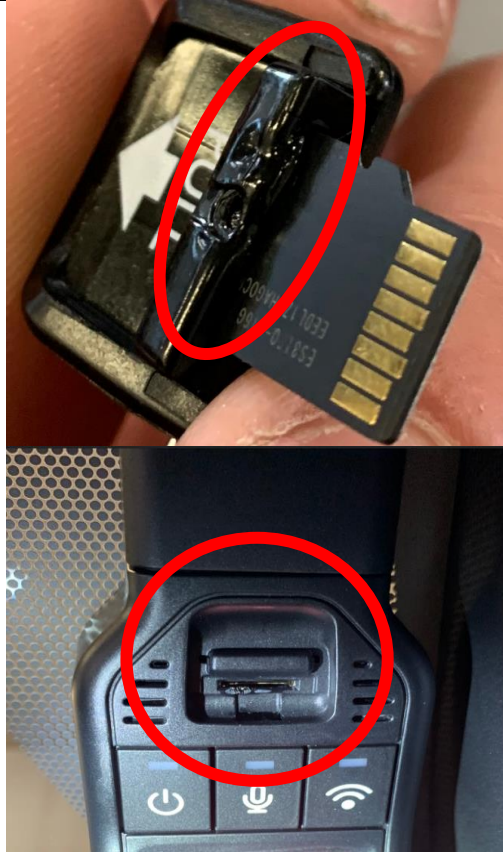
The involved vehicles are equipped with a Toyota Genuine Accessory Dash Camera. When the Micro SD Card in the accessory dash camera is damaged and an error is detected, the accessory dash camera continuously attempts the read/write function leading to a rise in temperature of the accessory dash camera components and potential melting of the Micro SD card and the surrounding area on the accessory dash cam.

Example of **Failed/NG** Dash Camera Housing and SD Card Holder
(This damage is expected to be extremely rare)

***Note: Parts needed will be dependent on inspection results. If thermal event damage is found on the Dash Camera Assembly, the vehicle will require a new Dash Camera Assembly. If no thermal event damage found, the vehicle DOES NOT REQUIRE Dash Camera Assembly.**

REVIEW SECTION BELOW (POST INSPECTION FLOW CHART) TO DETERMINE NEXT STEPS
