2023 Sequoia HV Pre-Delivery Service (PDS)

Section Pre-Delivery Service

YEAR(S)	MODEL(S)	ADDITIONAL INFORMATION
2023	Sequoia HV

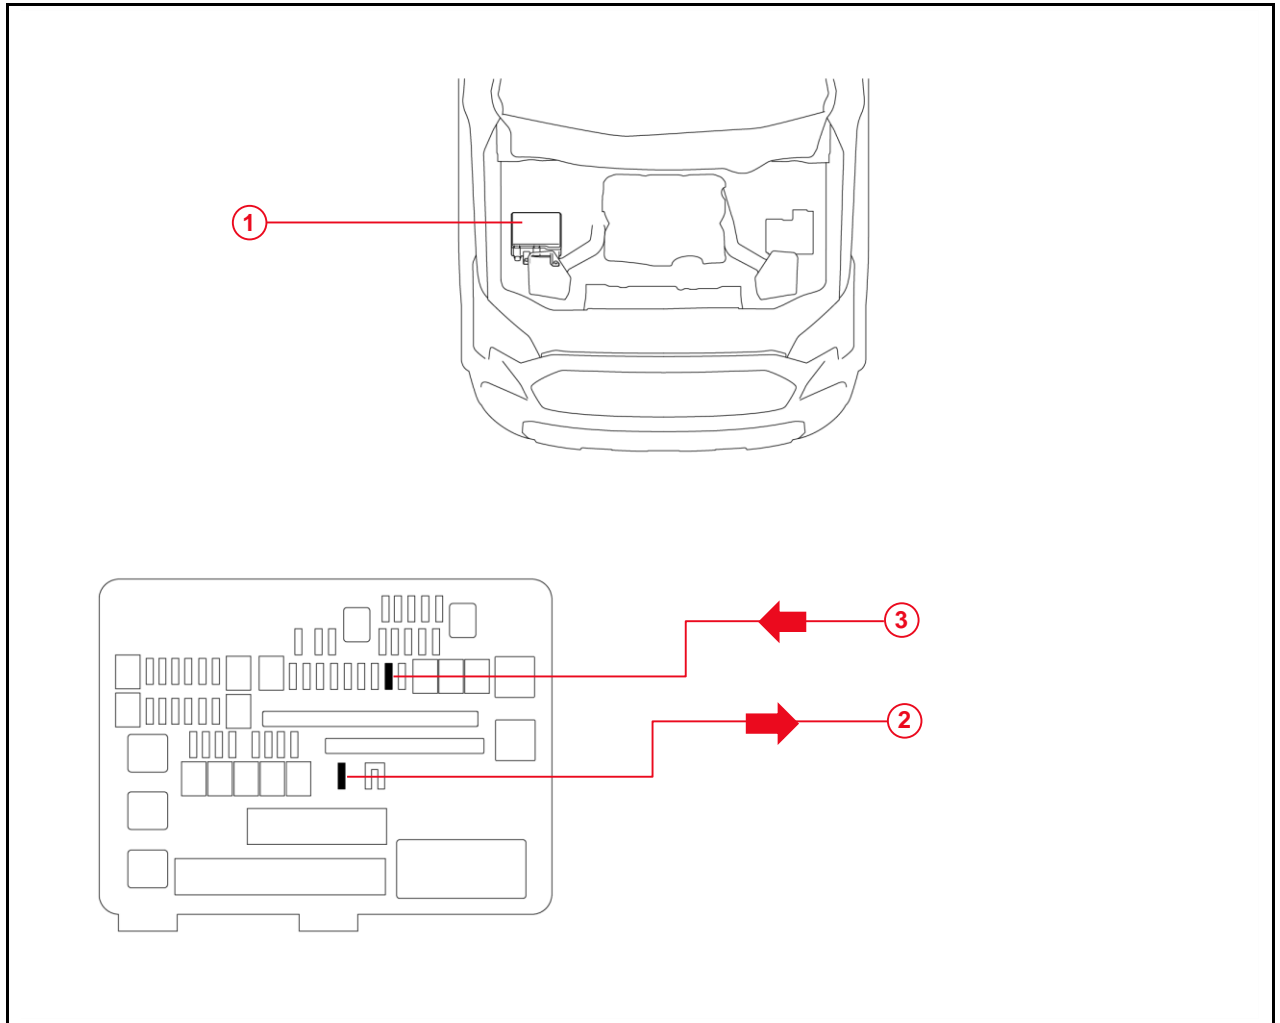
Figure 1.

To minimize battery discharge, the D/C cut fuse (30A) has been removed and stored in the engine compartment relay block. Install the D/C cut fuse (30A) and confirm ALL related Diagnostic Trouble Codes (DTCs) are cleared.

1	Relay Block
2	Remove D/C Cut Fuse (30A)

3	Install D/C Cut Fuse (30A) (Original Location)
----------	---

With the D/C cut fuse (30A) removed, the DTC is detected when the ignition is turned on during transportation. Using Global Techstream Software (GTS), clear ALL DTCs AFTER ensuring that there are no malfunctions.
