Tail Lamp Contacting Body

Service Category Vehicle Exterior

Section Lighting (ext)

Applicability

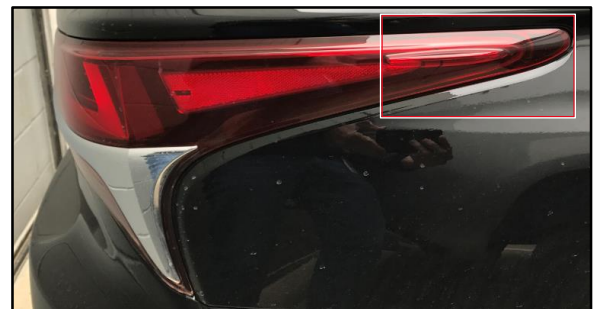
Figure 1. Rear Combination Lamp Movement Location

Some 2018 – 2019 model year LS 500 and LS 500h and 2019 – 2022 model year RX 350 and RX 450h vehicles may exhibit a condition where the rear combination lamp front corner on the right and/or left-hand side expands and contacts the body. This condition may occur in hot and/or sunny conditions and may result in paint chipping on the body panel. Follow the Repair Procedure in this bulletin to address this condition.

1. Confirm the condition exists.
Does the vehicle exhibit signs of contact between the rear combination lamp front corner and the body, as shown?
 - **YES** — Continue to step 2.
 - **NO** — This bulletin does NOT apply. Continue diagnosis using the applicable Repair Manual.

Figure 1 shows an LS vehicle. RX vehicles exhibit the condition in a similar location.

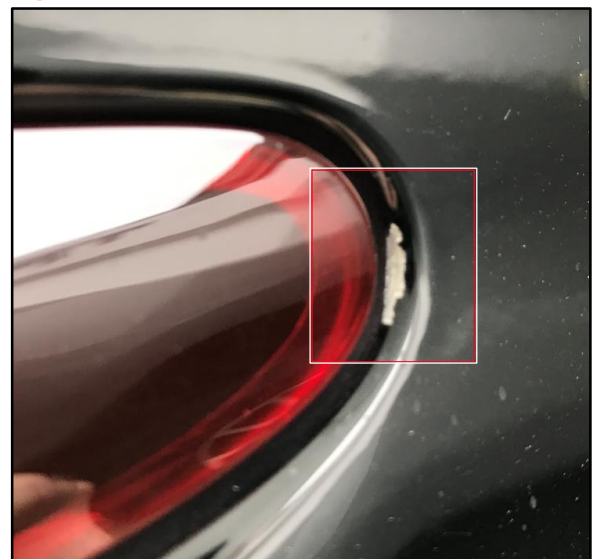
Figure 2. Chipped Paint Condition

3. Does the body near the rear combination lamp front corner exhibit chipped paint as shown?

- **YES** — Sublet the vehicle to a body shop for proper refinishing of paint chips on the body, then continue to step 4.
- **NO** — Continue to step 4.

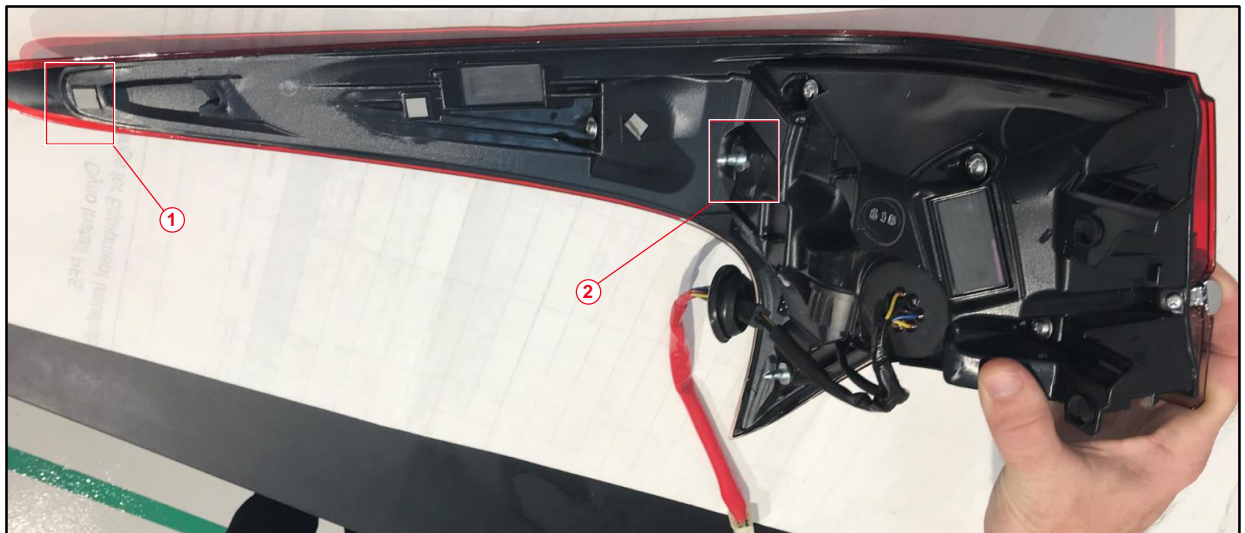
Figure 3. Inside Surface View of Rear Combination Lamp

4. Locate the upper alignment pin and the forward pad on the inside of the tail lamp surface as shown.

| 1 | Forward Pad |

| 2 | Upper Alignment Pin |

5. Remove the existing forward pad located on the rear combination lamp assembly.
