Subject		Market
2018-2022 GX460 Transfer Case Leak		USA
Service Category	Section	
Drivetrain	Transfer/4wd/AwdAwd	
Applicability		
2018-2022 GX460

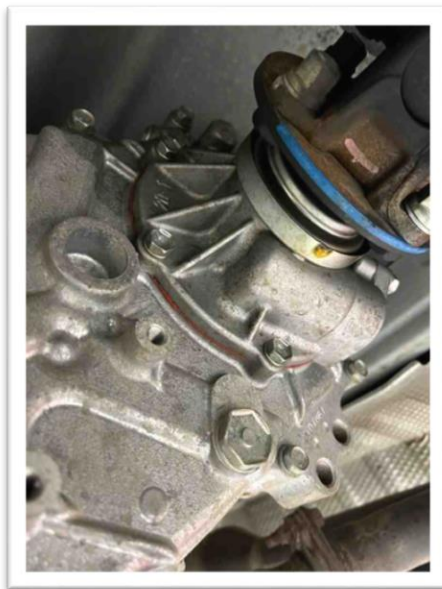
This condition is currently under investigation. Oil may be found leaking from the transfer case input or rear output shaft seal as seen in the example pictures below:

Figure 1 Rear Output Shaft Seal Leak

If you see this condition, please create a TAS case and contact TAS for instruction prior to diagnosing or repairing of the vehicle. If it is a weekend or holiday, continue with diagnosis and repair. Please save all parts and/or details and contact TAS on the next available workday.
