SIB 01 12 19

2022-08-09

FRONT GRILLE UPPER/LOWER ACTIVE AIR FLAPS: LTD WTY EXT TO 15 YEARS/150,000 MILES

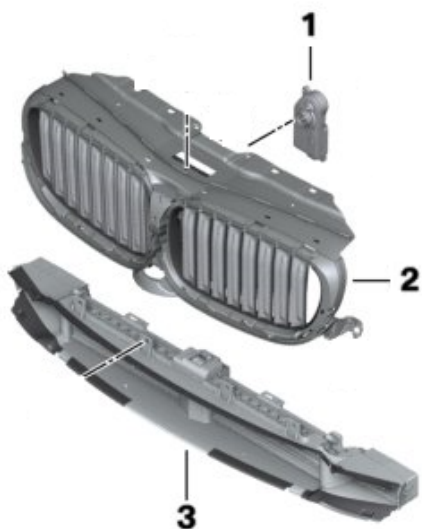
1. Air flap control (link) active, upper (G12, G30 and G32)
2. Air flap control (drive), active, upper
3. Air flaps, upper (assembly)
4. Air flaps, lower (assembly)

A check control message or MIL (Malfunction Indicator Lamp) may be illuminated with faults stored related to the upper and/or lower active air flap(s).

- Faulty upper air flap link (G12, G30, G32)
- Faulty upper air flap actuator (G01, G02, G12, G30, G32)
- Faulty upper flap assembly (G01, G02, G12, G30, G32)
- Faulty lower air flap assembly (G01, G02, G12, G30, G32)
- Software error in the DME affecting the upper flap (G01, G02 only)

- Upper air flap link (G12, G30, G32)
- Upper air flap actuator
- Upper air flap assembly
- Lower air flap assembly
- Software update (G01, G02)
