SIB 41 05 22

WATER INGRESS IN THE F44 RIGHT TAIL LAMP

E-Series	Model Description
F44	2 Series Gran Coupe

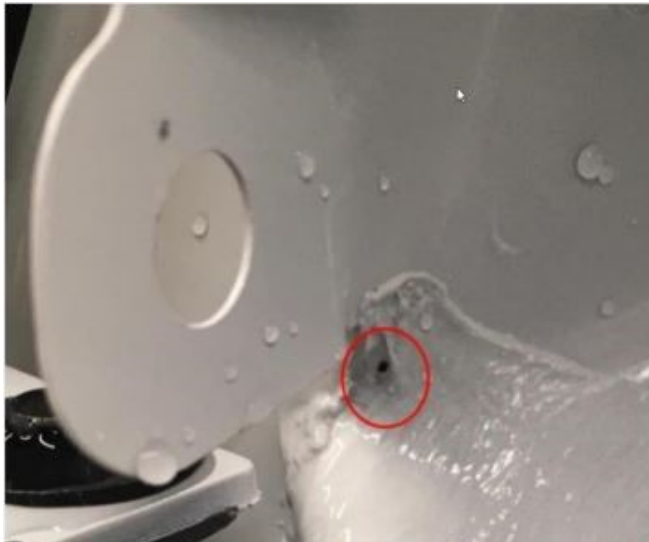
Hole in the PVC seam on the right tail lamp pocket.

Note: The hole in the PVC seam may not always be readily visible.

Seal the hole on the right tail lamp pocket using D2 sealant.

2. Seal the hole using D2 sealant.
