SIB 51 13 22

FUEL FILLER DOOR OPENS AUTOMATICALLY WHILE DRIVING

E-Series	Model Description
G80	M3 Sedan
G82	M4 Coupe
G83	M4 Convertible

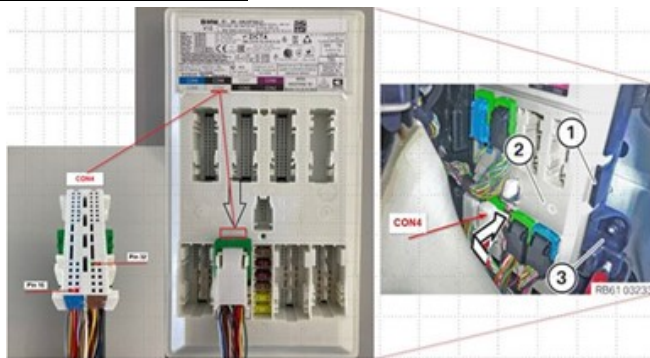
During strong acceleration, the fuel filler door possibly opens automatically.

The fuel filler door is not electrically locked while driving.

A pin at the BDC (Body Domain Controller) needs to be relocated.

- Reference the repair instructions in AIR/ISTA (61 35 278) to access the BDC (Body Domain Controller).
 - The BDC (Body Domain Controller) does not need to be removed
- At “connector 4” at the BDC (Body Domain Controller), pin 16 must be relocated to empty pin chamber 32.
- Make sure that the menu option in the Head Unit “lock when driving off” is selected.
