PIT5626D Intermittent Communications Concerns - Possible Multiple MILs on U0073 or Multiple U-Codes Stored

Brand:	Model:	Model Years:	VIN:		Engine:	Transmissions:
			from	to		
Chevrolet	Colorado	2016 - 2022	All	All	LCV	All
GMC	Canyon	2016 - 2022	All	All	LCV	All

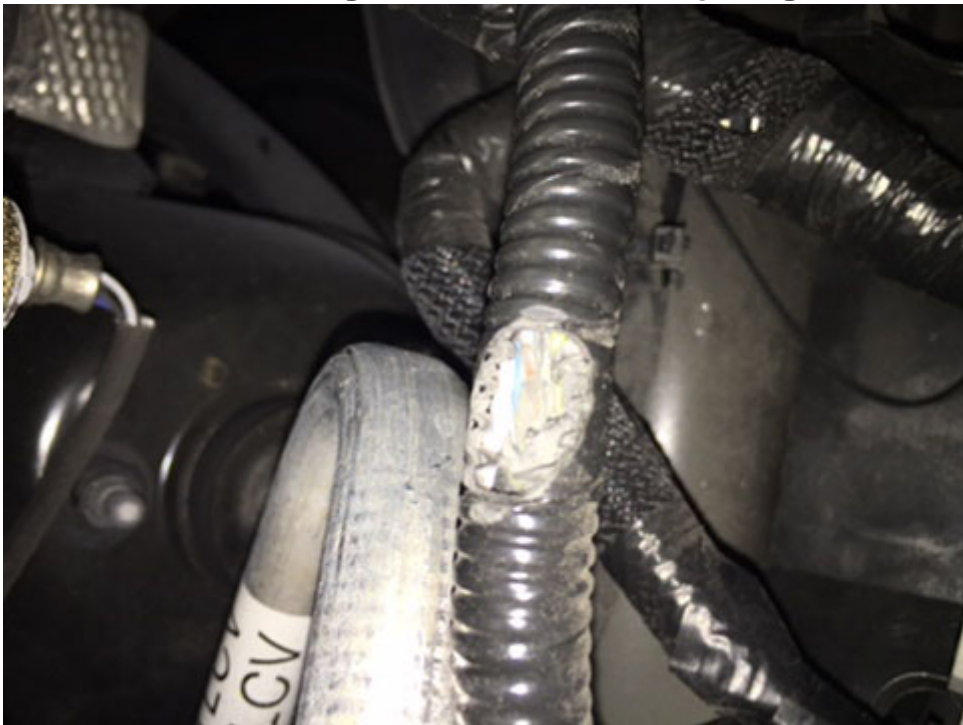
Involved Region or Country:	North America
Condition:	Intermittent multiple MIL's or messages, loss of communication, potential U-codes.
Cause:	Main harness chaffed under hood.

Check for harness chaffing on the low side A/C pipe, left side below the exhaust manifold. This is best observed through the left wheel well opening.

Repair per instructions in SI and secure harness away from the pipe.
