# Preliminary Information

## PIP5810A Transfer Case Input Seal Installation

Brand:	Model:	Model Years:	VIN:		Engine:	Transmissions:
			from	to		
Chevrolet	Silverado 2500 HD/3500 HD	2020 - 2023	All	All		MGM MGU
GMC	Sierra 2500 HD/3500 HD	2020 - 2023	All	All		MGM MGU

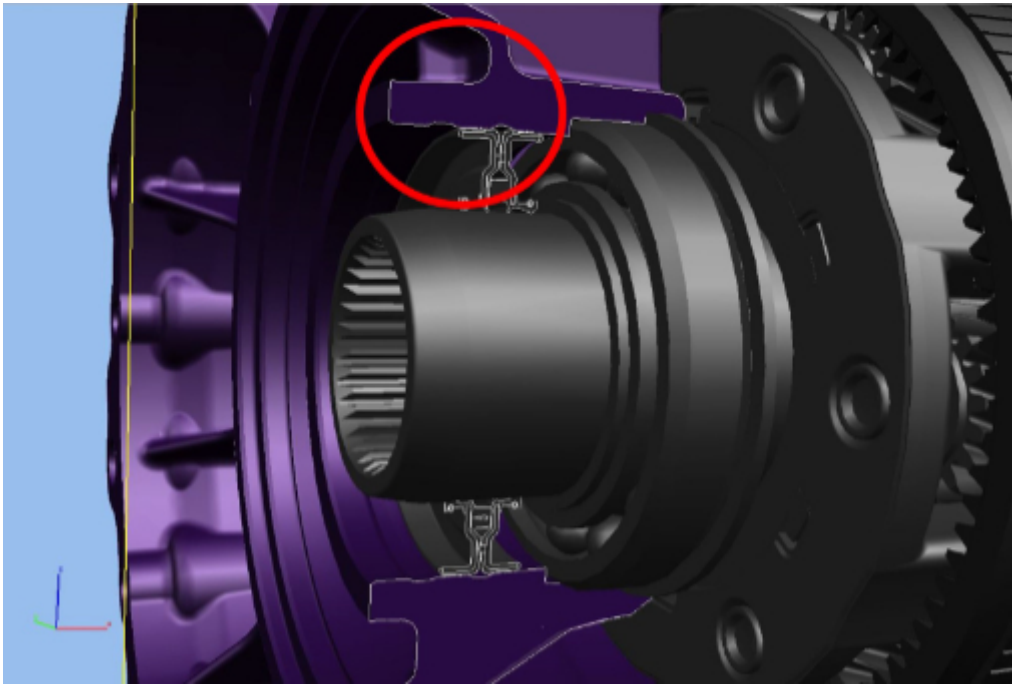
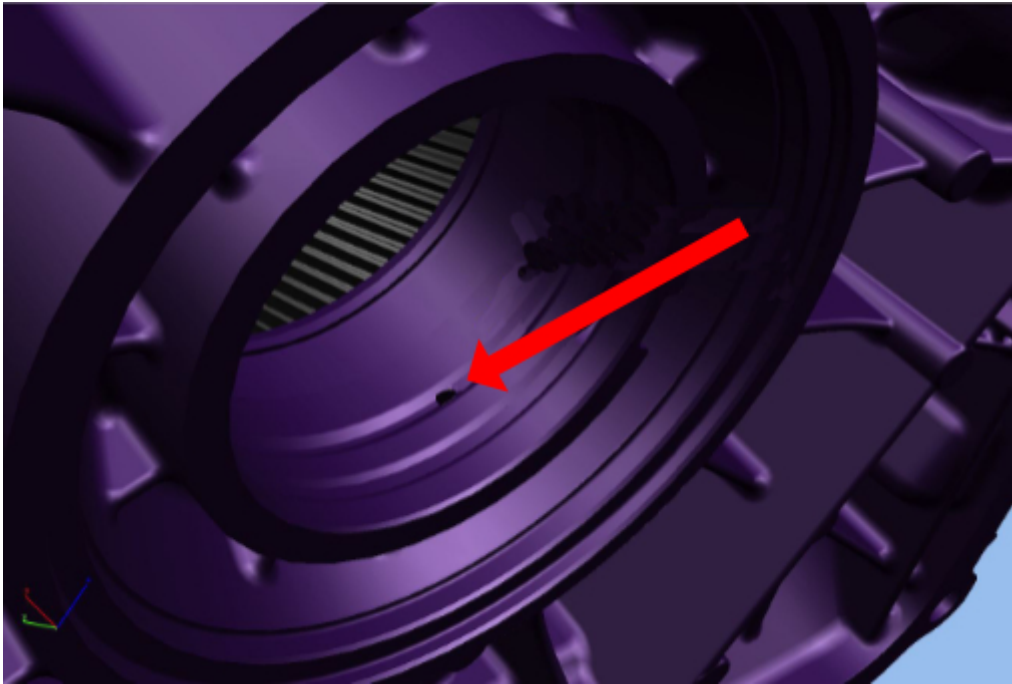
Seal installation depth is critical when replacing the transfer case input seal. There is a gap around the outer portion of the seal that needs to be centered over a weep hole in the case. Weep hole is drilled in the center of a groove machined into the case. Tool # DT-50648-A Seal Installer will not work for these applications.

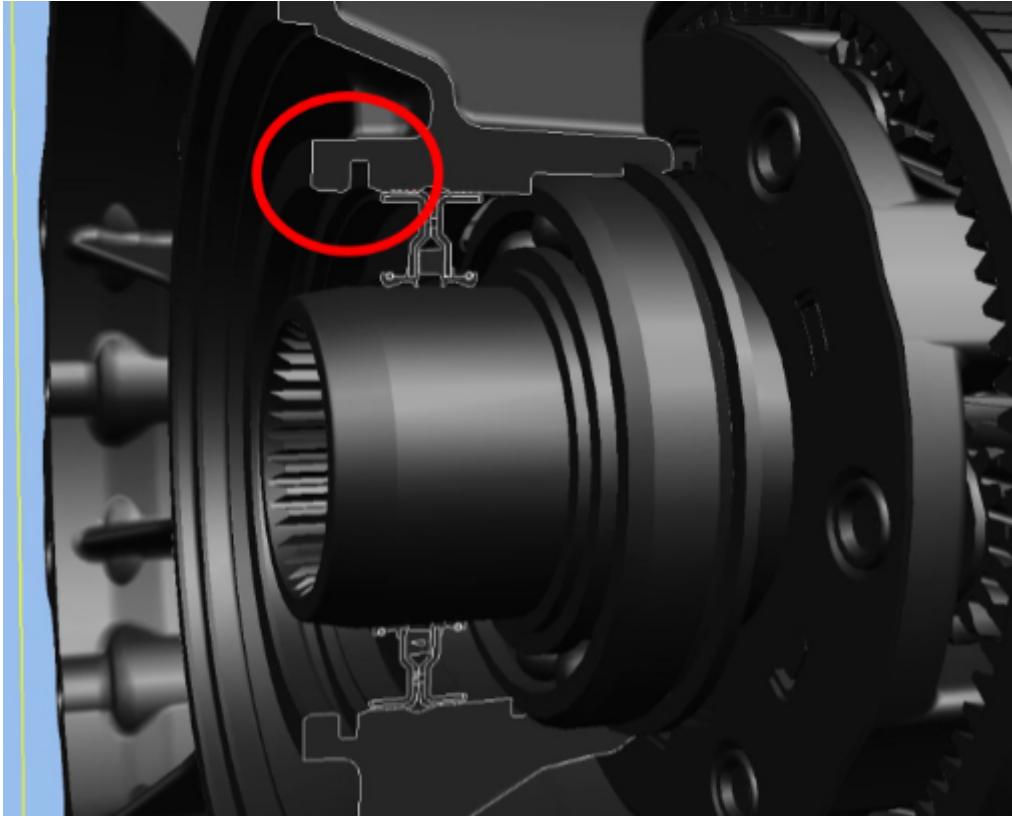
First Design

There are 2 design transfer case front case halves and the seals install at different depths between design 1 and 2. To identify design level look for a machined groove where the seal is installed (Red circles below). If there is a defined machined groove in the case then it is a first design case. If there is not a defined groove machined into the case then it is second design.
