Bulletin No.: PIT5950

PIT5950 Diagnostic Tip - Repeat Front Wheel Speed Sensor DTC After Sensor Replacement - ABS Traction Stability Control MIL DTC C0505 C050B C0511 C0517 C0501 C0502 C0503 C0504 C0507 C0508 C0509 C050D C050E C050F C0510 C0513 C0514 C0515 C0516 and/or C050A

Brand:	Model:	Model Years:	VIN:		Engine:	Transmissions:
			from	to		
Chevrolet	Silverado 1500 (New Model)	2019	All	All	All	All
Chevrolet	Silverado 1500	2020 - 2023	All	All	All	All
GMC	Sierra 1500 (New Model)	2019	All	All	All	All
GMC	Sierra 1500	2020 - 2023	All	All	All	All

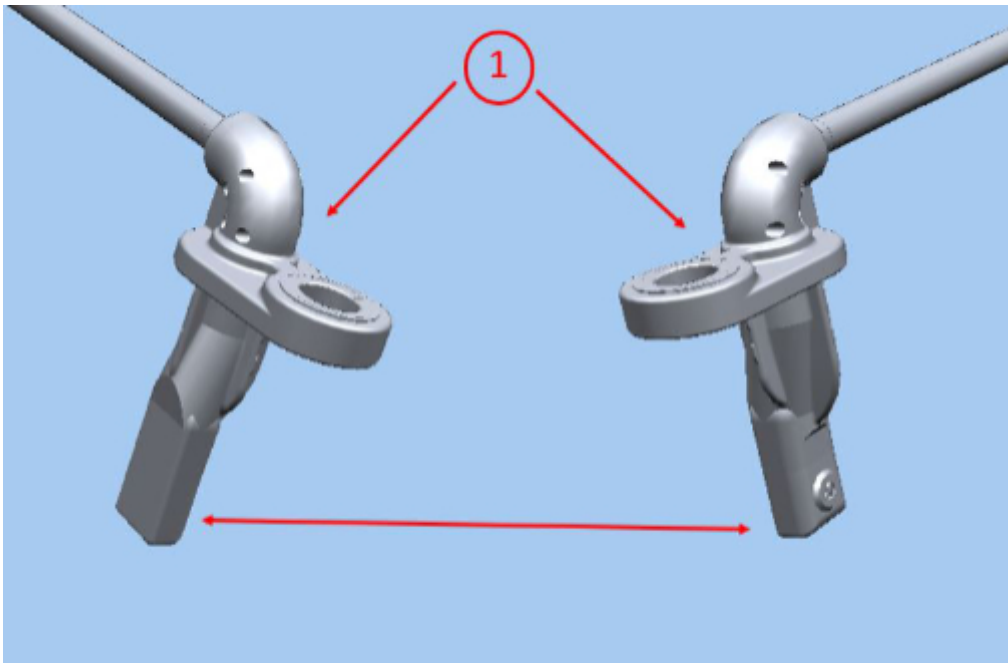
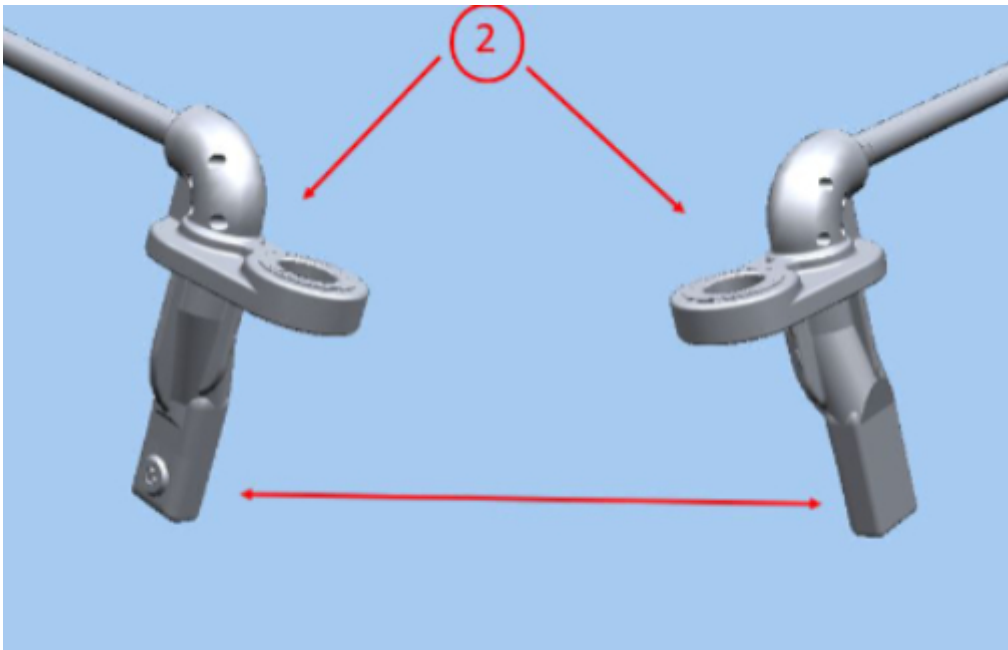
Involved Region or Country	North America
Condition	<p>When replacing a front wheel speed sensor (WSS) it is critical that the correct part number WSS sensor be installed for it to properly sense the magnetic encoder ring located on the wheel bearing assemblies.</p> <p>The Right (1) and Left (2) front WSS, shown below, look very similar and there have been many cases where the wrong sensor has been installed.</p> <p>An example would be a right WSS installed on the left side of the vehicle.</p> <p>Subsequently, several unnecessary parts are replaced, such as, Brake System Control Modules, wheel bearings, additional wrong WSS, pigtail connectors, etc.</p>
Cause	Incorrect part number WSS installed.

If a front WSS is replaced and you continue to set WSS DTC(s) for the same side, then check to make sure the correct part number front WSS was installed.

Inspect the tip of the WSS to ensure the flat side of the sensor tip is orientated towards the wheel bearing magnetic encoder ring.
