**Published date:** 09/30/2022

# **Preliminary Information**

## PIT5832C Diagnostic Tip: No Start Or Unable To Perform Theft Relearn After Replacing Or Programming A Module / DTC U1962

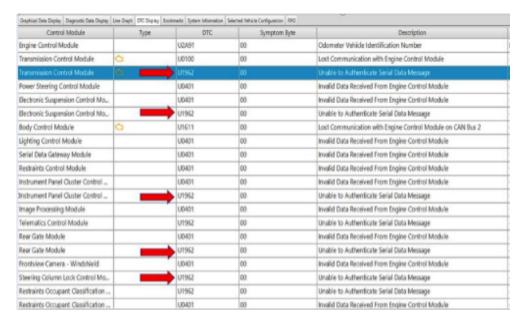
6. You may also notice that the VIN number will not self-populate in GDS2
	The serial Data Authentication Configuration procedure runs automatically as part of the programming procedure.
Cause	The Serial Data Authentication Configuration is a security handshake between all the modules on the vehicle. One of the main indicators the Serial Data Authentication Configuration did not complete properly is DTC: U1962 is current in one or more modules.
	See Example below:

The dealer will need to perform the Serial Data Authentication Configuration (SDAC) following Instructions in SI using Document ID: 5404959. Be sure the vehicle is Power Moded to the OFF position before running the Serial Data Authentication Configuration procedure.

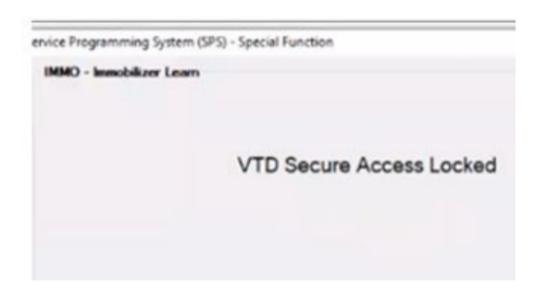
- 1. If a module was replaced, make sure the new module was SPS programmed correctly or the SDAC will fail and not complete correctly.
- 2. If a module such as the BCM is replaced, and the immobilizer learn needs to be completed after replacement, the tech needs to make sure that the SDAC completes correctly, or a pop-up message like the one below will be displayed:

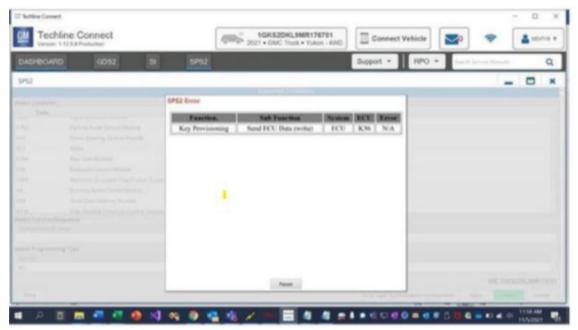
4. The SDAC will run 3 times before it fails. When it fails, there should be a pop box that shows up on the screen like the one below. Check and record the items listed under System and ECU. If the system box reads "Server" then the issue is related to the SPS system server or internet connection and not related to the vehicle. Attempt the SDAC again at a later time.

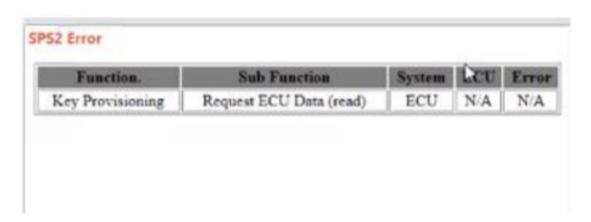
- 5. If the system box reads "ECU", then the Global ID of the module that is causing the concern should be able to be obtained. In the example below, the Global ID is listed as K36, which is for the SDM. The module's name can be found by looking at the global codes listed under "Control Module References" document in SI for the vehicle that is being working on.
- 6. Sometimes the pop-up box will read "ECU" but it will not give you a Module ID in the ECU box. In this case, the servicing dealer will have to contact Techline support and they will have to assist by getting a SPS log file from the dealership's system. If this is the case, they must be contacted right after the SDAC failure. If any other programming is attempted before contacting Techline, then the SPS log will be erased.

7. Once the module that caused the concern has been identified, pull the fuse that supplies battery power to that module. Sometimes the fuse is a three-prong fuse that feeds other modules. In this case, the servicing technician will need to find a two-prong fuse to power the other module that was not involved in the SDAC failure.

8. If the SDAC completes after removing battery power from the module in question, that module will need to be replaced. Afterwards, verify that the SDAC completes after SPS programming of the new module.
