Technical product information

Topic	DTC P1B8100 stored within 006B – Aerodynamic control unit - No test plan in ODIS to assist with diagnosis
Market area	Russische Föderation (5RU),Australia E04 Bentley rest Asia and Australia (6E04),China 796 VW Import Comp. Ltd (Vico), Beijing (6796),Germany E02 Bentley rest Europe (6E02),Japan E03 Bentley Japan (6E03),Korea, (South) E08 Bentley South Korea (6E08),United Arab Emirates E06 Bentley Middle East and Africa (6E06),United Kingdom E01 Bentley UK (6E01),United States E05 Bentley USA and rest America (6E05)
Brand	Bentley
Transaction No.	2068151/1
Level	EH
Status	Approval
Release date

New Continental GT

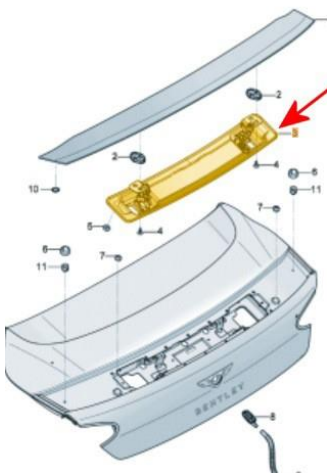
Figure 1

Refer to the ETKA parts catalogue for the deployable rear spoiler assembly (lifting platform as Figure 1) part number

- Should no wiring issues be evident - Referring to Rep.Gr 66 replace the deployable rear spoiler assembly
