## Technical product information

<b>Topic</b>	Front door clash condition with the rear door brightware (left and/or right hand side)
<b>Market area</b>	Russische Föderation (5RU),Australia E04 Bentley rest Asia and Australia (6E04),China 796 VW Import Comp. Ltd (Vico), Beijing (6796),Germany E02 Bentley rest Europe (6E02),Japan E03 Bentley Japan (6E03),Korea, (South) E08 Bentley South Korea (6E08),United Arab Emirates E06 Bentley Middle East and Africa (6E06),United Kingdom E01 Bentley UK (6E01),United States E05 Bentley USA and rest America (6E05)
<b>Brand</b>	Bentley
<b>Transaction No.</b>	2068064/1
<b>Level</b>	EH
<b>Status</b>	Approval
<b>Release date</b>

### Bentayga and Bentayga EWB

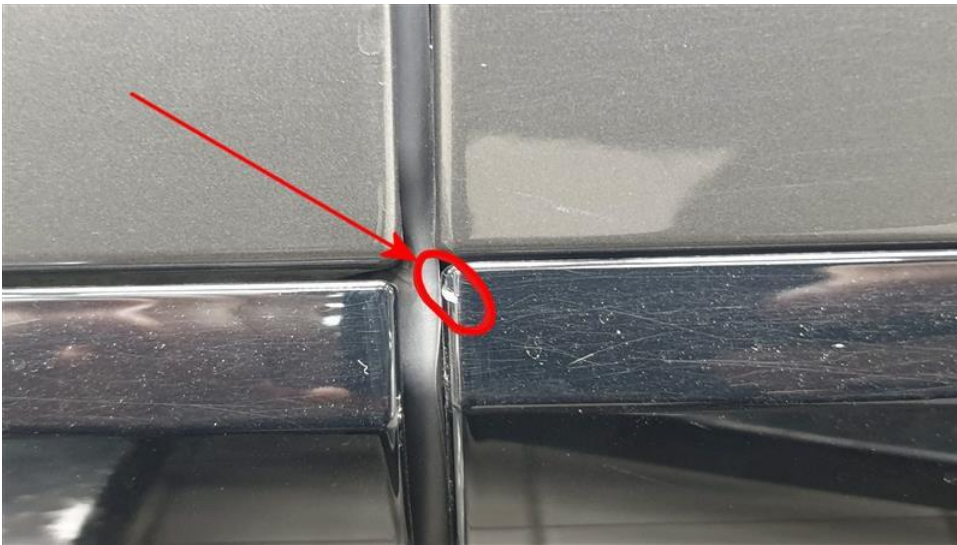
Figure 1

The front door inner panel hem is clashing with the rear door lower brightware (Figure 1) during the closing operation of the front door

The clash condition can occur on the left and/or right hand side, for photographic purposes the repair is shown on the left hand side

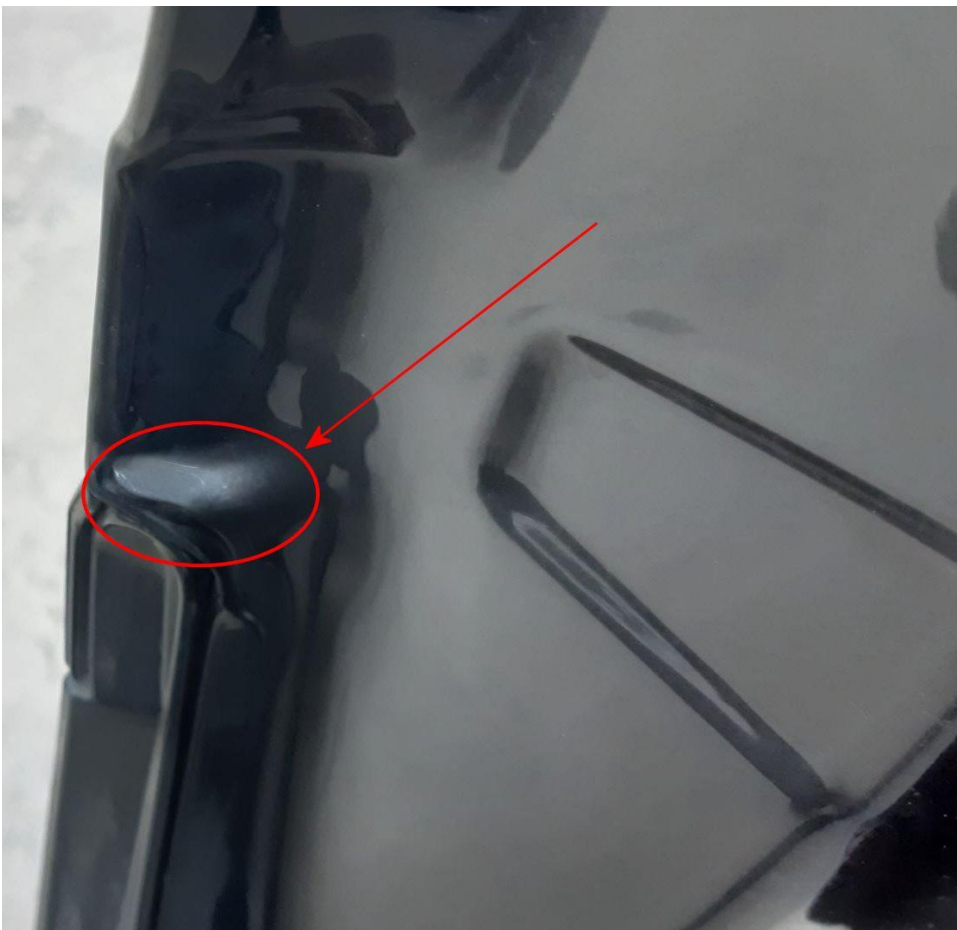
Figure 2

The issue is evident due to a clash condition between the front door inner panel hem (Figure 2) and the rear door lower brightware (Figure 3)

1) With extreme care - Use a suitable "smooth cut hand file" to remove the raised inner door panel hem edge, until the hem edge is as shown in Figure 4
