## Aftersales Bulletin

### 00 51 48 05 00 – Service Action Comfort Entry Access Check and Rework

This Service Action affects Rolls-Royce Ghost (RR21/22) and Cullinan (RR31) models produced from January 28<sup>th</sup>, 2022, up to March 11<sup>th</sup>, 2022. These vehicles are equipped with Comfort Entry Access feature (option code 322) which has been identified as having a potential issue with this system functionality. Due to an issue relating to a semi-conductor shortage, the Comfort Entry System would not operate as intended.

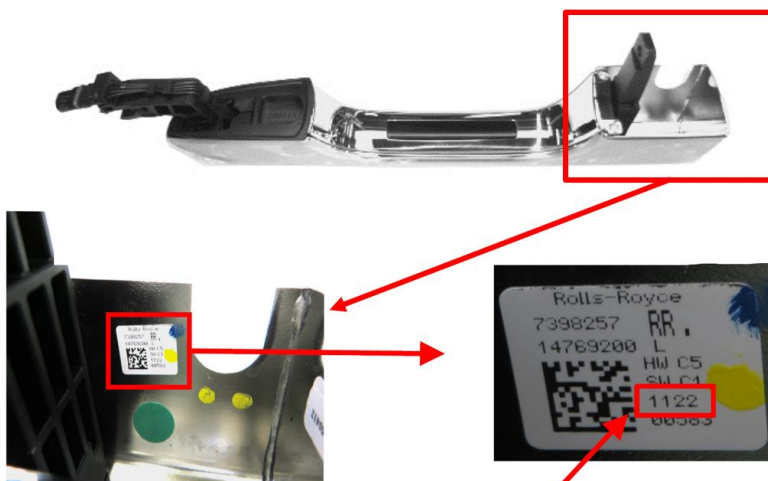
4. Check the supplier build day code on the white label to see if it is between range 0192 and 0982 (from 19th to 98th day of 2022).

Batch Identification Number	Status
xxxx 0190 0191	If number is lower than 0192, Part is OK – Do not replace insert
0192 xxxx xxxx xxxx 0982	If number is in this range part is <b>Not OK</b> and will require insert replacement work to be performed
0983 0984 xxxx	If number is higher than 0983 Part is OK – Do not replace insert

- If the number on label is outside (lower than 0192 or higher than 0982) of this range (OK part), go to Step 29 of this instruction.
  - If the number on label is within the day range above (**not OK** part), the insert will need to be replaced. Continue with repair from steps 7 onwards.
5. Place the door handle to be repaired on a clean padded surface.
  6. Observe the original position and quantity of previously installed spacer washers that may be already fitted to the part, as this will need to be replicated after replacement of plastic handlebar electronics.

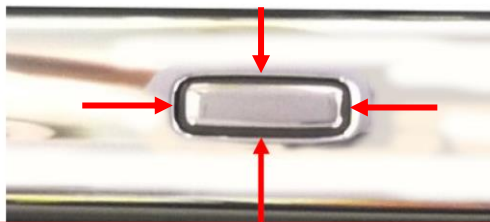
Button sensor alignment centered.  
Gap around button sensor:  $1.2 \pm 0.2$  mm

21. Double check again the alignment of the button sensor within the outer metal shell to ensure that it is centralized. Correct alignment gap should be 1.2 mm with  $\pm 0.2$  mm tolerance all the way around (min 1.0 mm / max 1.4 mm gap).

- If the button sensor alignment gap is within the required range ( $1.2 \pm 0.2$  mm) – adjustment is not needed. Please go to Step 28 of this repair instruction.
- If the button sensor alignment gap is outside the required range ( $1.2 \pm 0.2$  mm) – further adjustment is needed. Follow Steps 22 – 27 for the additional work.

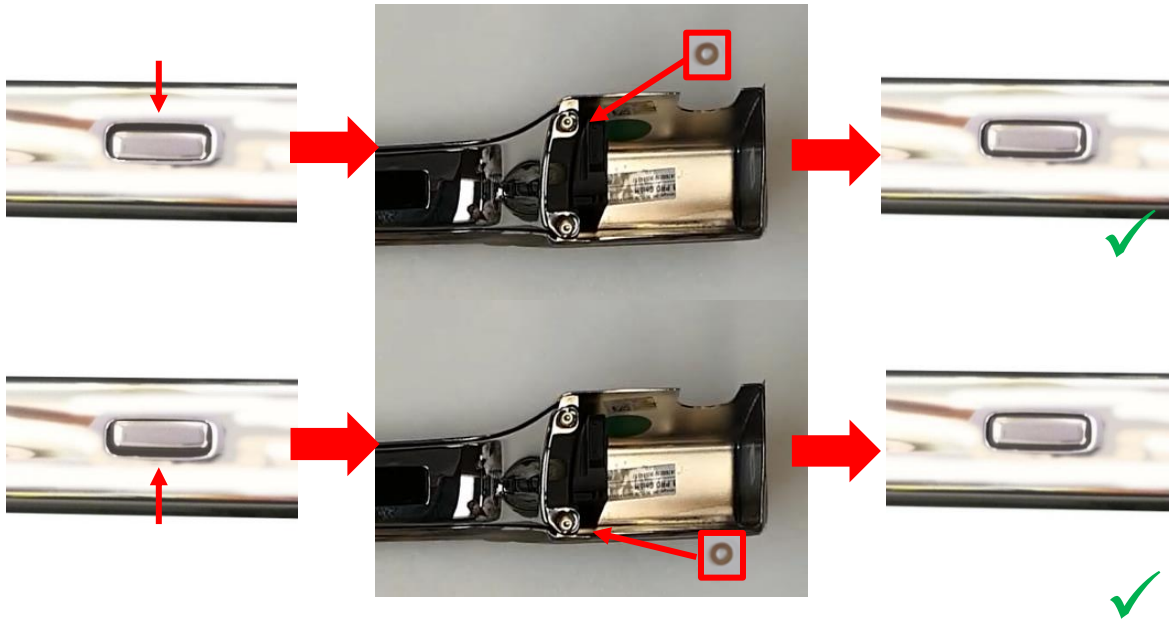
A spacer washer reduces the gap between the button sensor and the outer shell on the same side where it is inserted.

23. Remove or place a single spacer washer between the outer metal shell and door plastic handlebar electronics to adjust the gaping.
