Dealer Service Instructions for:

Customer Satisfaction Notification YA9 D-Pillar Power Outlet

2021 (VF) Ram ProMaster

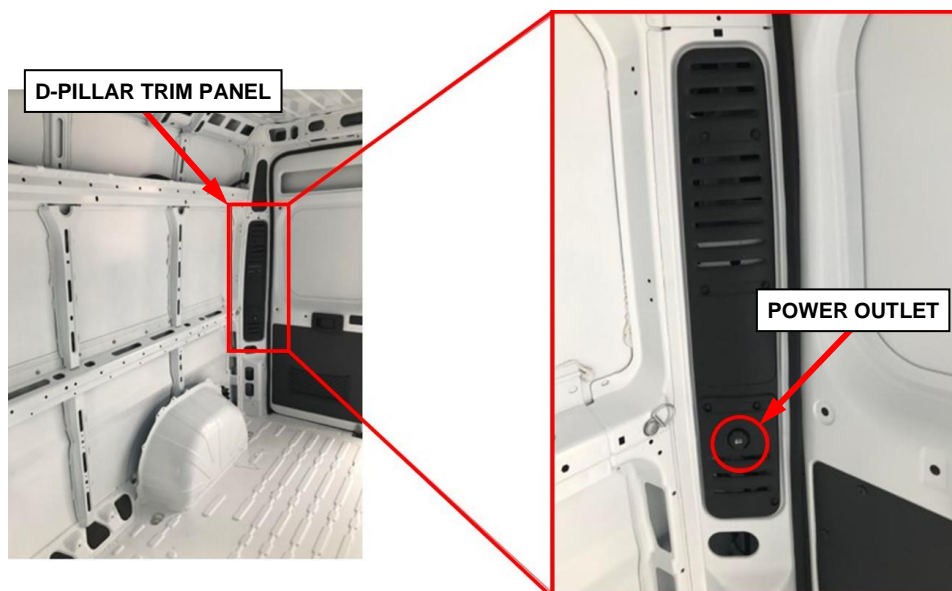
1. Access the interior of the vehicle.
2. Locate the right side rear D-pillar trim panel. (Figure 1)

Figure 1 – Right Side Rear D-Pillar Trim Panel With Power Outlet

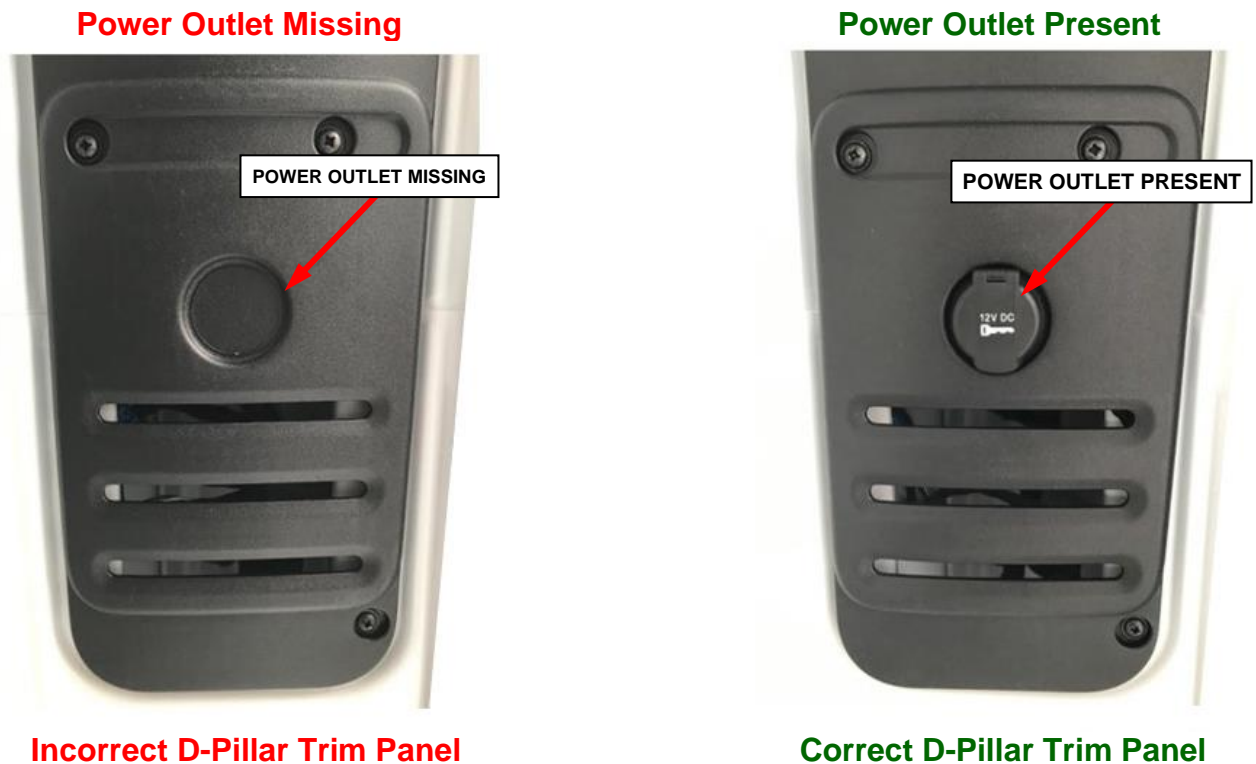
3. Is there a power outlet located in the D-pillar trim panel? (Figure 2)

Figure 2 – Inspect the Right Side Rear D-Pillar Trim Panel for a Power Outlet

Power Outlet Present: Vehicle will not require repair. Claim the inspection LOP 08-YA-91-81 to close the Customer Satisfaction Notification Campaign YA9.

Power Outlet Missing: Order the necessary parts listed in the Parts Information section of this document then have a technician perform the Service Procedure.

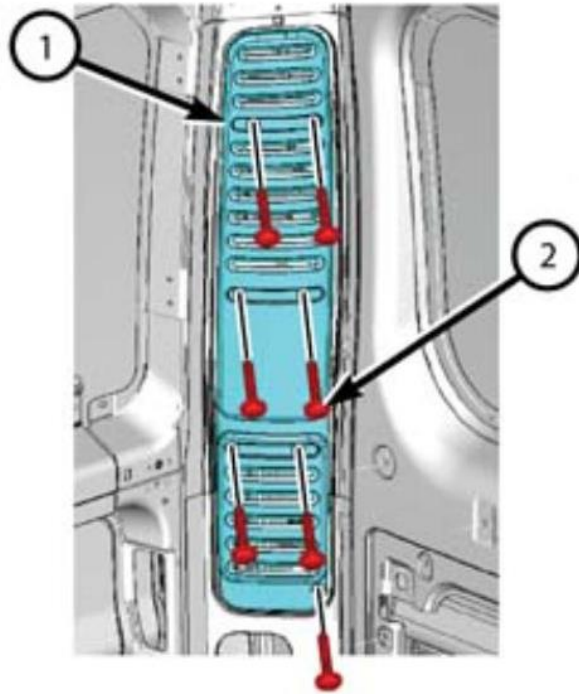
Figure 3 – Right Rear Quarter Trim

1. Remove the seven screws (2) then remove the quarter trim panel (1) and discard (Figure 3).
2. Obtain the NEW parts. Assemble the power outlet to the cap then install the assembly into the quarter trim panel (Figure 4).

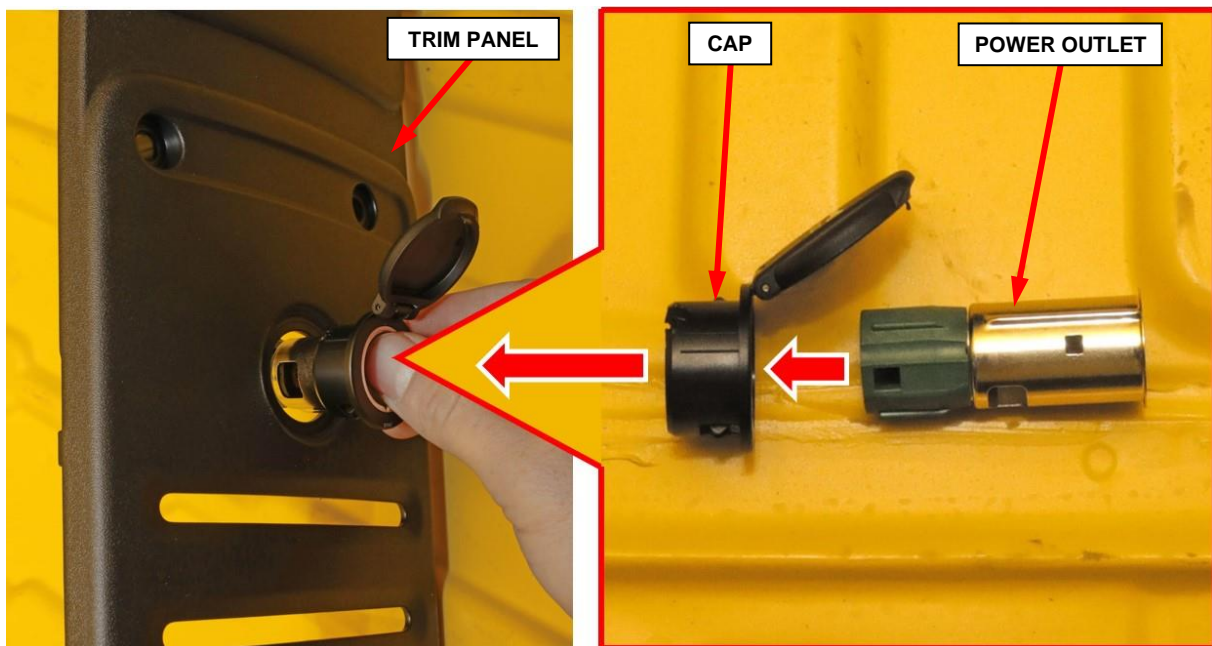
Figure 4 – Assemble NEW Parts: Power Outlet and Cap to Trim Panel

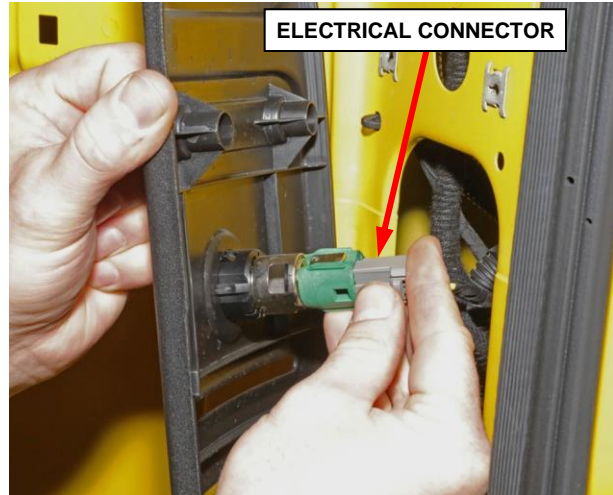
Figure 5 – Connect Wire Harness Connector to Power Outlet

3. Connect the vehicle wire harness connector to the power outlet (Figure 5).

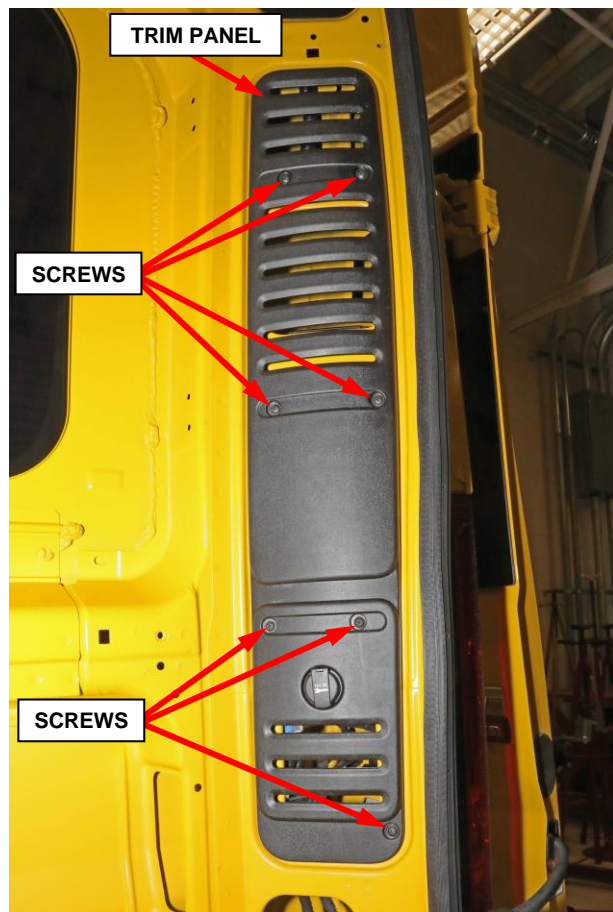
Figure 6 – Install Trim Panel then Fasten Securely with Screws

4. Position the NEW quarter trim panel with power outlet to the D-pillar then securely fasten with the seven screws (Figure 6).

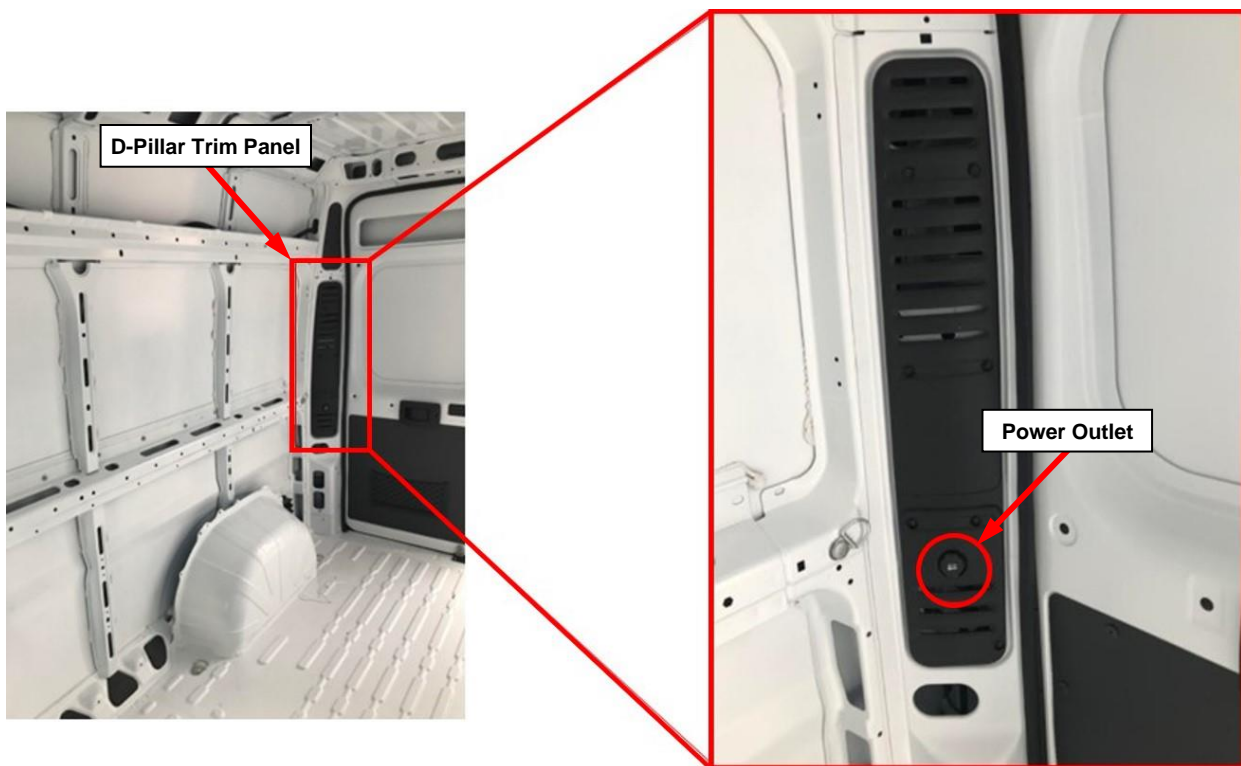
1. Access the interior of the vehicle.
2. Locate the right side rear D-pillar trim panel. (Figure 1)

Figure 1 – Right Side Rear D-Pillar Trim Panel With Power Outlet

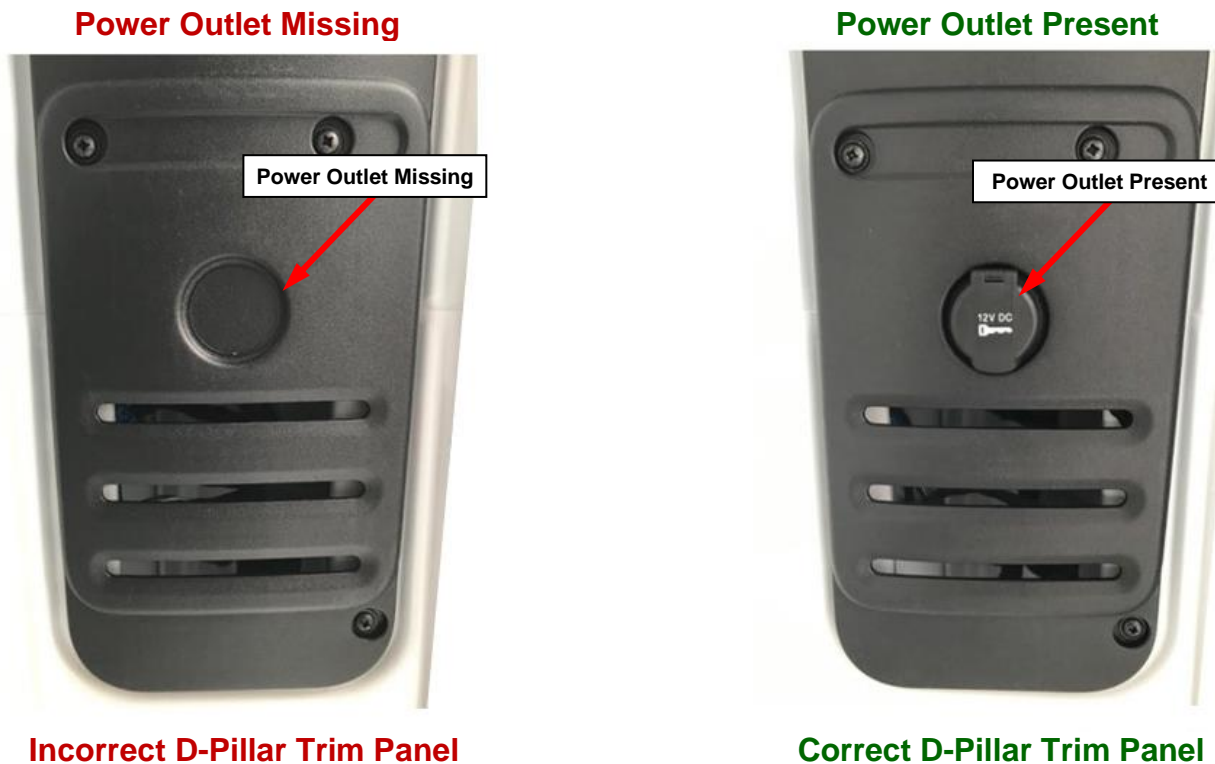
3. Is there a power outlet located in the D-pillar trim panel? (Figure 2)

Figure 2 – Inspect the Right Side Rear D-Pillar Trim Panel for a Power Outlet

Power Outlet Present: Tell your authorized *BusinessLink* dealer that your vehicle is already equipped with a power outlet and to please remove your vehicle from Customer Satisfaction Notification Campaign YA9. Your vehicle will not require repair.

Power Outlet Missing: Tell your authorized *BusinessLink* dealer that your vehicle is missing the power outlet and to please schedule an appointment to install the power outlet to complete Customer Satisfaction Notification Campaign YA9.
