Technical Service Bulletin

39 Bevel box separation point is leaking

39 22 48 2059759/3 October 21, 2022. Supersedes Technical Service Bulletin Group 39 number 20-37 dated November 17, 2020, for reasons listed below.

Model(s)	Year	VIN Range	Vehicle-Specific Equipment
Q3	2015 – 2021	All	With quattro ®

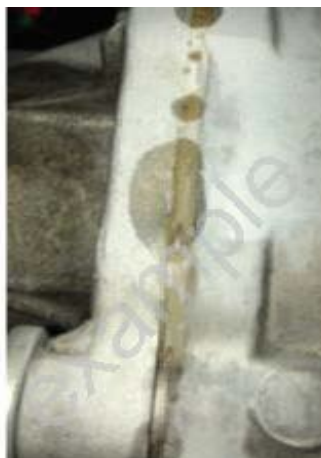
- The customer statement can be confirmed.
- The oil leak can be seen along the case seam of the bevel box (Figure 1), on the passenger side of the propeller shaft on the side facing the engine. It should be between the two bolts in the picture below marked with arrows (Figure 2). These bolts connect the bevel box to the engine bracket (Figure 3, position 1).

Figure 1. Bevel box case seam leak location.

2. Thoroughly clean the bevel box in the area of the case seam (Figure 1) and the two housing bolt holes (Figures 2 and 3).

3. Apply silicone sealant (part number D 174 003 M2) to the case seam (Figure 4, yellow arrows). Apply a continuous seam of the silicone with a width of about 10 mm (Figure 4, red lines) and a height of about 3 mm.

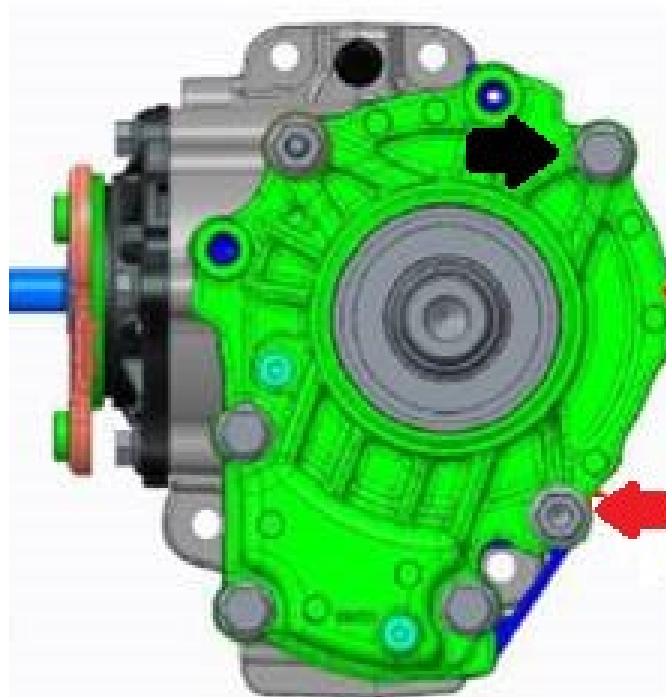
Figure 2. Bolt locations.

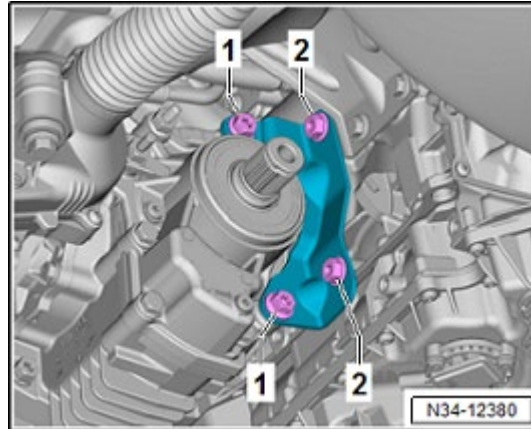
Figure 3. Bolt locations position #1.

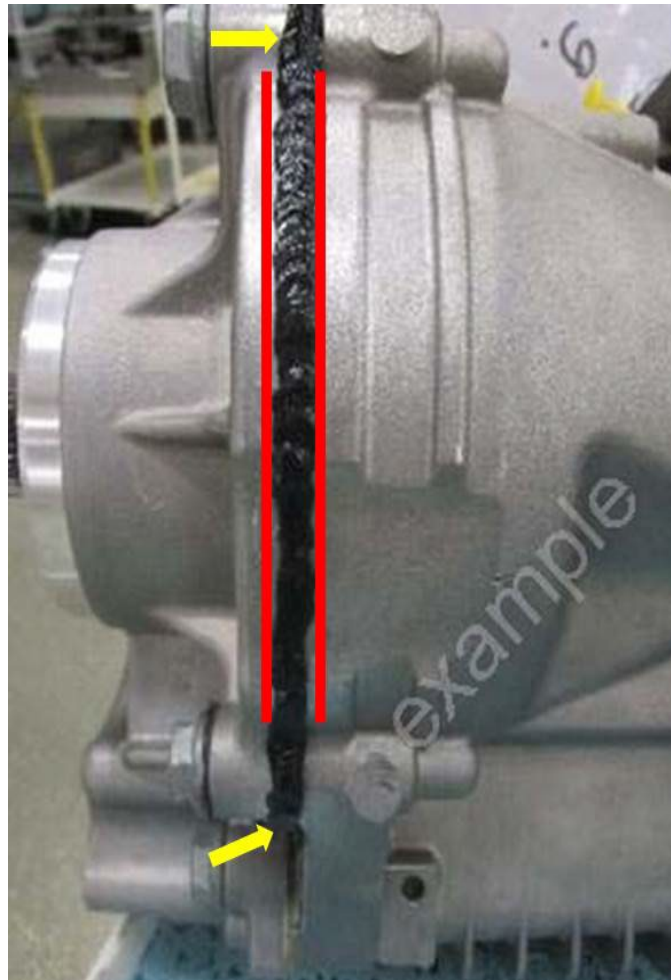
Figure 4. Silicone sealant application.

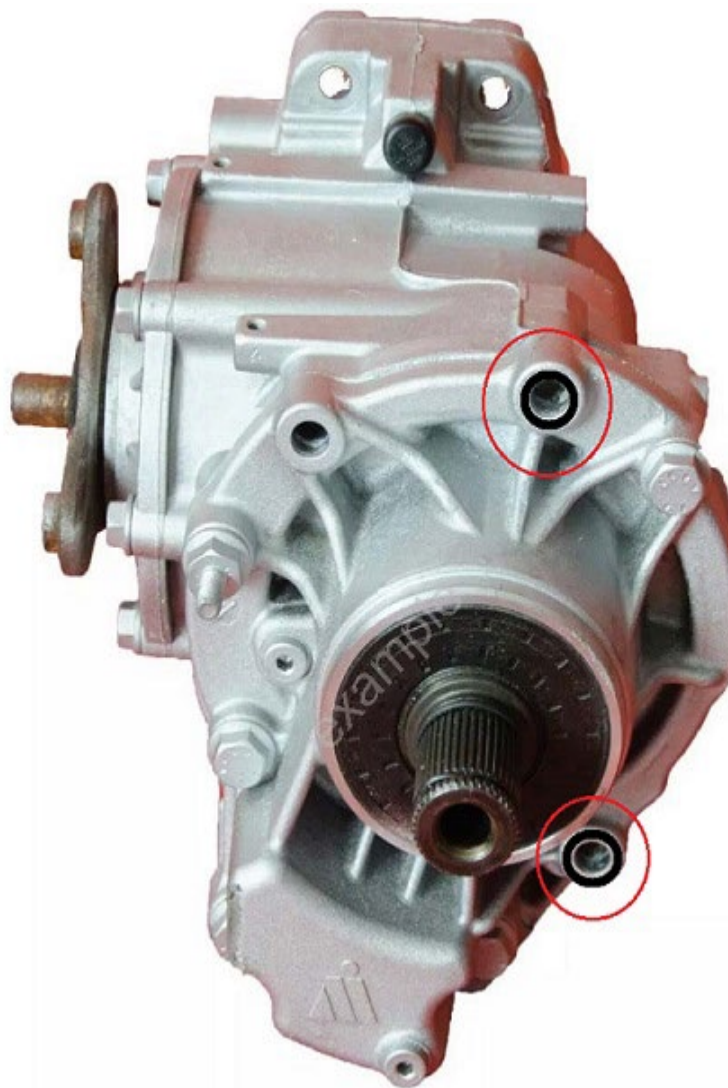
Figure 5. Silicone sealant at bolt holes.

4. Apply silicone sealant (part number D 174 003 M2) continuously to the holes of the housing bolts just before installation (Figure 5, red circles).

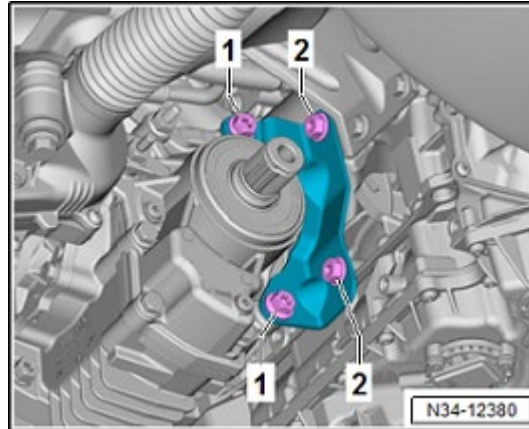
Figure 5. Bolts and engine bracket.

5. Continuously apply the silicone sealant to the shoulder of the removed housing bolts just before installation to form a seal at the engine bracket (Figure 6, position 1).
